# In-flight uncontained engine failure Airbus A380-842, VH-OQA

overhead Batam Island, Indonesia | 4 November 2010

**ATSB Transport Safety Report**  
Aviation Occurrence Investigation  
AO-2010-089  
Final – 27 June 2013

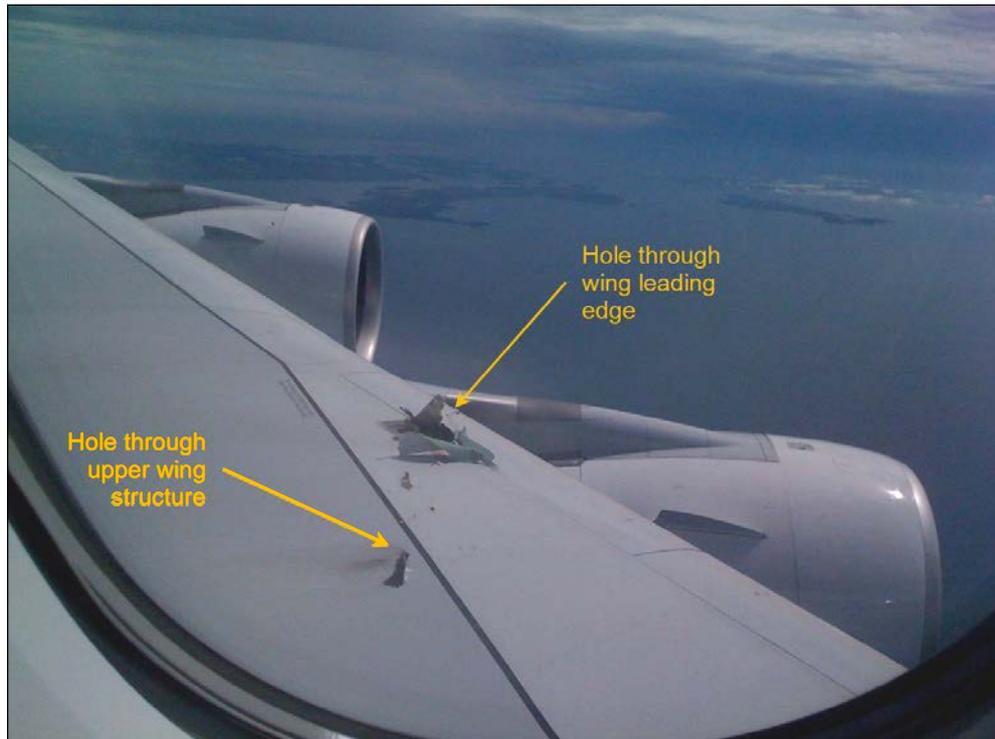
**Figure 7: Examples of damage to the left wing**

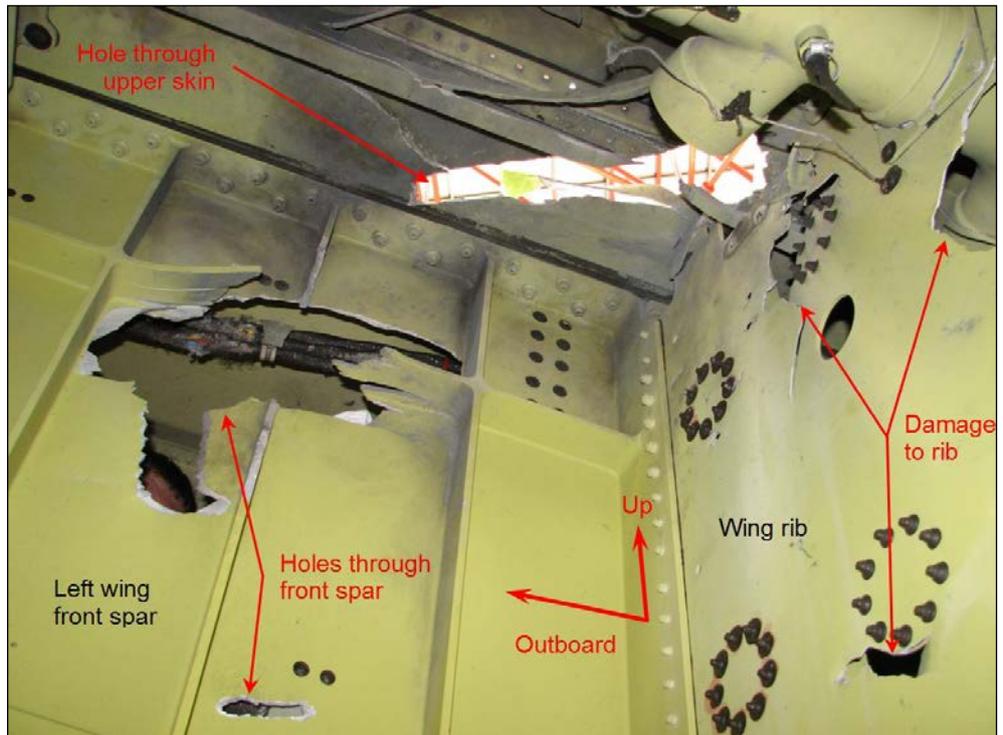
**Figure 8: Example of internal damage to the left wing (looking forward and up)**

In addition to the damage to the primary structure, the left wing lower skin, fuselage skins and vertical and horizontal stabilisers contained numerous indentations and score marks from debris impacts. Further information on the airframe damage is contained in Appendix B.

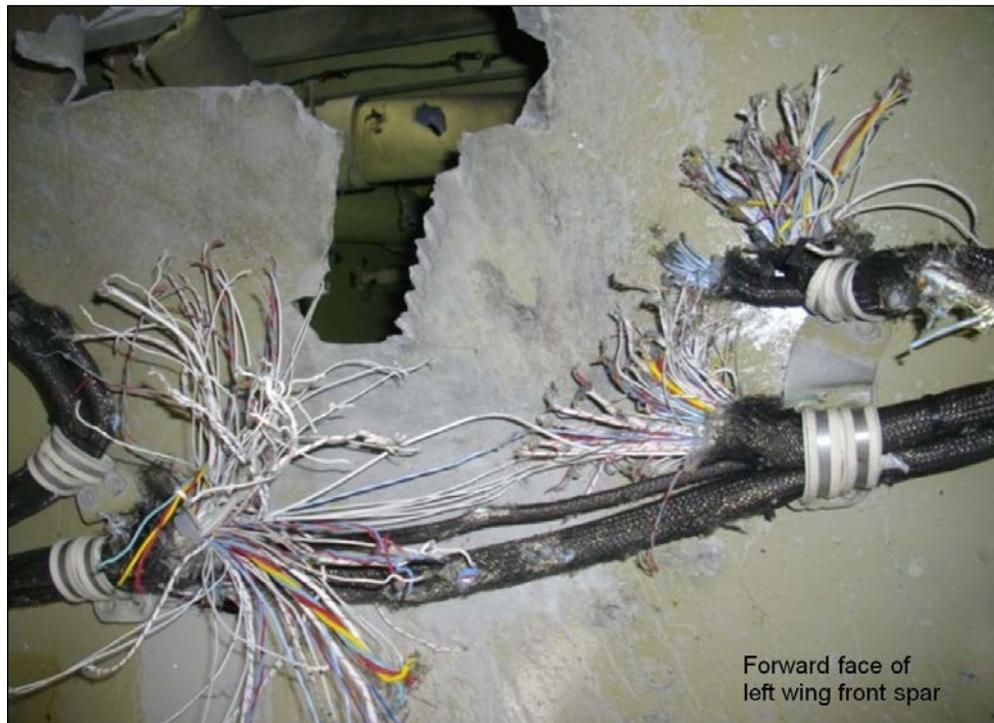
**Figure 9: Example of wiring damage in the left wing (looking rearwards)**

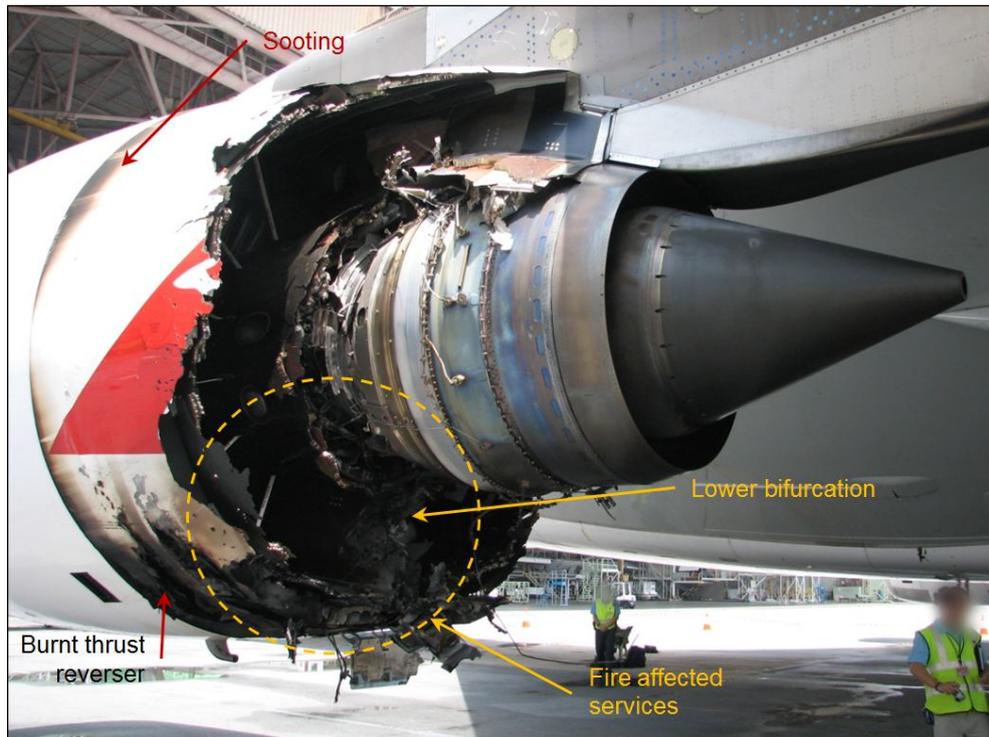
**Figure 16: No. 2 engine showing fire damage to the lower left engine nacelle**

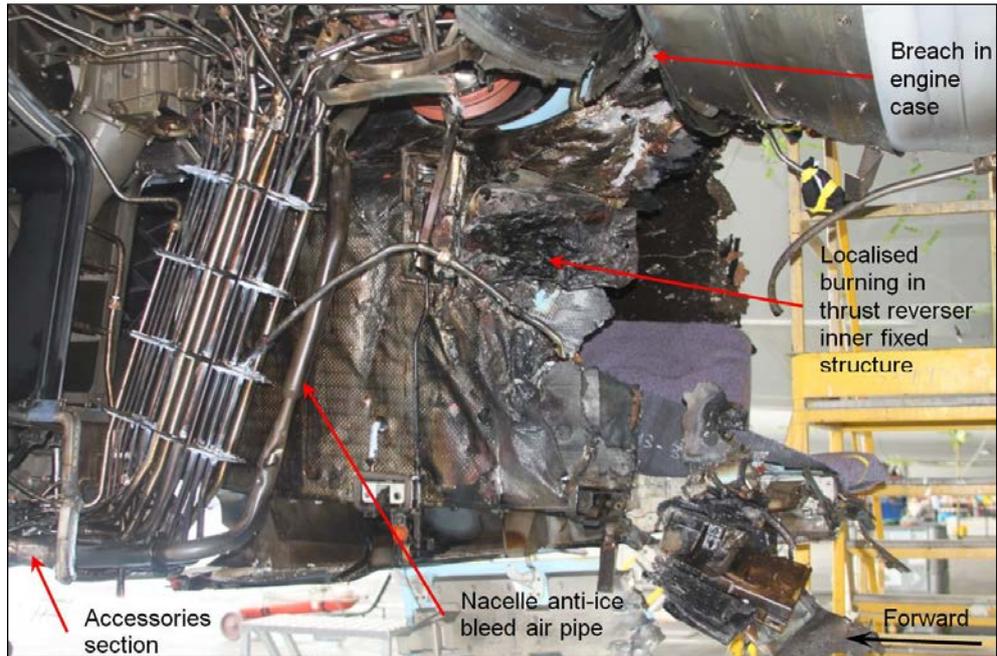
Initial on-site inspection identified that the fire was most intense in the lower left thrust reverser section and in the lower bifurcation<sup>13</sup> (Figure 17 and 18). Sooting, glazing and the effects of heat were observed on a number of electrical, air, oil and hydraulic supply lines and the nacelle anti-ice bleed air ducts within the core section, lower bifurcation and accessories section (on the fan casing). A significant amount of oil was smeared on the lower panel of the thrust reverser cowl (Figure 18).

**Figure 17: Example of fire damage in lower the bifurcation (looking to the forward and right of the No. 2 engine)**

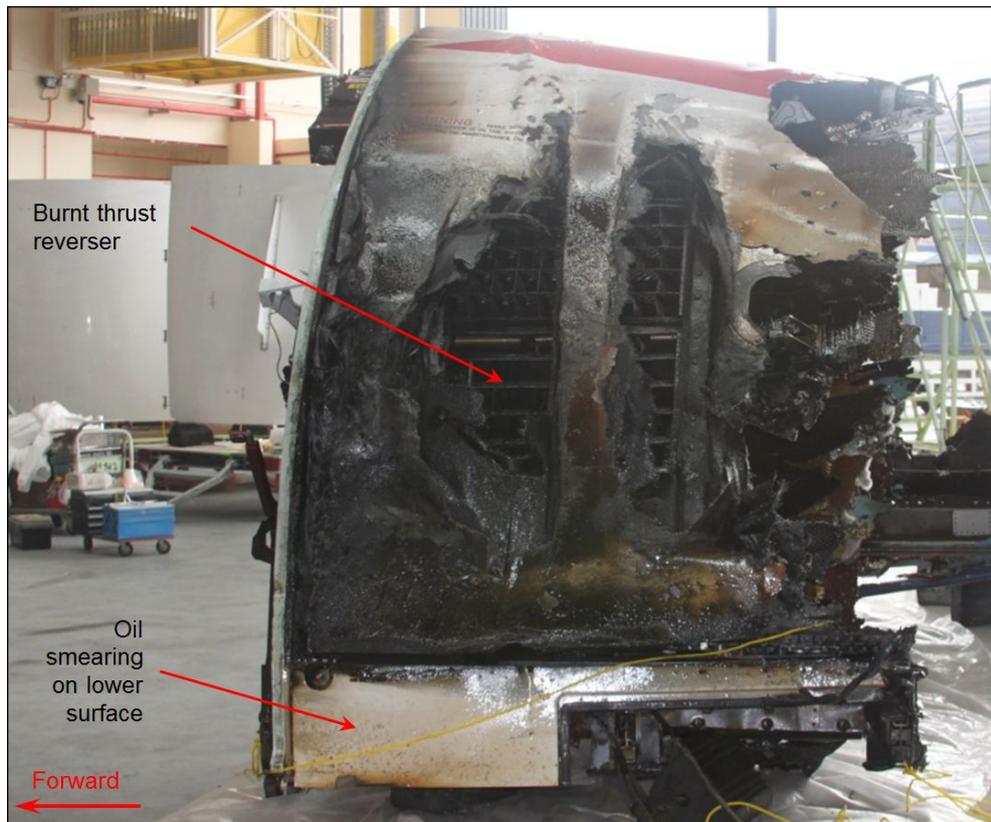
**Figure 18: Left thrust reverser section (looking at the lower surface of the engine)**

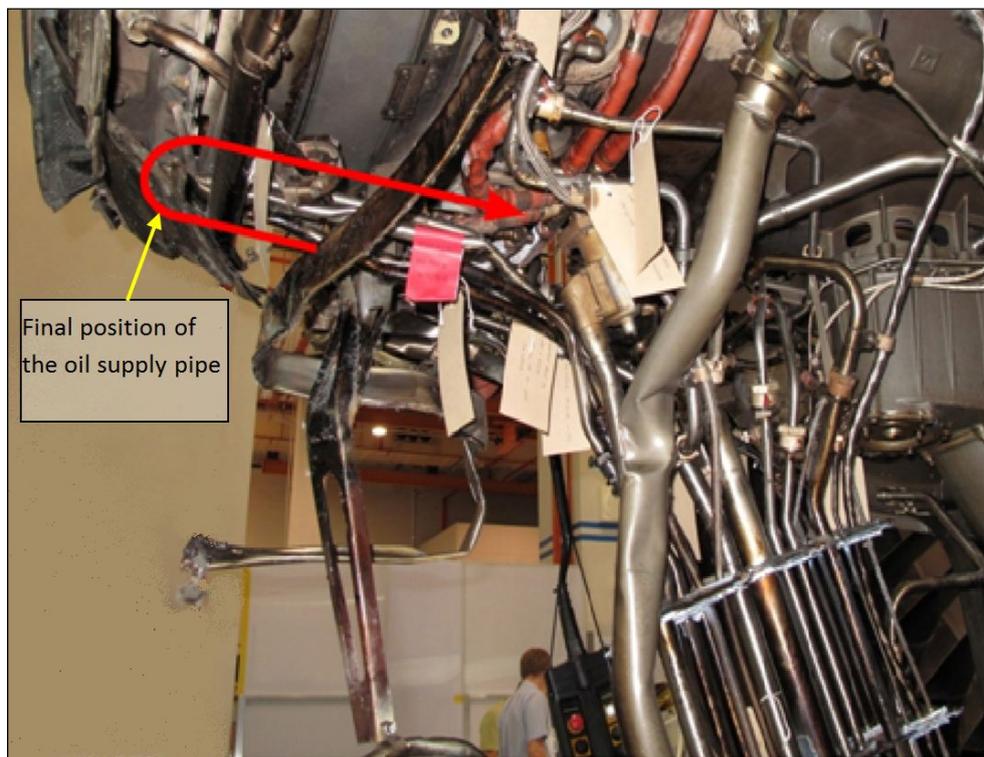
During the subsequent engine inspection, it was noted that an oil supply pipe to the HP/IP and low pressure (LP) turbine bearings that was located within the lower bifurcation had been severed and was kinked forward (Figure 19). That damage was

**Figure 19: Representation of the position of the oil supply pipe to the HP/IP and LP turbine bearing chambers (severed and bent forwards during the engine failure sequence)**

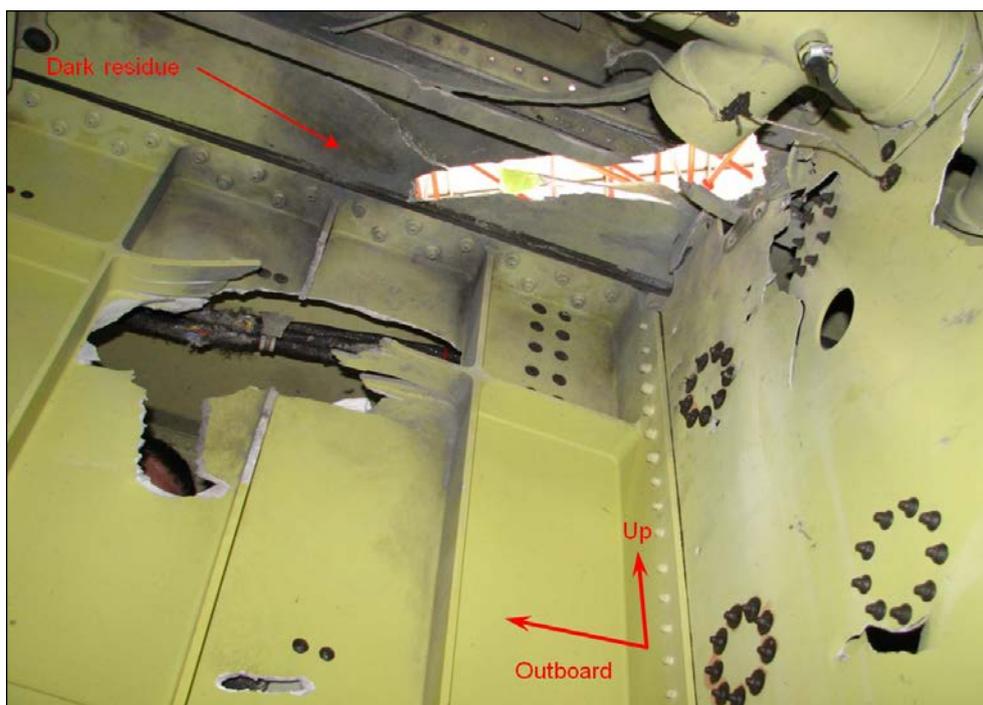
**Figure 23: Dark residue in left inner wing fuel tank (looking up and forward)**

The ATSB conducted a detailed inspection of the left inner fuel tank region to identify potential sources of ignition. The surface temperature of the turbine disc fragment and the frictional effects associated with the passage of the fragment would have been sufficient to ignite the fuel vapour within the tank volume. No other potential sources of ignition were identified as being sufficient to have initiated the fire.

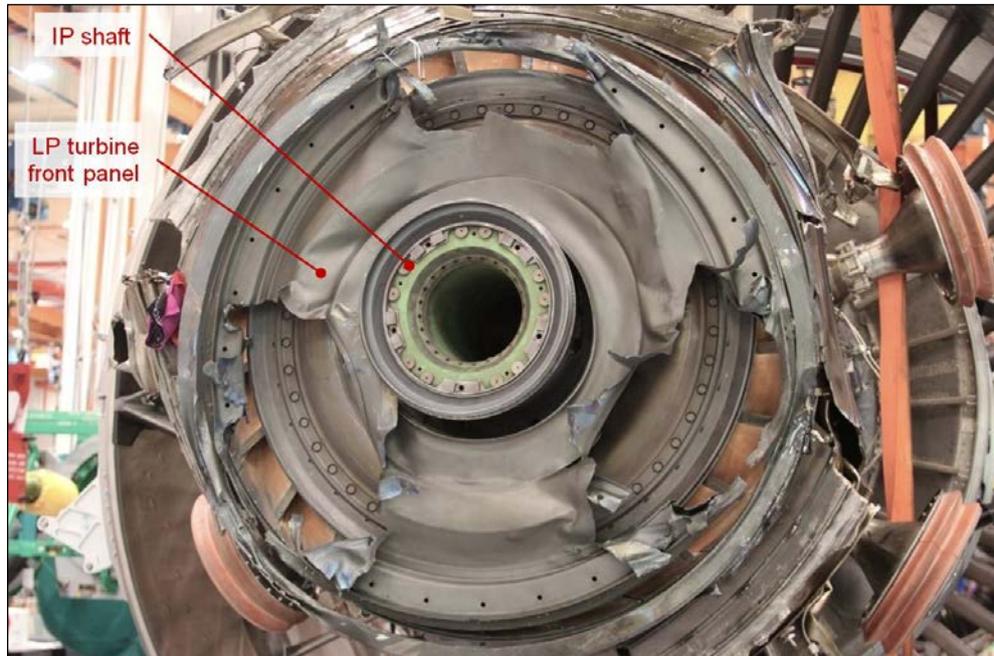
**Figure 33: LP turbine front panel damage**

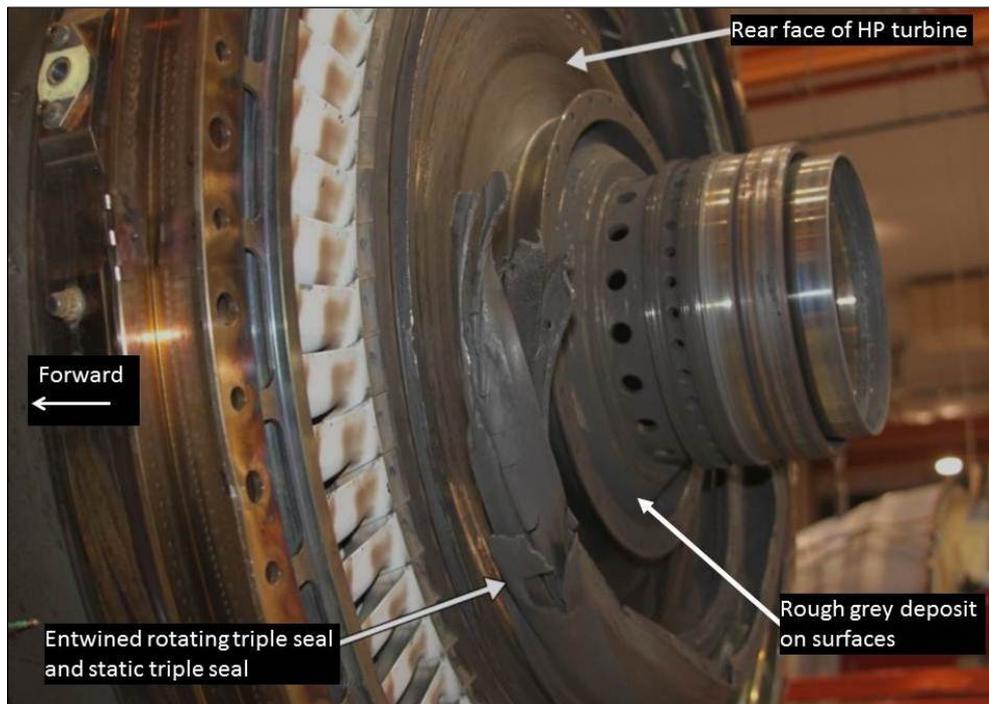
**Figure 35: Damage between the HP/IP structure and HP turbine**

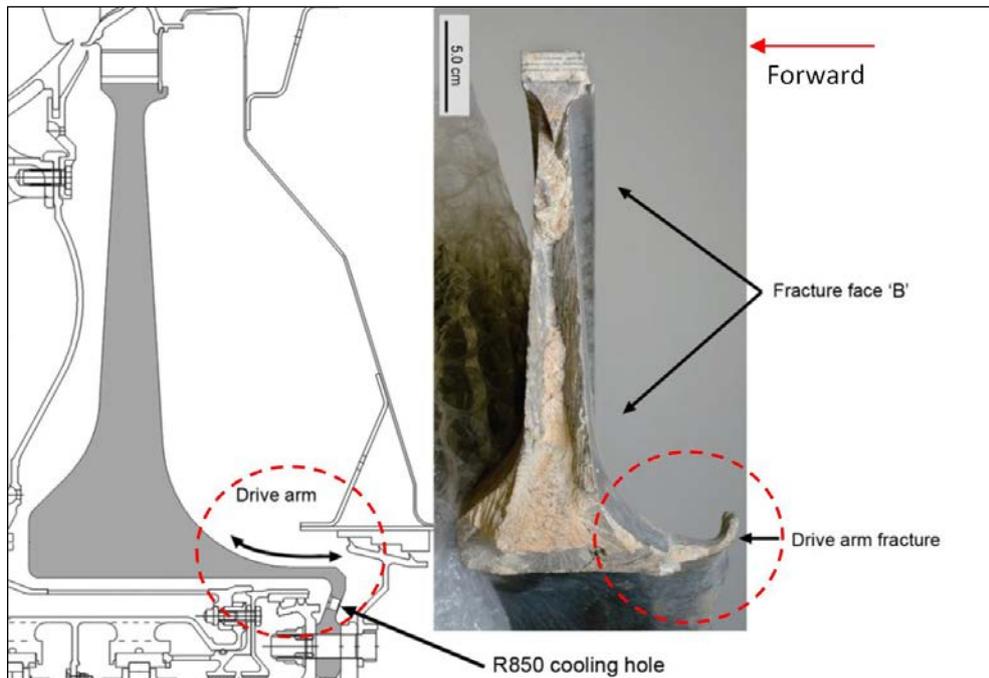
**Figure 39: Comparison of a diagrammatic representation of the IP turbine disc with the recovered segment of the disc**

The disc segment exhibited a significant amount of overall deformation. There was an average radial growth of about 19 mm and the blade restraint (firtree) slots had opened by 0.3 to 0.4 mm when compared to the manufacturer's specifications.

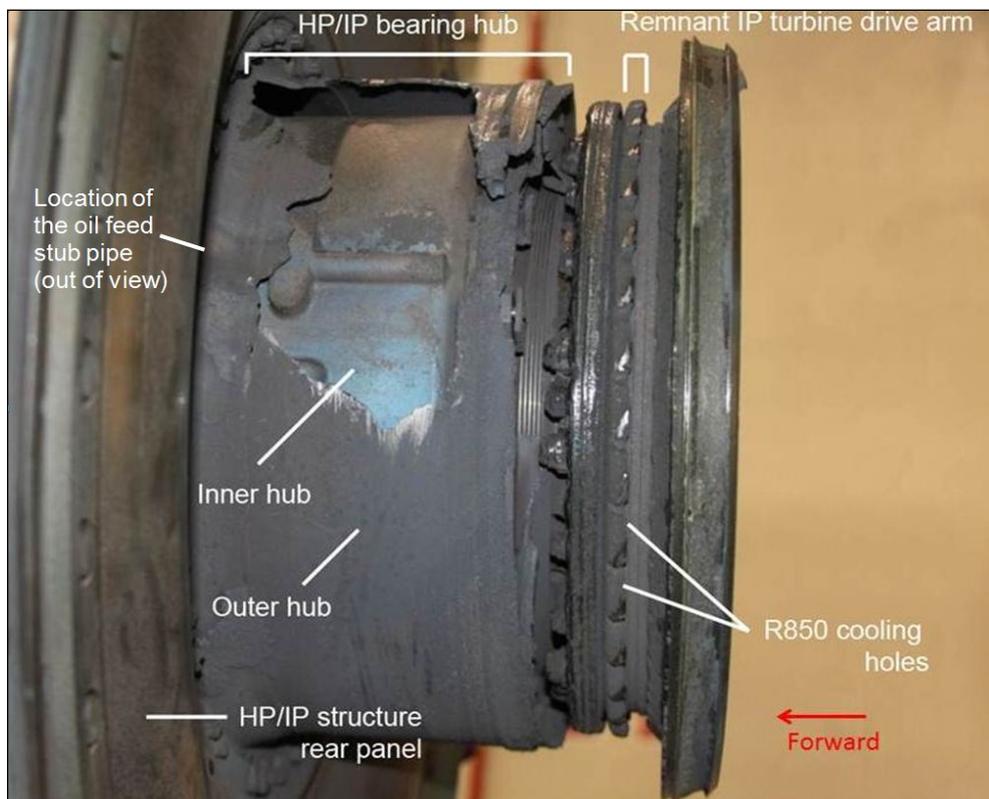
**Figure 40: Damage to the HP/IP hub structure**

The oil feed stub pipe had detached and displaced outwards about 30 mm from the inner hub. A remnant of the oil feed stub pipe remained in the inner hub (Figure 41).

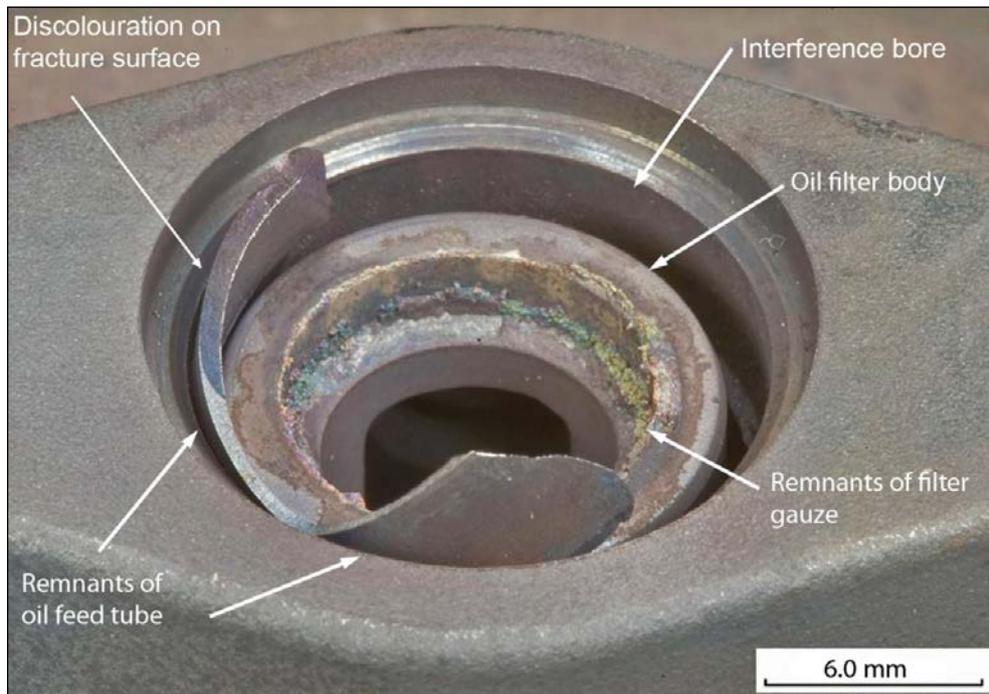
**Figure 42: HP/IP inner hub oil feed pipe**

The oil feed stub pipe was fractured in two planes, one around the weld that attaches the pipe to the inner hub, and the other further outboard, close to the shoulder where the pipe presses into the inner hub. Three distinct fracture regions were identified on the oil feed stub pipe:

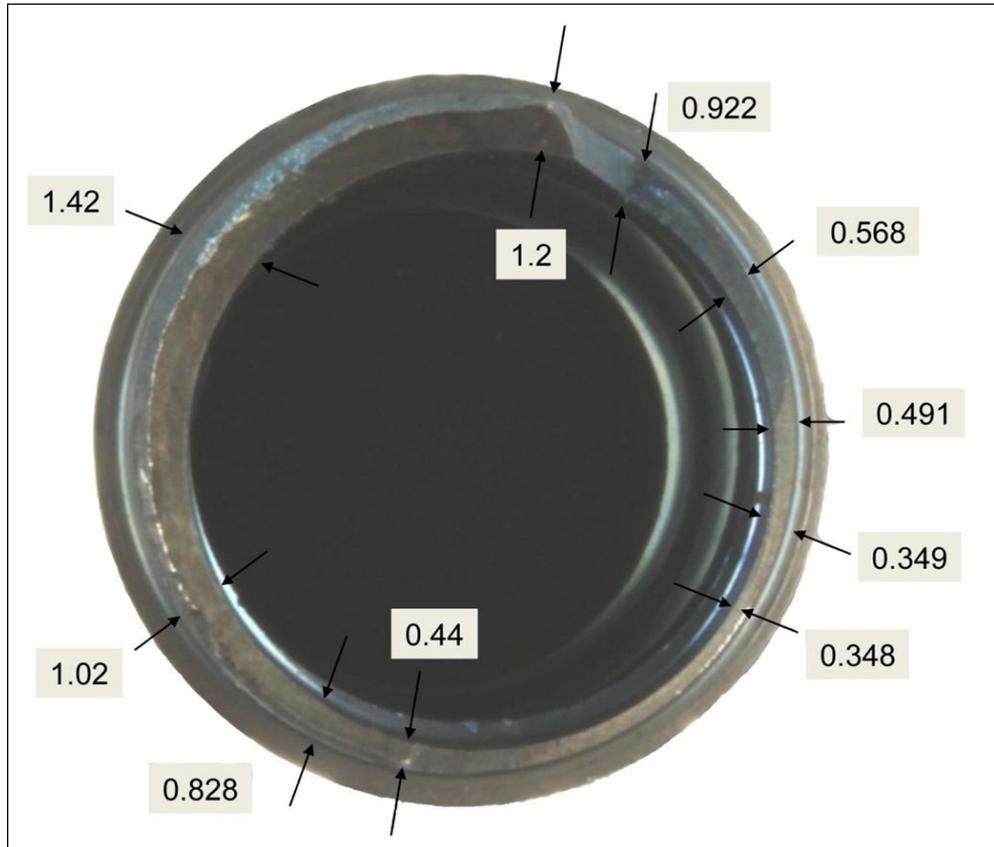
**Figure 45: Fractured oil feed stub pipe wall measurements**

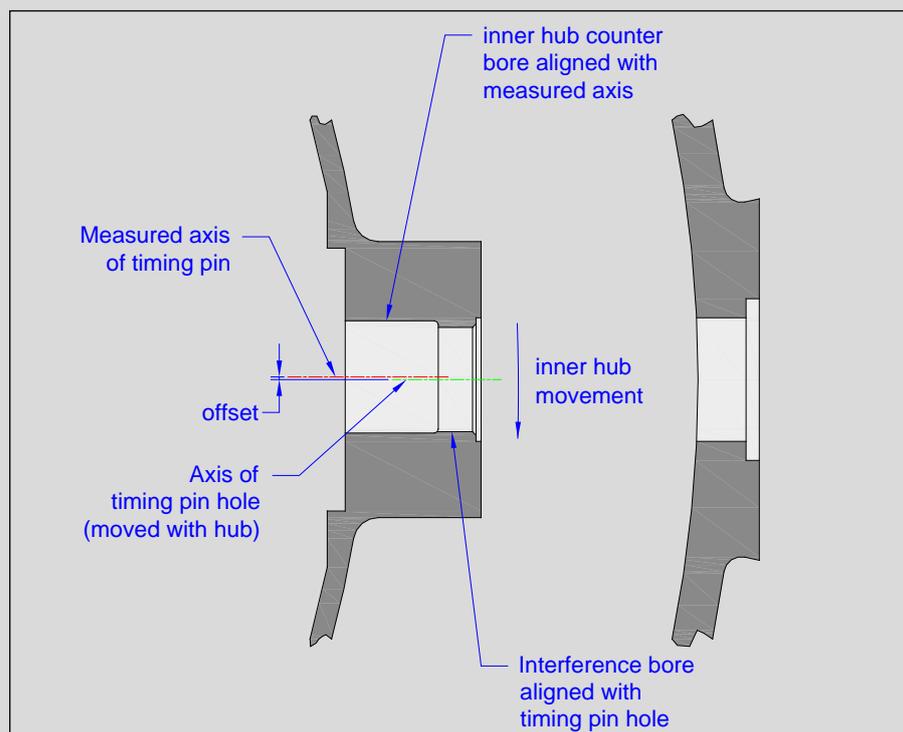
**Figure 74: Example of inner hub counter bore/interference bore offset**

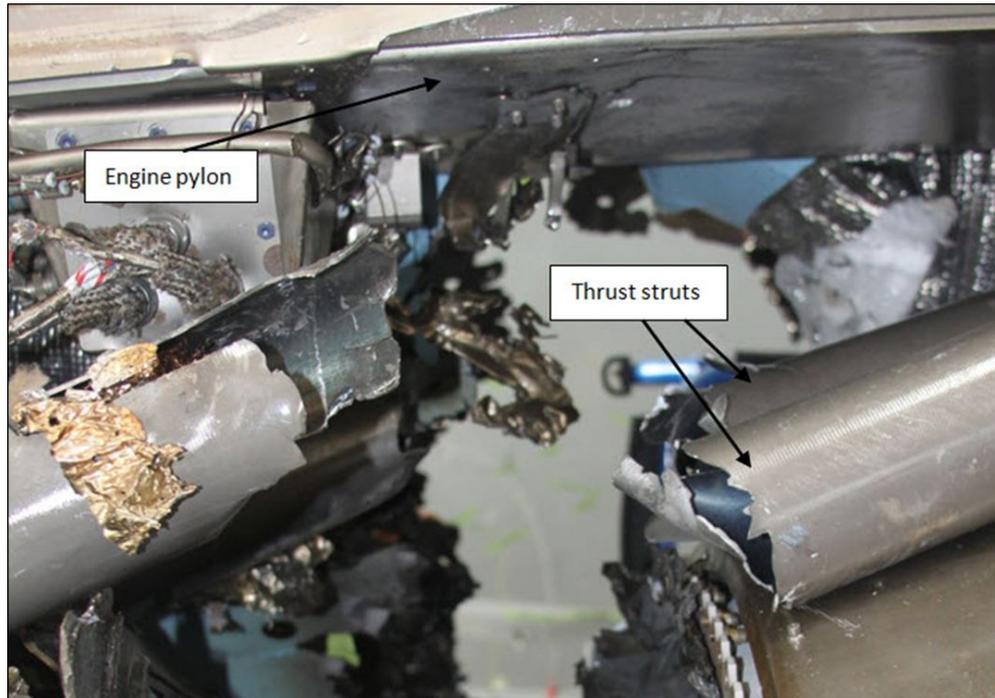
**Figure B4: Fractured tubular thrust struts**

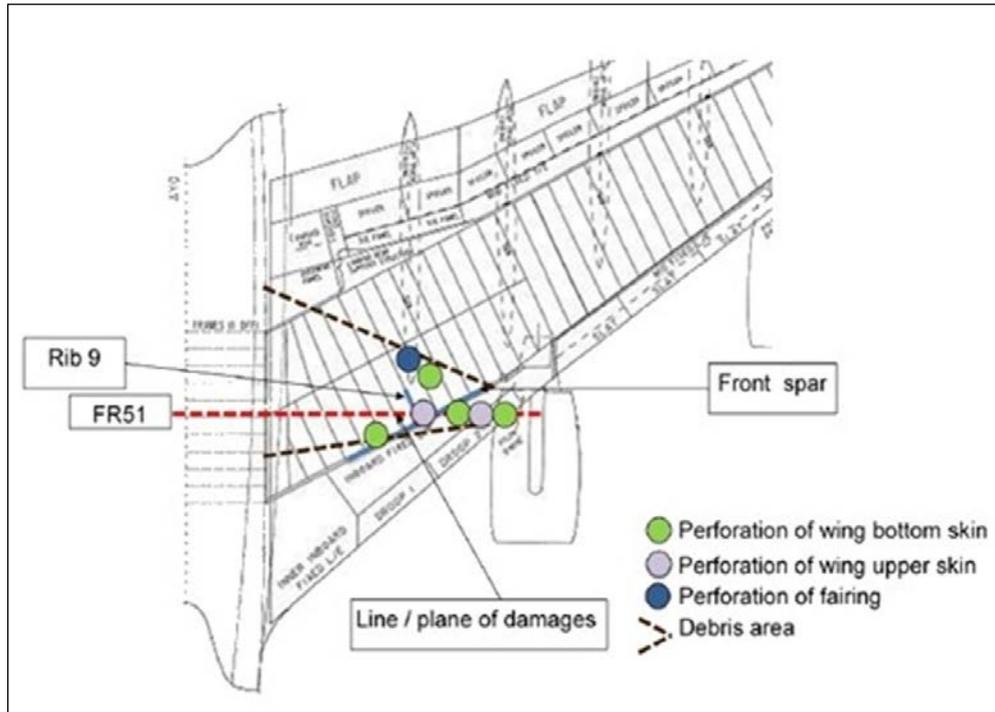
**Figure B6: Left wing schematic showing the locations of significant wing skin damage and distribution of debris path**

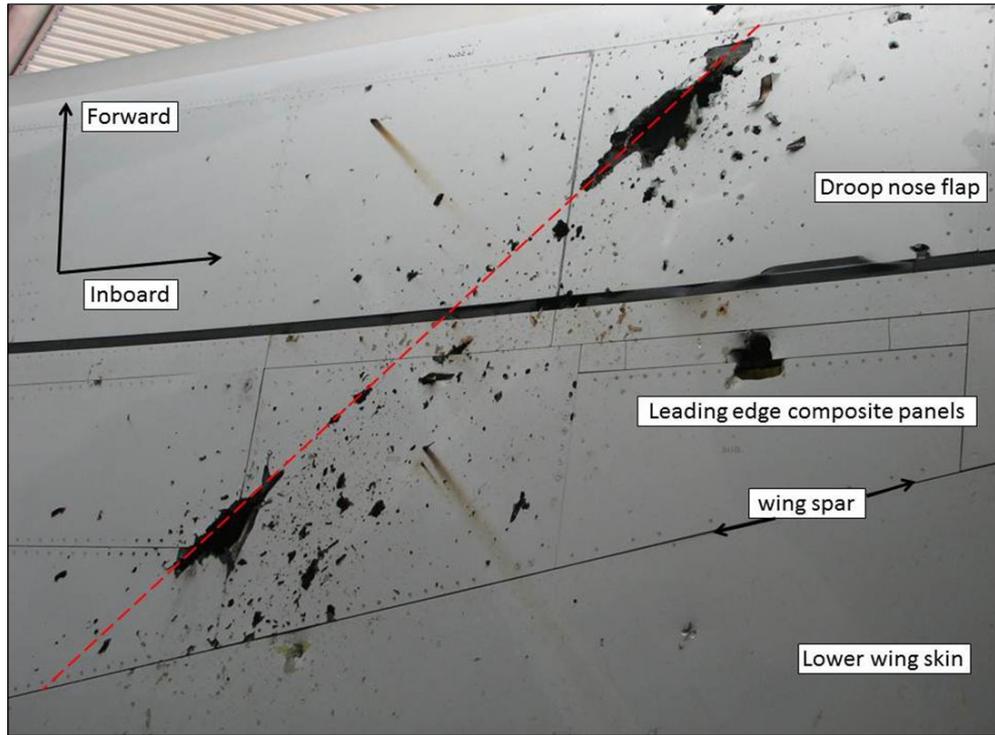
**Figure B10: Penetration damage to the lower wing skin and droop nose flap from major IP turbine disc fragments and other engine debris that were ejected after the burst**

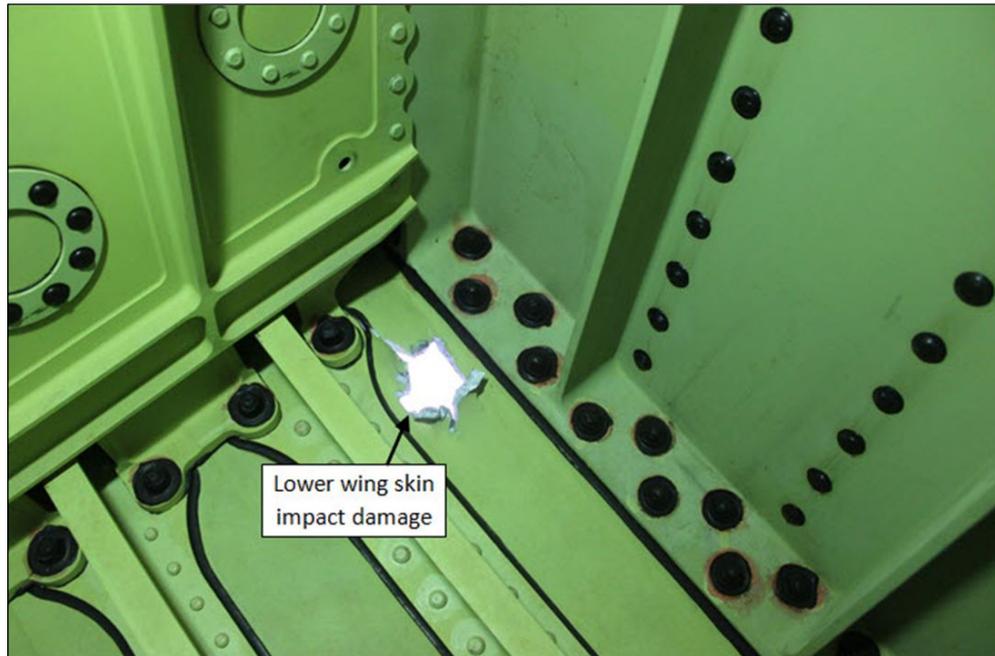
**Figure B12: Puncture damage to the left-lower wing skin looking forward from inside the wing**

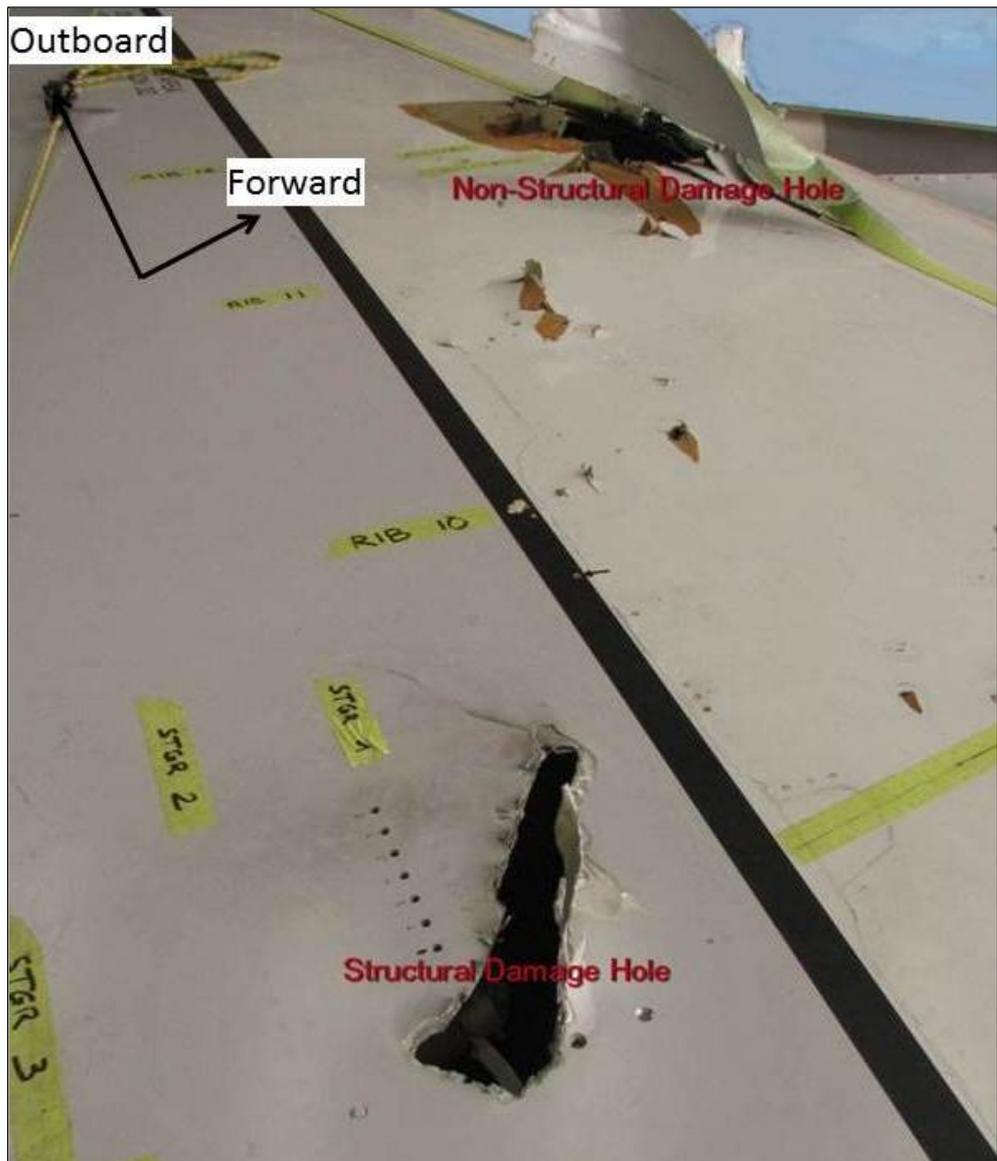
Figure B15: Upper wing damage showing structural and non-structural damage

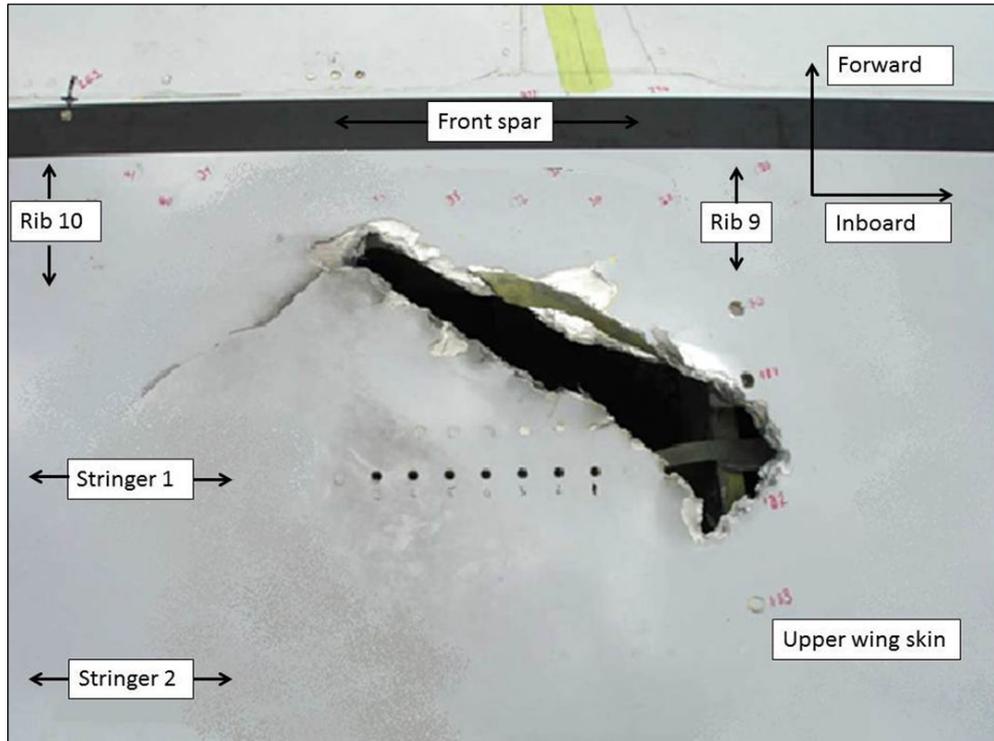
**Figure B16: Damage to the upper wing skin from a significant disc fragment, panel No. 1 between Ribs 9 and 10**

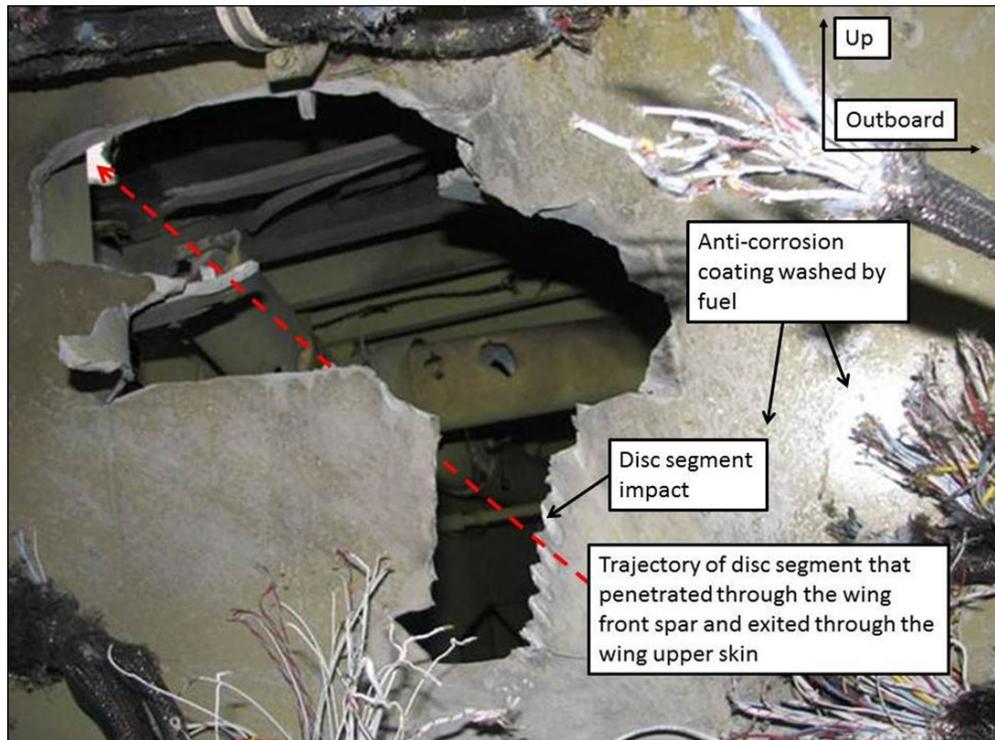
**Figure B17: Impact damage from penetration of a disc fragment through the front spar of the left wing. The fragment continued in its trajectory to exit through the upper wing skin**

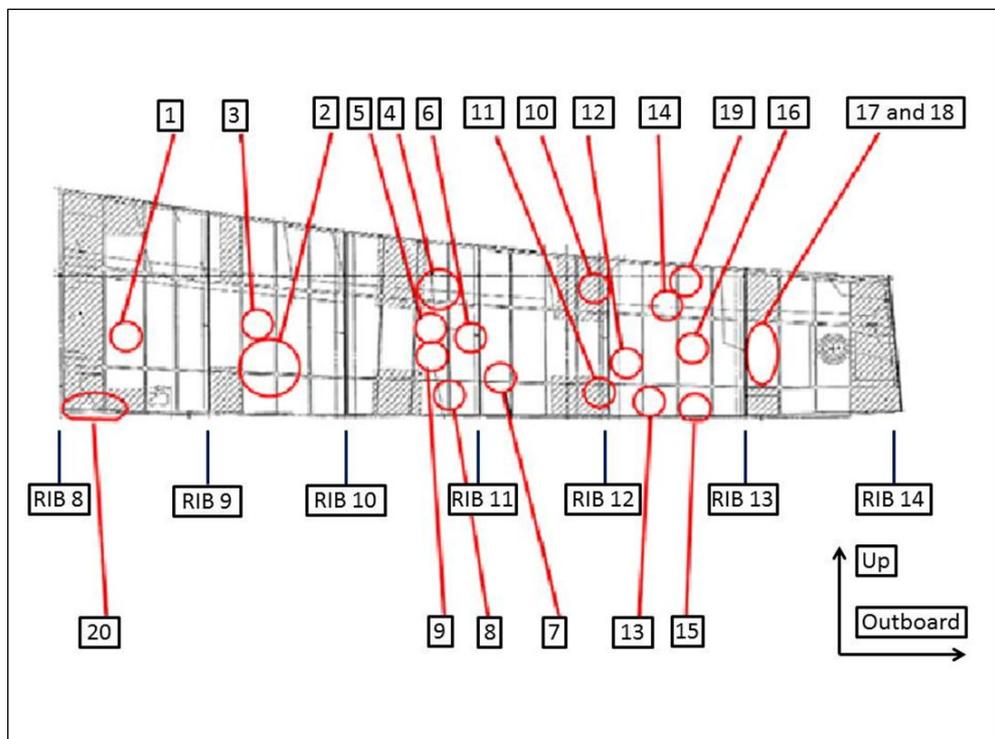
**Figure B18: Damage schematic of the left wing front spar, looking at the forward side that extended between Rib 8 and Rib 14**

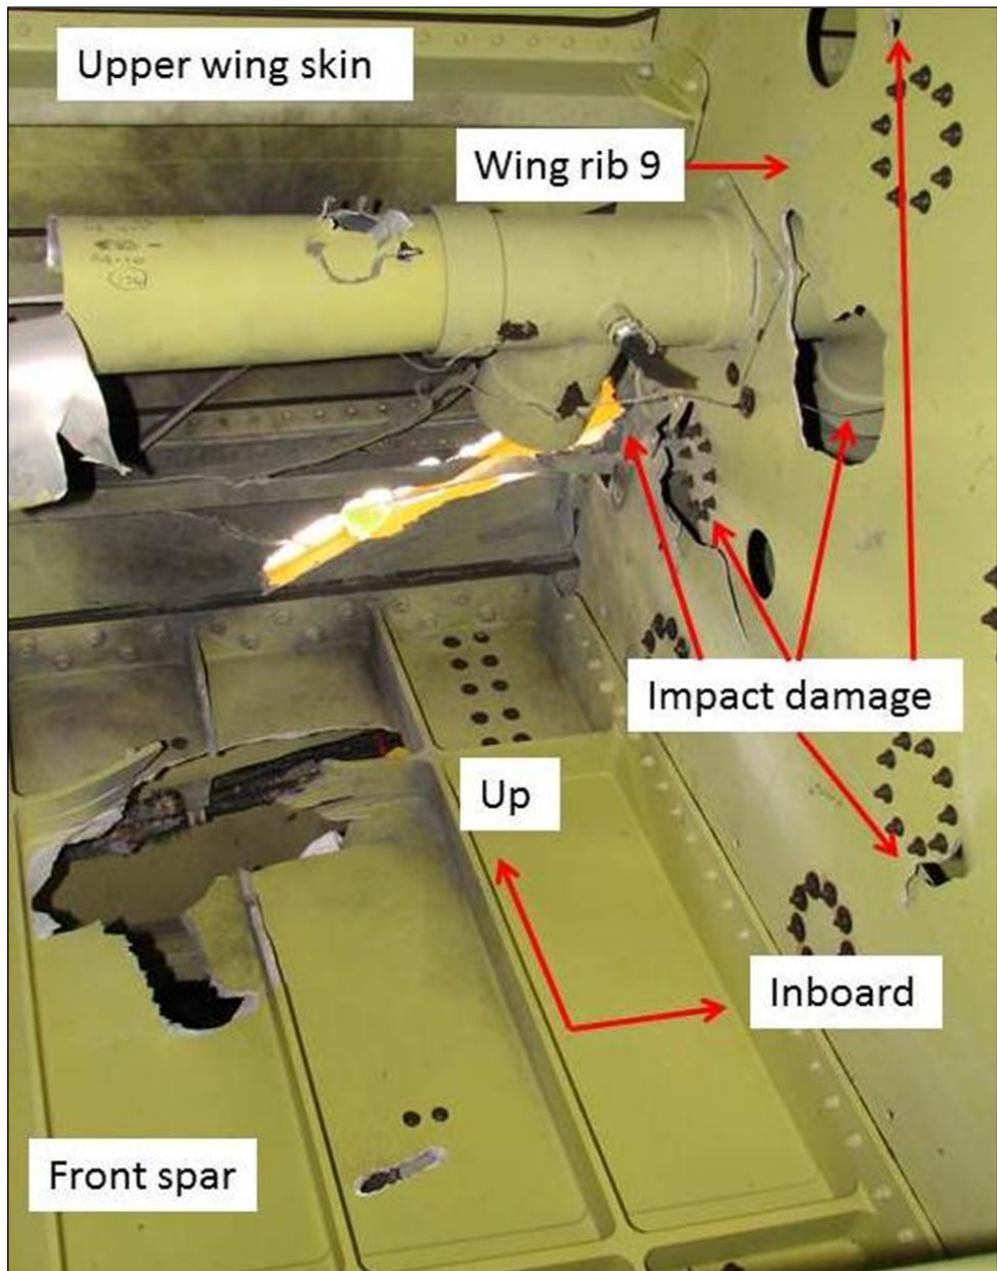
Figure B19: Internal wing rib damage showing damage in 5 locations. Viewed from lower wing skin access panel

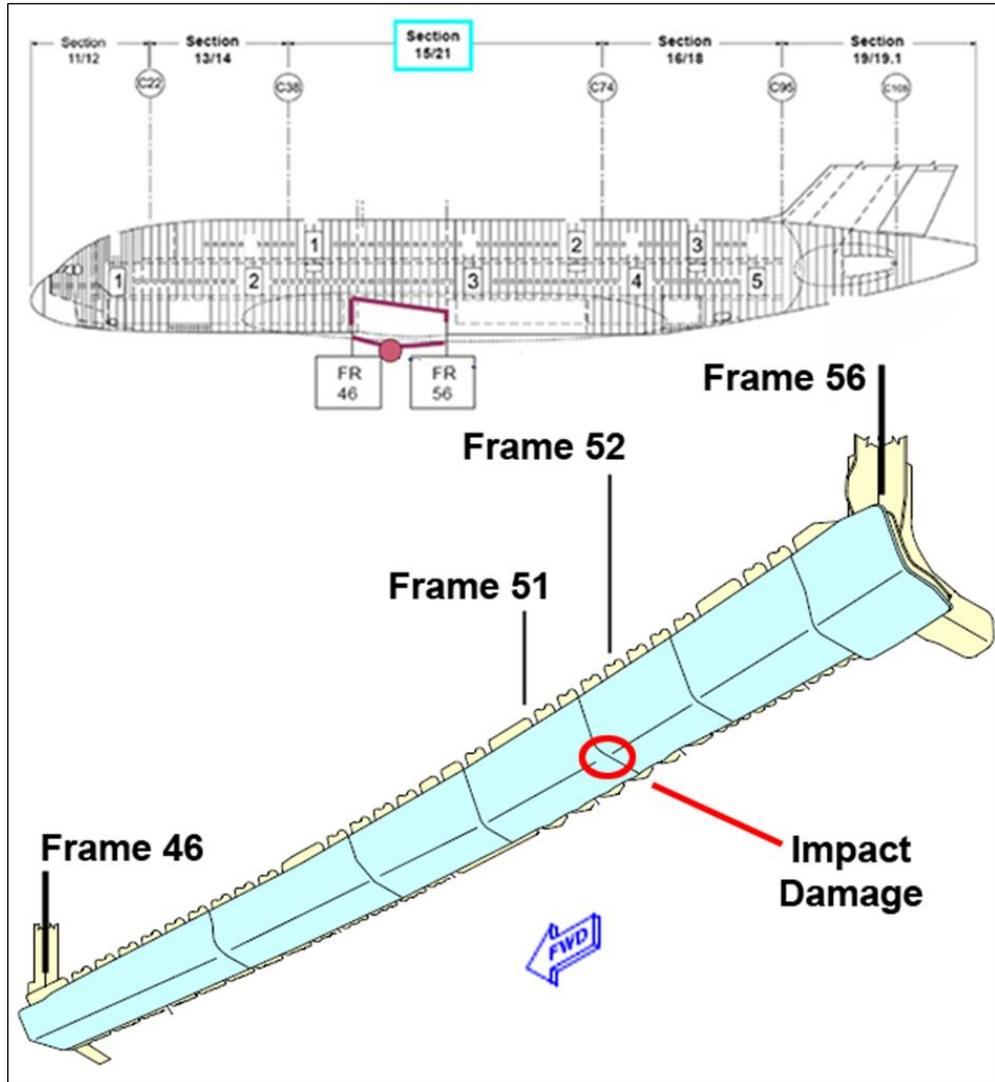
Figure B22: Left butt-straps and damage location between Frame 52 and 51

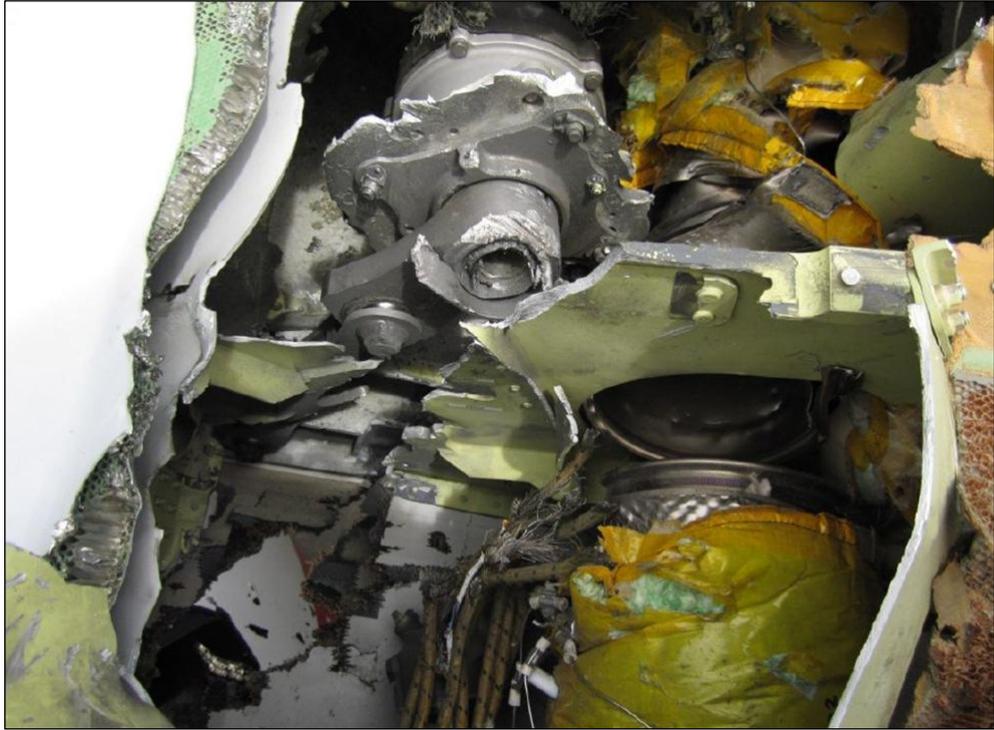
**Figure B29: Engine debris impacted the wing droop nose slat, wing structure and components within the leading edge—viewed from the upper wing surface**

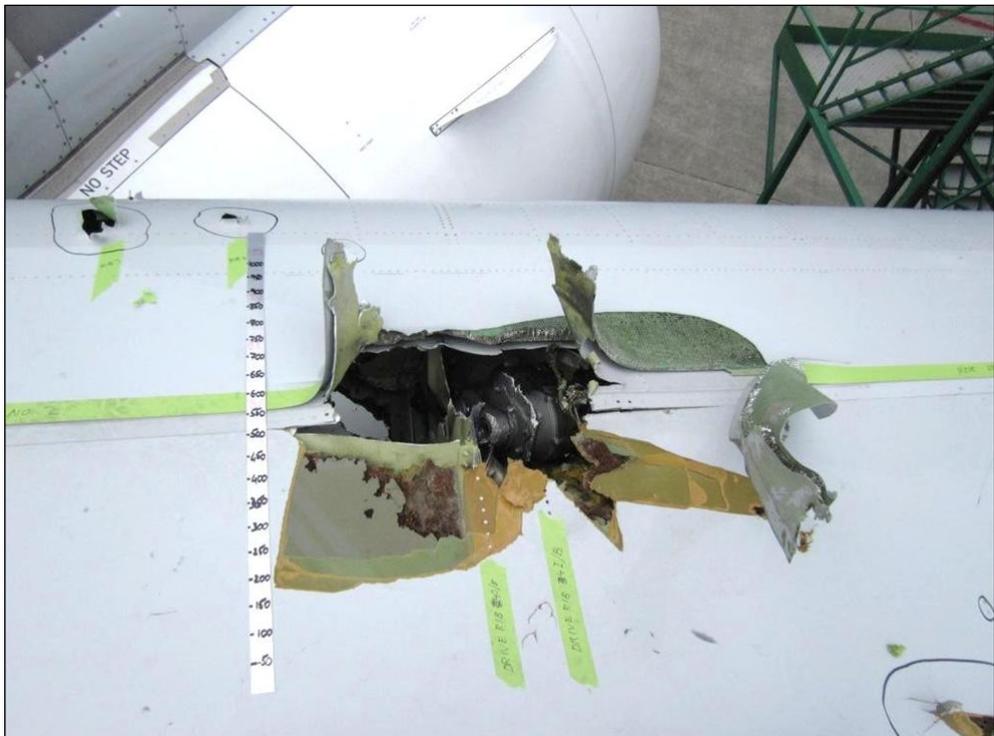
**Figure B30: Damage to the drive motor located at leading edge Drive Rib No. 4**

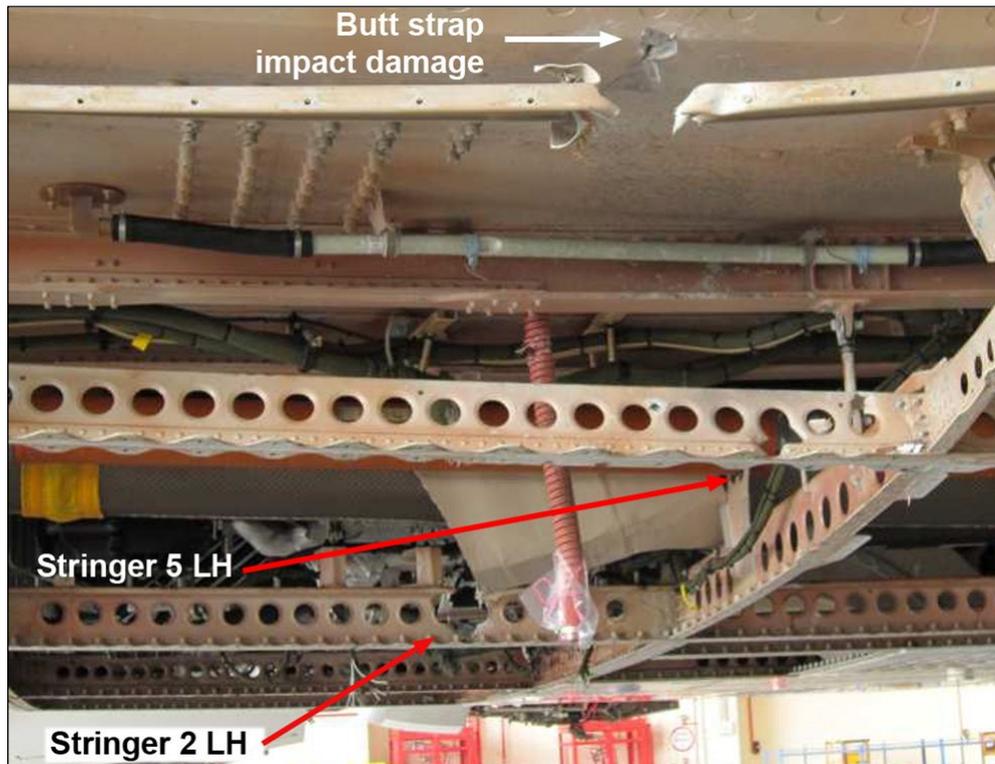
**Figure B34: Impact and penetration damage to the fuselage structure between airframe locations FR50 and FR54 from a high-energy fragment of the IP turbine disc**
