# In-flight uncontained engine failure Airbus A380-842, VH-OQA

overhead Batam Island, Indonesia | 4 November 2010

**ATSB Transport Safety Report**  
Aviation Occurrence Investigation  
AO-2010-089  
Final – 27 June 2013

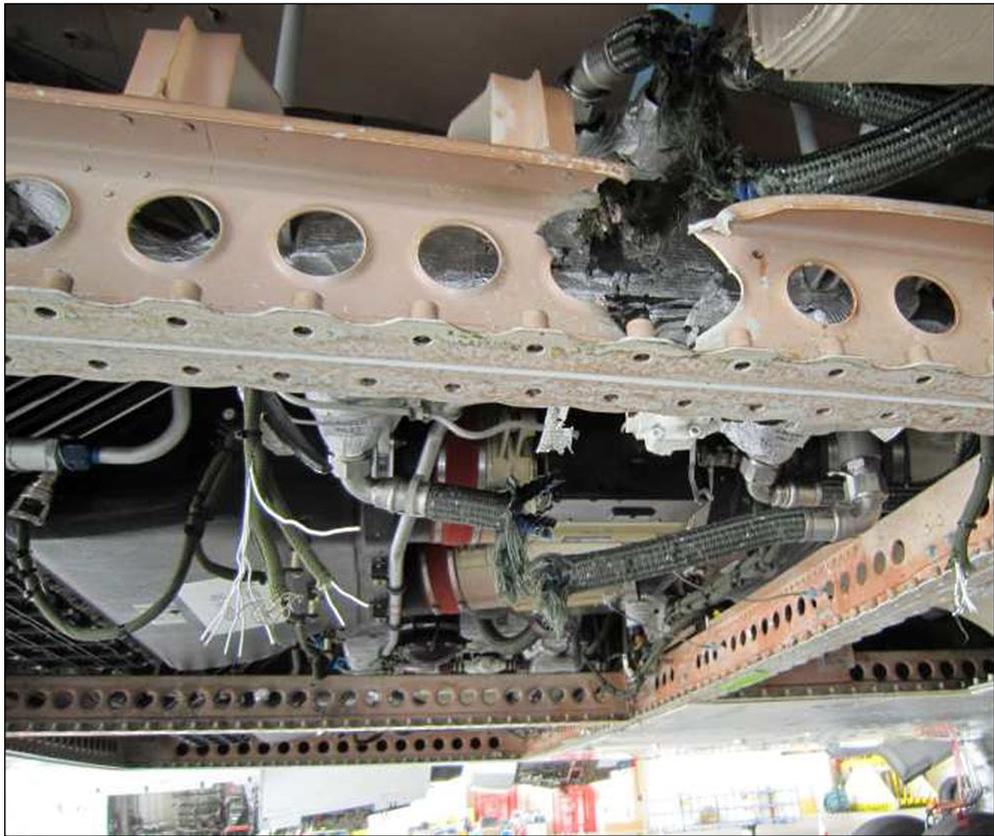
**Figure B35: Stringer 2 LH impact damage**

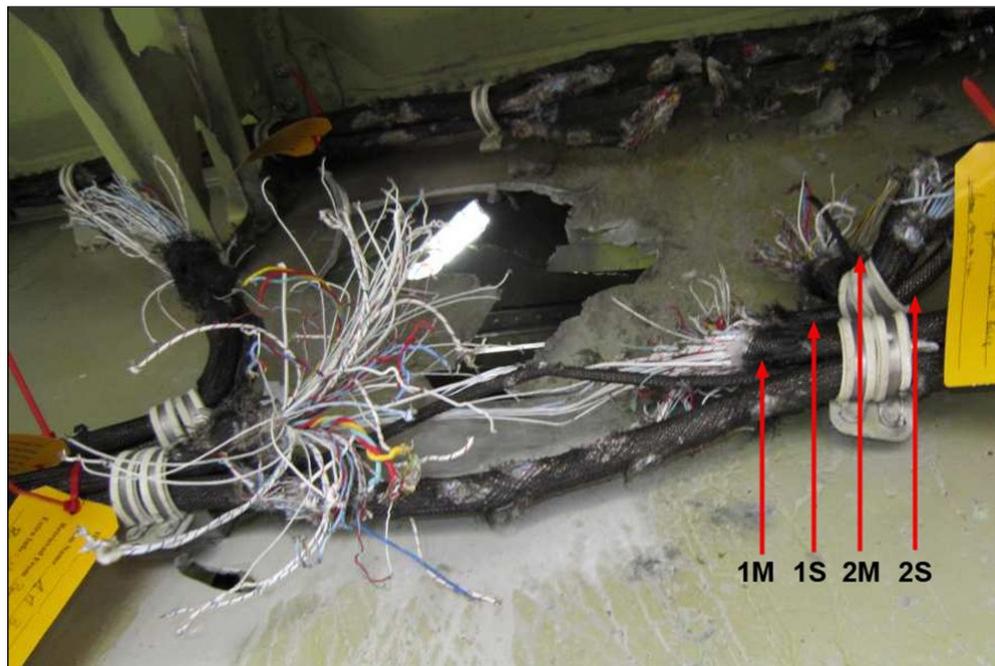
**Figure B41: Damage location (a) from Figure B40 showing complete severing of the route 1M, 1S, 2S and 2M wiring harnesses—the entry/exit hole through the front spar and upper wing skin from a high-energy disc fragment is also apparent**

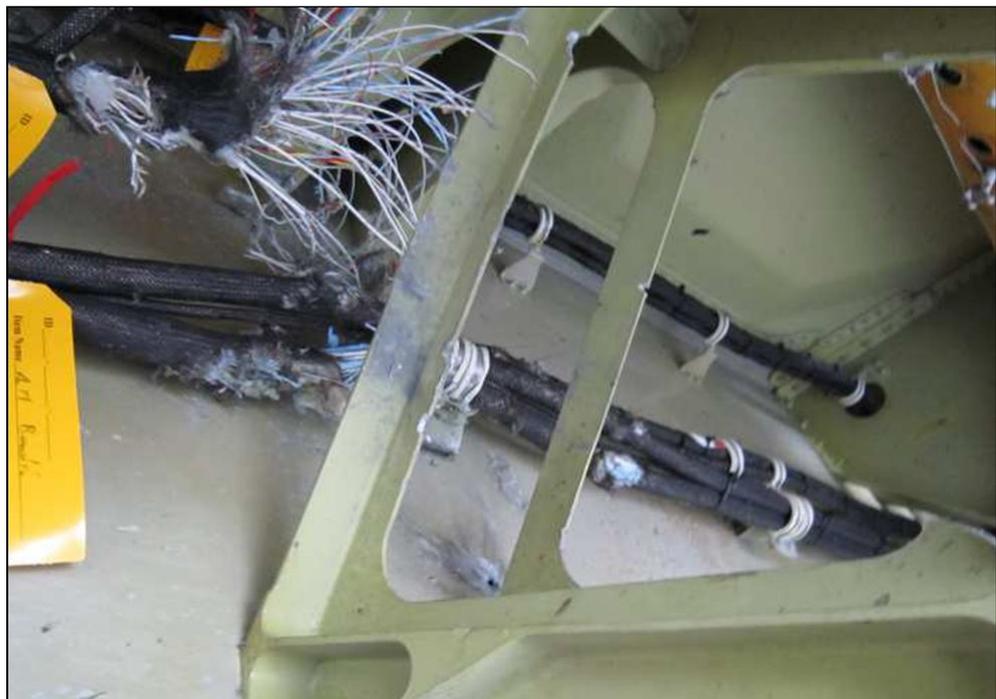
Figure B43: Damage location (c) from Figure B40

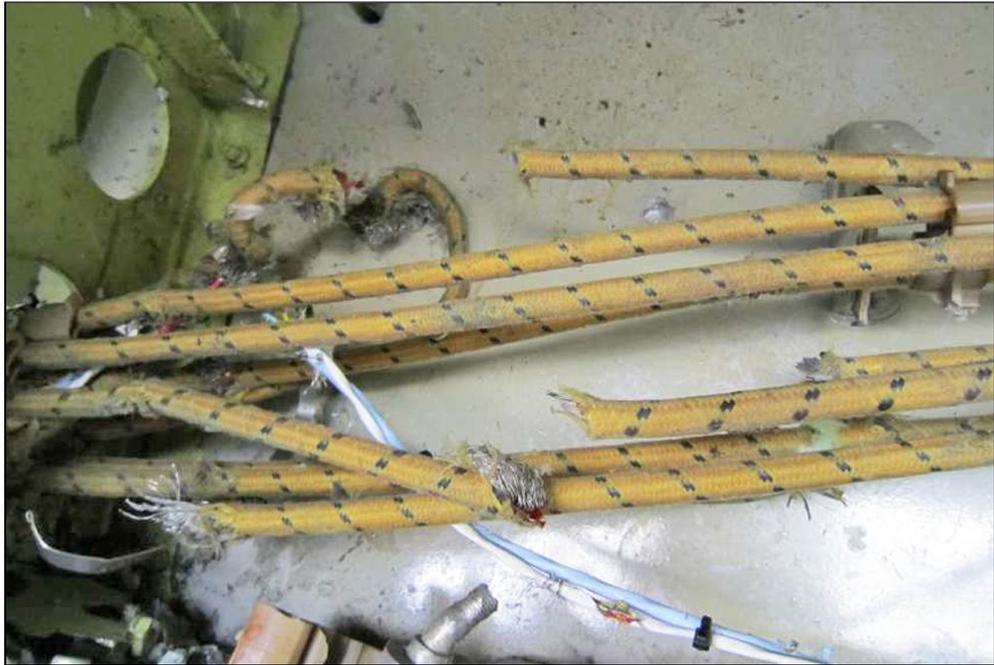
**Figure B46: Close detail of damage to route 1G, 3029VB harness, between Rib 10 and Rib 11**

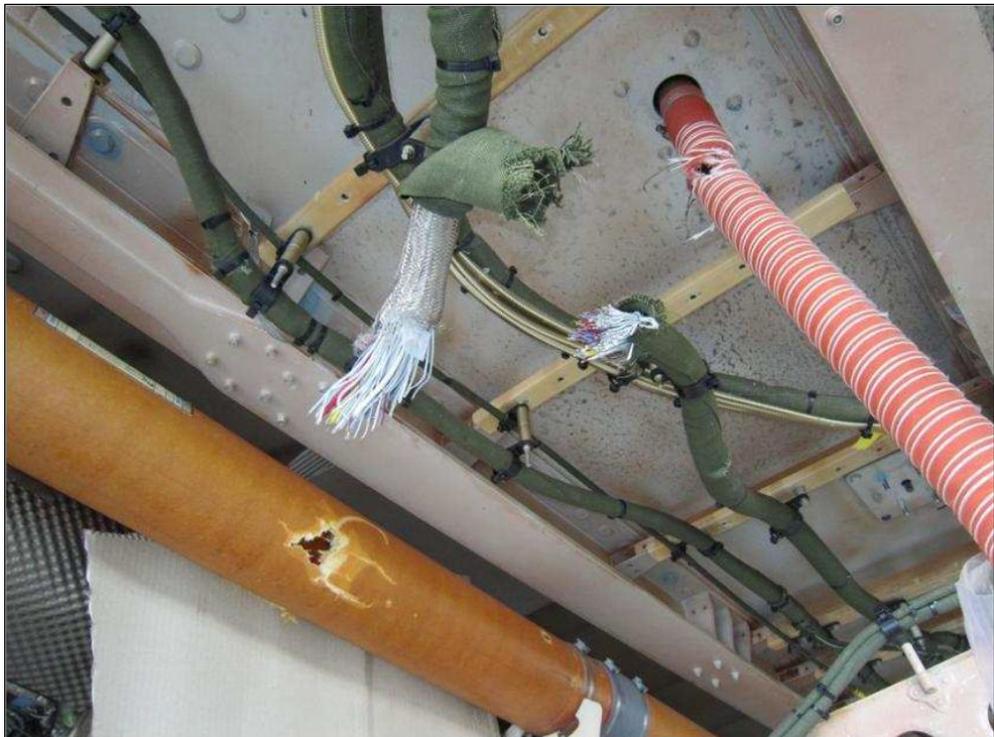
**Figure B47: Wiring harnesses within the belly region of the aircraft structure were damaged from the liberated engine debris. Shown is harness 1525VB (route 1MK). All wires were severed**

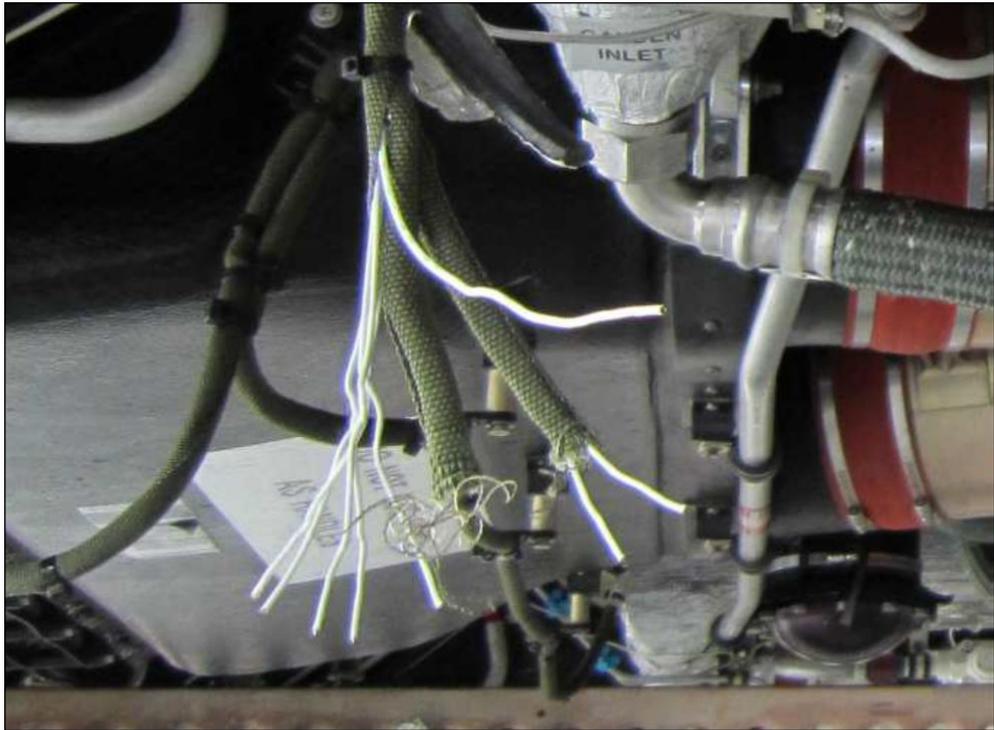
**Figure B48: Wiring harnesses within the belly region of the aircraft structure were damaged from the liberated engine debris. Shown is harness 1532VB (route 4M and 2MZ). All wires were severed**

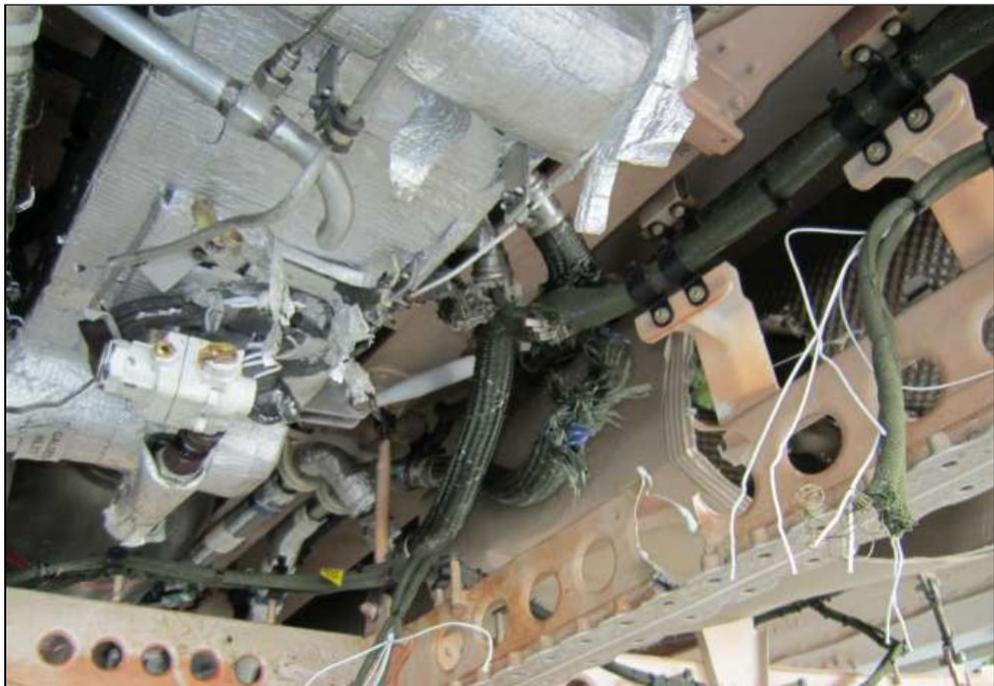
**Figure B49: Wiring harnesses within the belly region of the aircraft structure were damaged from the liberated engine debris. Shown is harness 500HW1 (route 1PZ). All wires were severed**

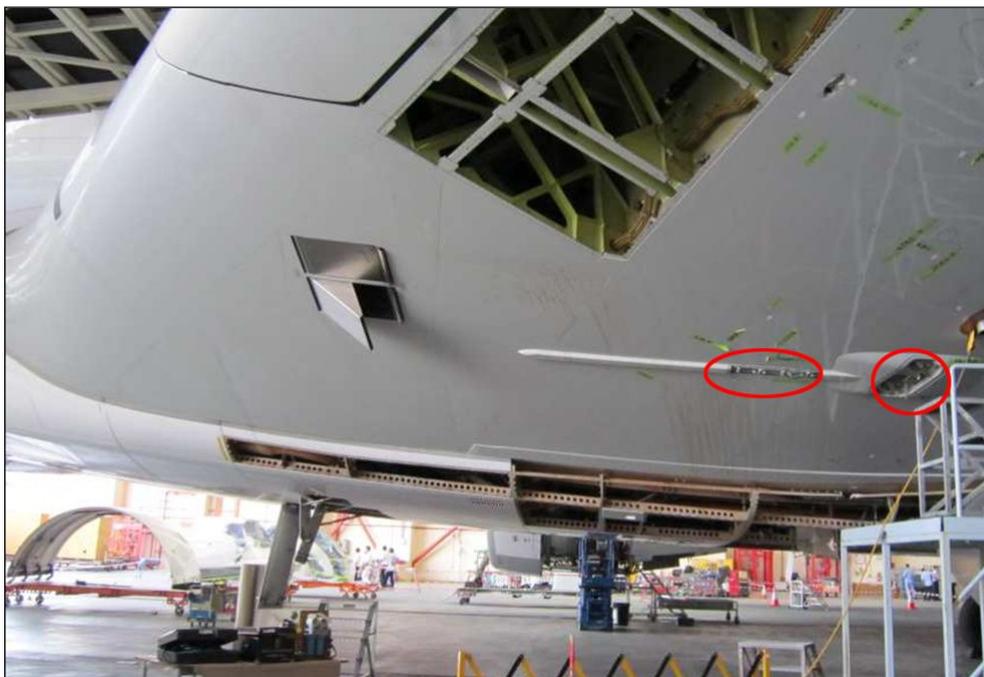
Figure B50: Location of the left wing fuel pump harness damage, routes 1M (fuel pump) and 2M (standby fuel pump) were both severed

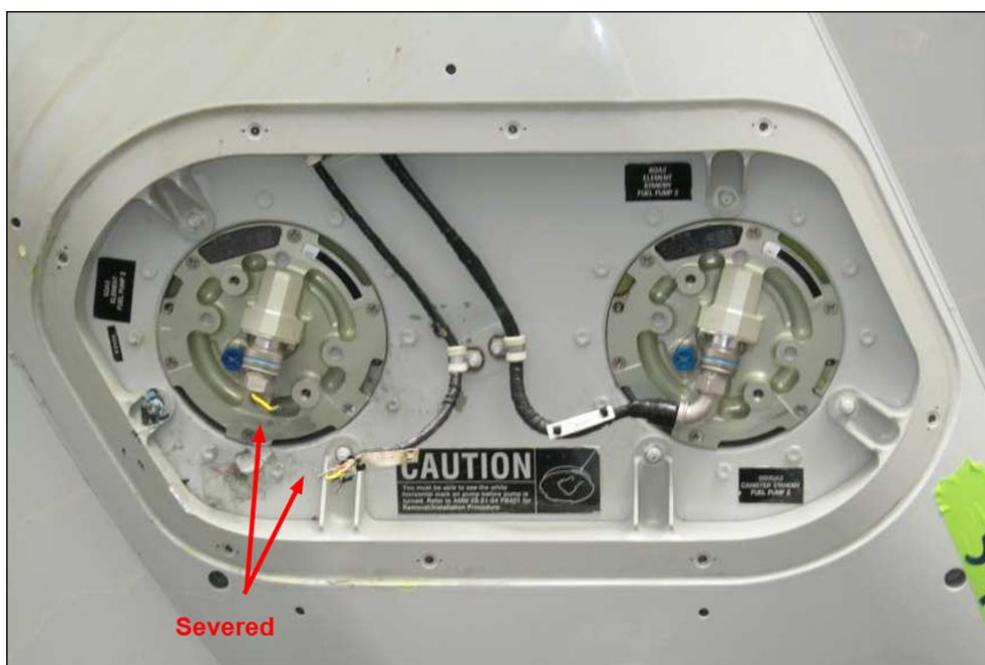
Figure B51: Damage to the 1M harness that supplied to the left wing forward fuel pump

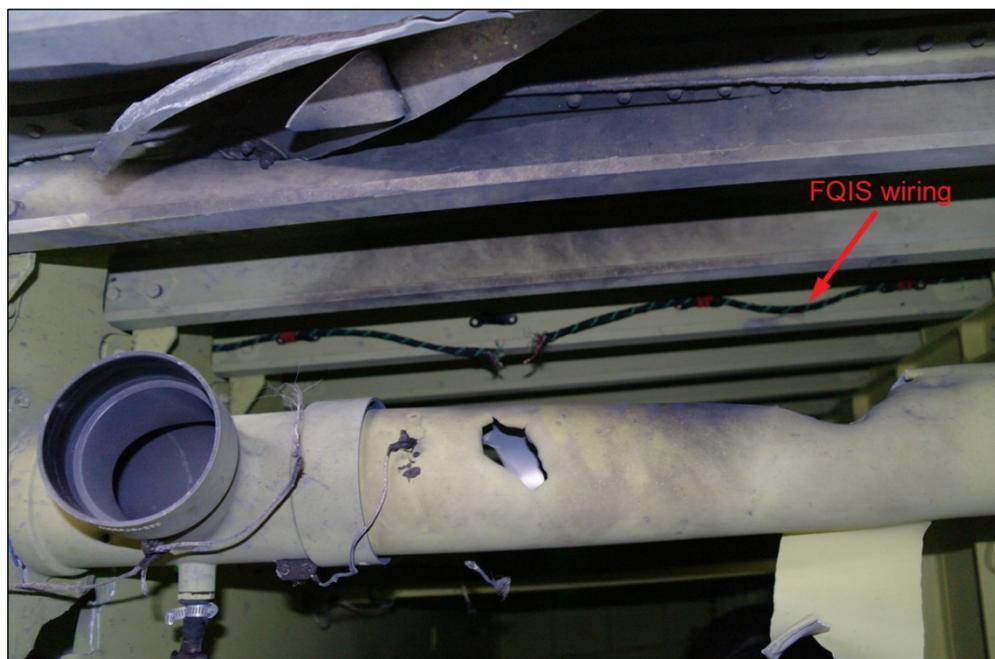
**Figure D6: Residue observed along the top of the LIT**
