# In-flight uncontained engine failure Airbus A380-842, VH-OQA

overhead Batam Island, Indonesia | 4 November 2010

**ATSB Transport Safety Report**  
Aviation Occurrence Investigation  
AO-2010-089  
Final – 27 June 2013

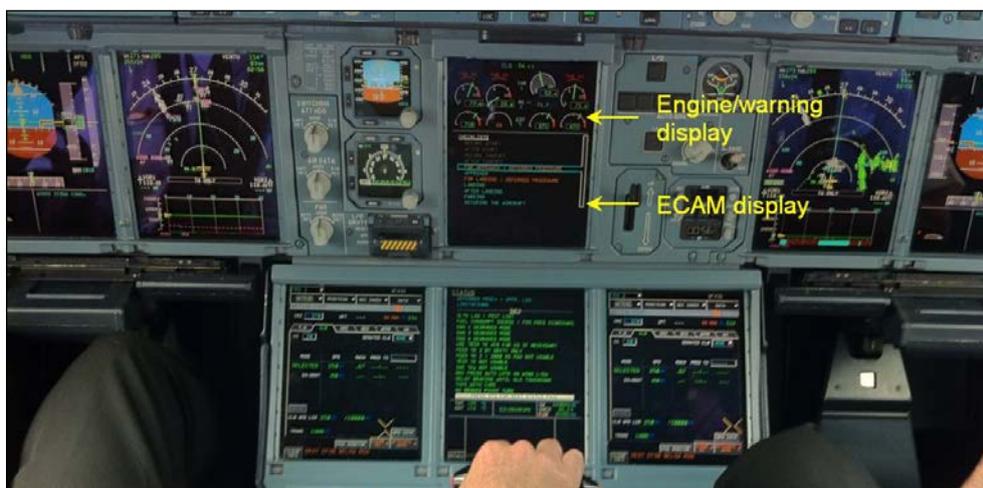
**Figure 1: Engine/warning display**

The engine/warning display indicated that the No. 2 engine had changed to a failed mode, No. 1 and 4 engines had reverted to a degraded mode<sup>5</sup> and that No. 3 engine was operating in an alternate mode (Figure 1).

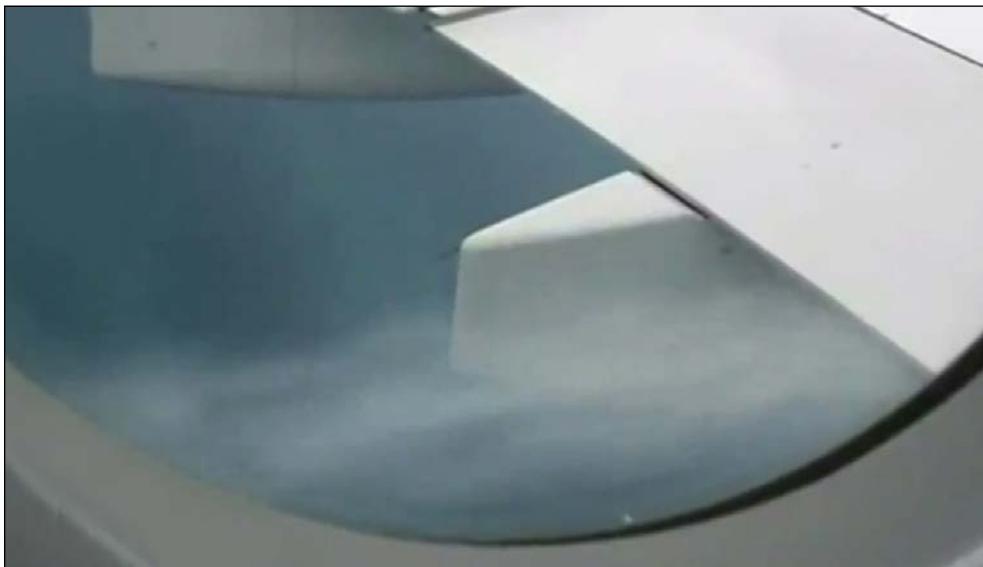
**Figure 3: Fuel leaking from the left wing**

The second officer proceeded to the main (lower) deck and observed damage to the left wing and fuel leaking from the wing. He recalled that the leak appeared to be coming from underneath the wing in the vicinity of the No. 2 engine, and that the trail was about 0.5 m wide (Figure 3). He reported that he could not see the turbine

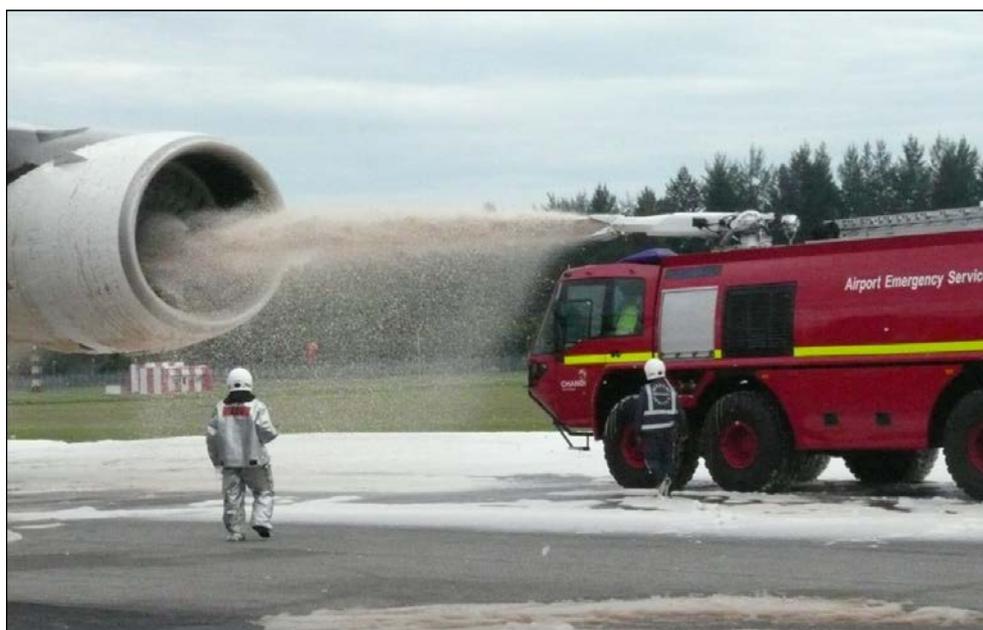
**Figure 4: Fire-fighters 'drowning' the No. 1 engine with foam**

Maintenance personnel also attended the aircraft and attempted a number of methods to shut down the engine, each without success. Finally, the decision was taken by the operator to 'drown' the engine, initially with water and then with fire fighting foam from the airport emergency services fire vehicles (Figure 4). The No. 1 engine was reported to have been shut down at 06:53:00, about 3 hours after the aircraft landed.

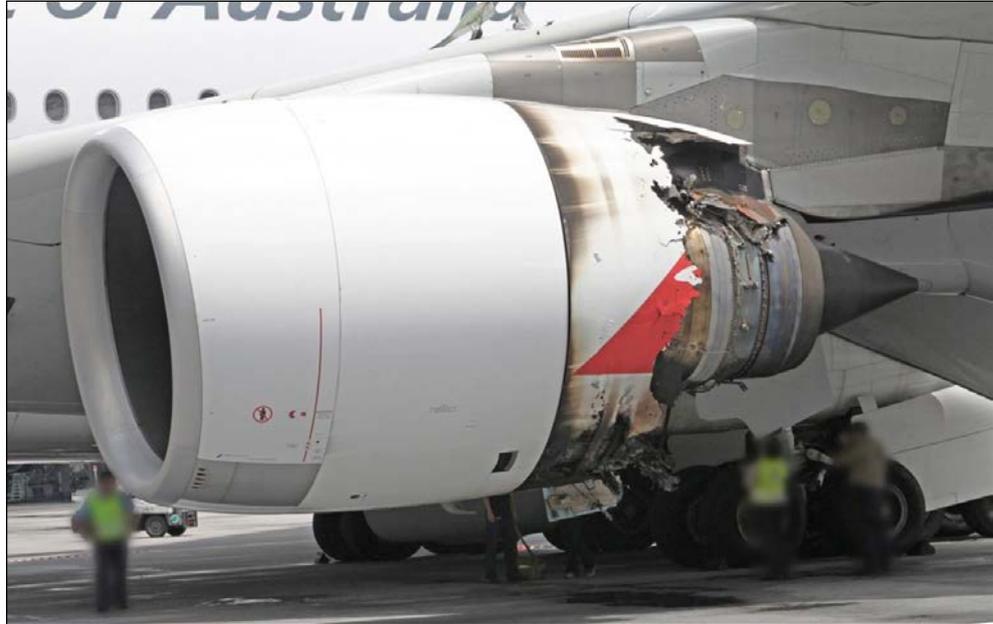
There was damage to the cowling and thrust reversers towards the rear of the engine and sooting on the rear section of the cowl (Figure 5). There was extensive damage to the turbine region of the engine, detail of which is covered in Part 2 of this report.

**Figure 5: General damage to the No. 2 engine**

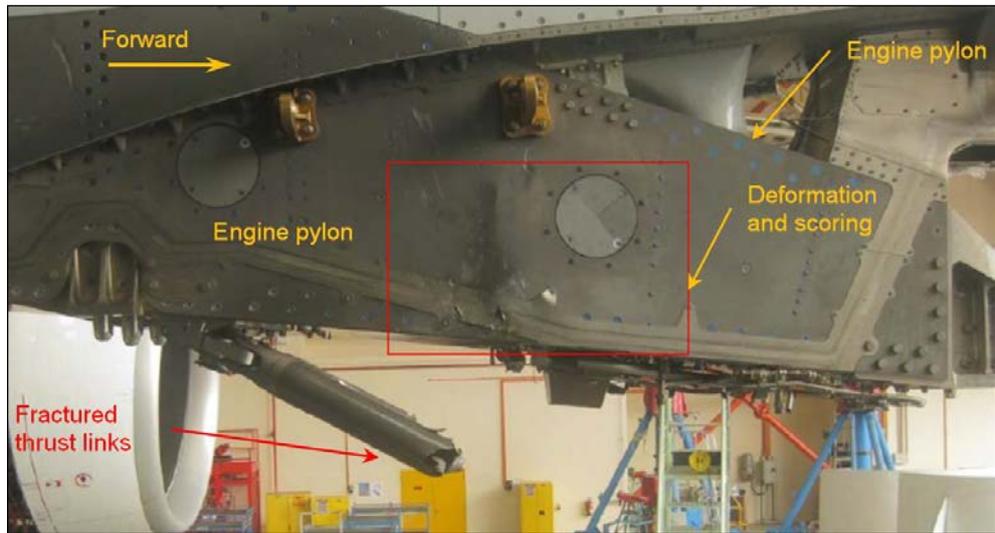
- No. 2 engine support structure (Figure 6)
- left wing upper and lower skins, front spar and internal ribs (Figure 7 and Figure 8)
- left wing-to-fuselage joint (indentation and scoring).

**Figure 6: Damage to the No. 2 engine support structure**

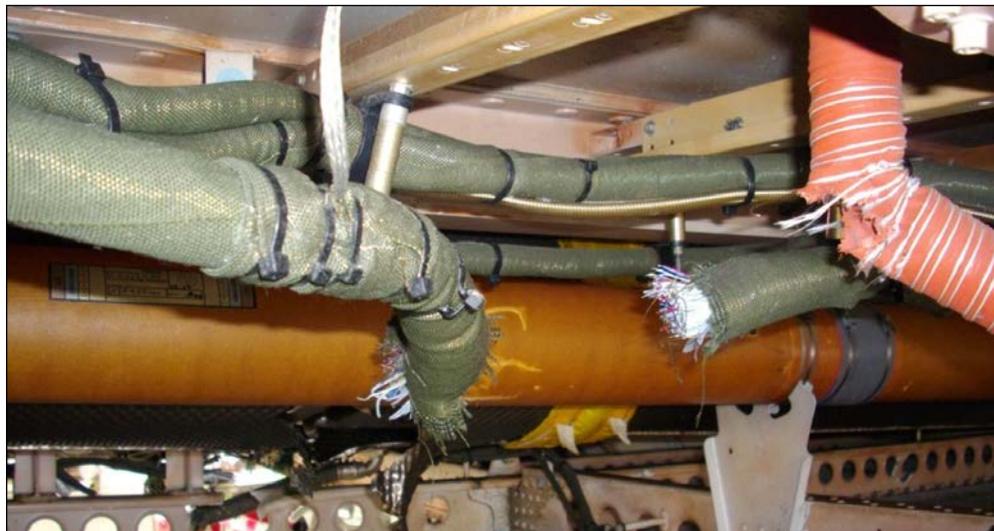
The debris from the engine failure directly damaged a number of systems and a number of other systems were affected as a result. Although some systems sustained direct mechanical damage, most of the affected systems were damaged through debris impact to the respective wiring looms. Two main wiring looms were impacted by debris; one running through the leading edge of the left wing (Figure 9), and the other in the belly fairing (Figure 10). This amounted to damage to about 650 wires in total.

**Figure 10: Damage to wiring in the belly fairing**

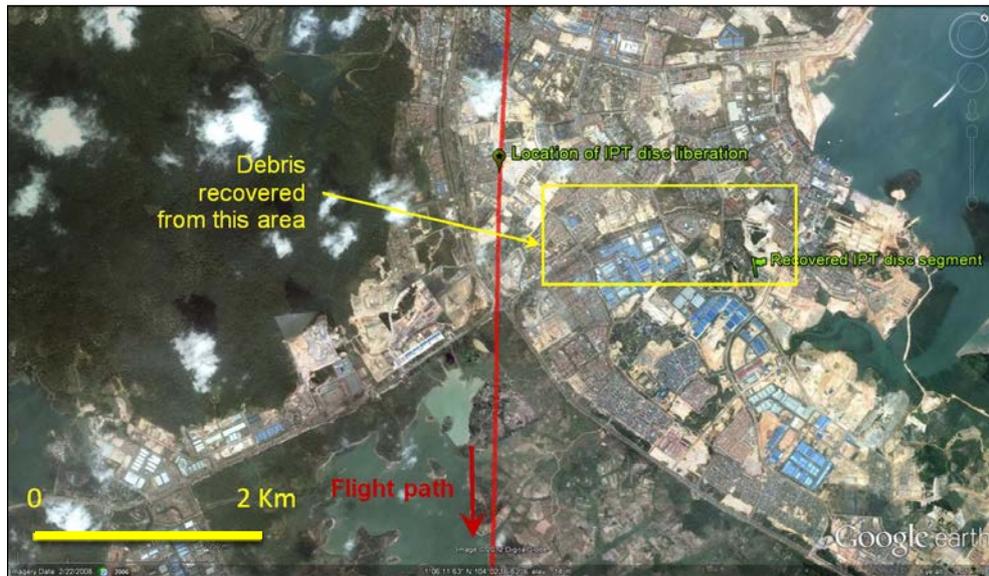
**Figure 11: Debris distribution on Batam Island**

A significant amount of debris from the aircraft fell over about 1.5 square km on Batam Island (Figure 11). A number of engine and other components were recovered from the island with the assistance of the local residents, Indonesian police, the National Transportation Safety Committee (NTSC) of Indonesia and the engine manufacturer.

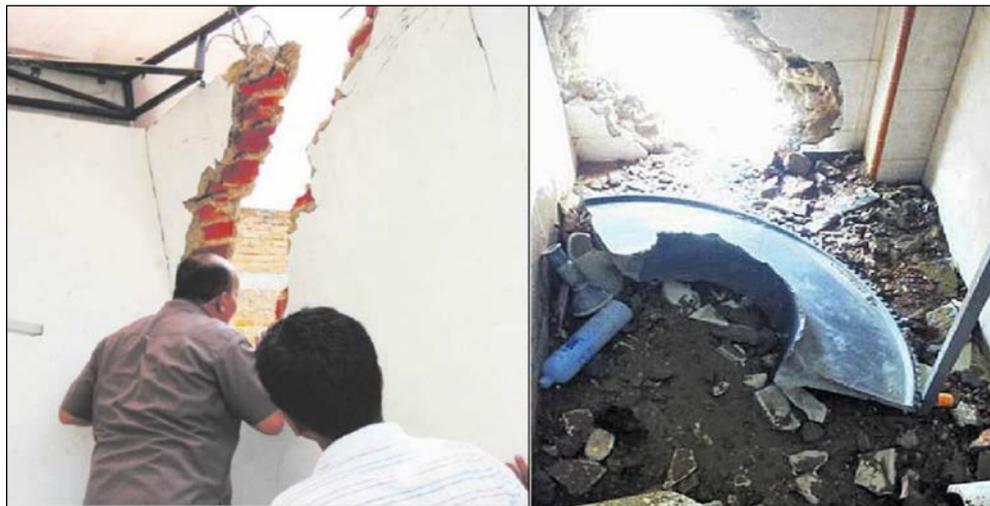
A section of the intermediate pressure turbine disc (about 40% of the disc) from the No. 2 engine was recovered from a property on Batam Island (Figure 12). Despite a search carried out over several days, no other significant fragments of the turbine disc were recovered. A number of other engine components were recovered, including sections of engine cowling and other components from the No. 2 engine.

Several buildings and other property were damaged by the debris.

**Figure 12: Property damage from a section of the No. 2 engine turbine disc**

The section of the IP turbine disc that was recovered from Batam Island, Indonesia (Figure 12) was examined in detail by the engine manufacturer under the supervision of the ATSB. This section of disc consisted of about 43% of the total disc and weighed about 70 kg. In addition, two radial fractures in the disc and a circumferential fracture in the drive arm were identified (Figure 38). The examination found that all of the fractures were consistent with an overstress of the material. There was no evidence of any pre-existing material defect or damage that contributed to the fractures.

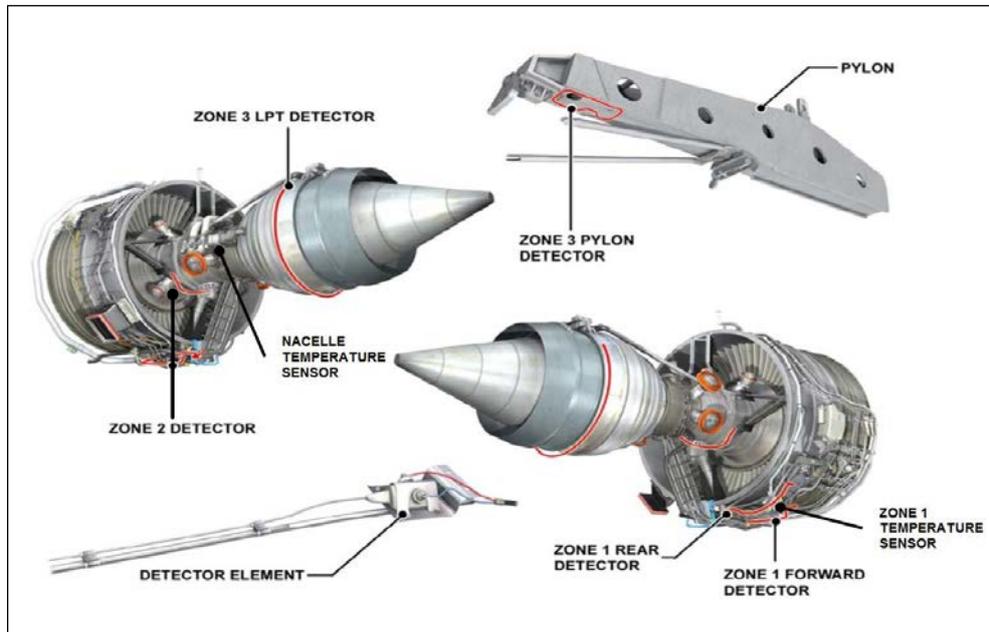
**Figure 20: Fire detector layout**

During the event, the power supply to No. 2 engine loop A was interrupted when the cable was cut by debris, resulting in a FAULT condition on all of the fire detectors in that loop. The recorded data showed that faults were also detected in loop B of the Zone 2 and 3 detectors. This meant that the only remaining operable engine fire detectors were in zone 1 (the fan casing).

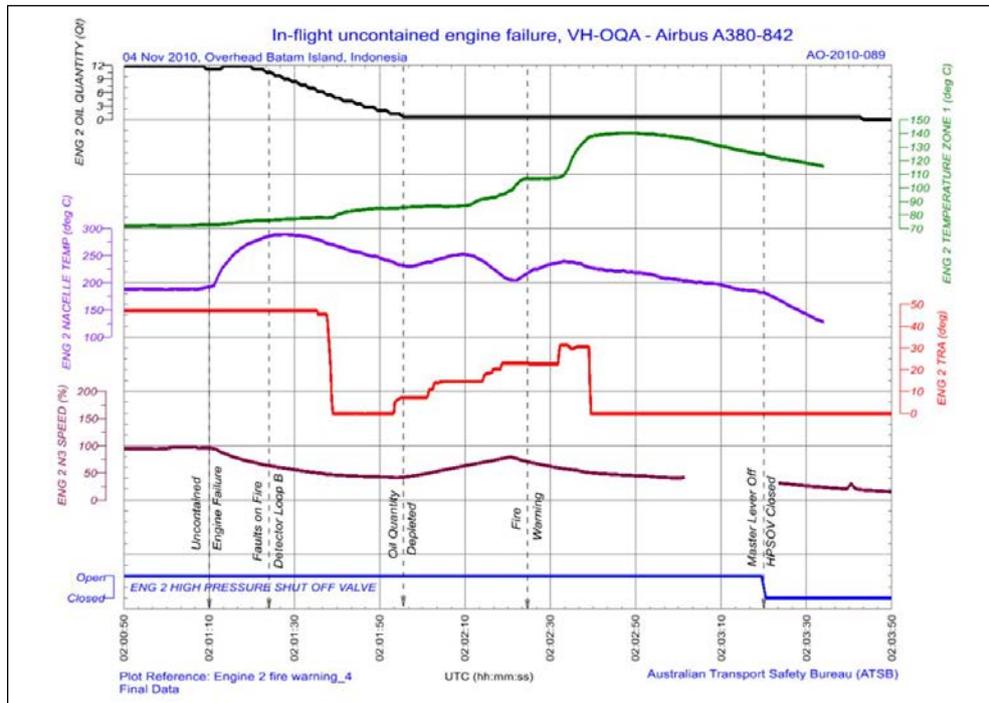
**Figure 21: Engine fire – key data**

The recorded data showed that at 02:01:52 the No. 2 engine thrust lever was advanced (Figure 21). There were increases in the zone 1 temperature that followed further thrust lever inputs, suggesting a correlation. That apparent correlation became more significant at higher thrust lever settings. When the thrust lever was returned to idle at 02:02:39 the temperature in that zone stabilised.

At 02:02:25 a fire warning was displayed for 2 seconds before being reset. Figure 21 shows that around this time the temperature in zone 1 had increased to about 107 °C and shortly after rapidly increased further, reaching a maximum of about 140 °C before slowly decreasing.

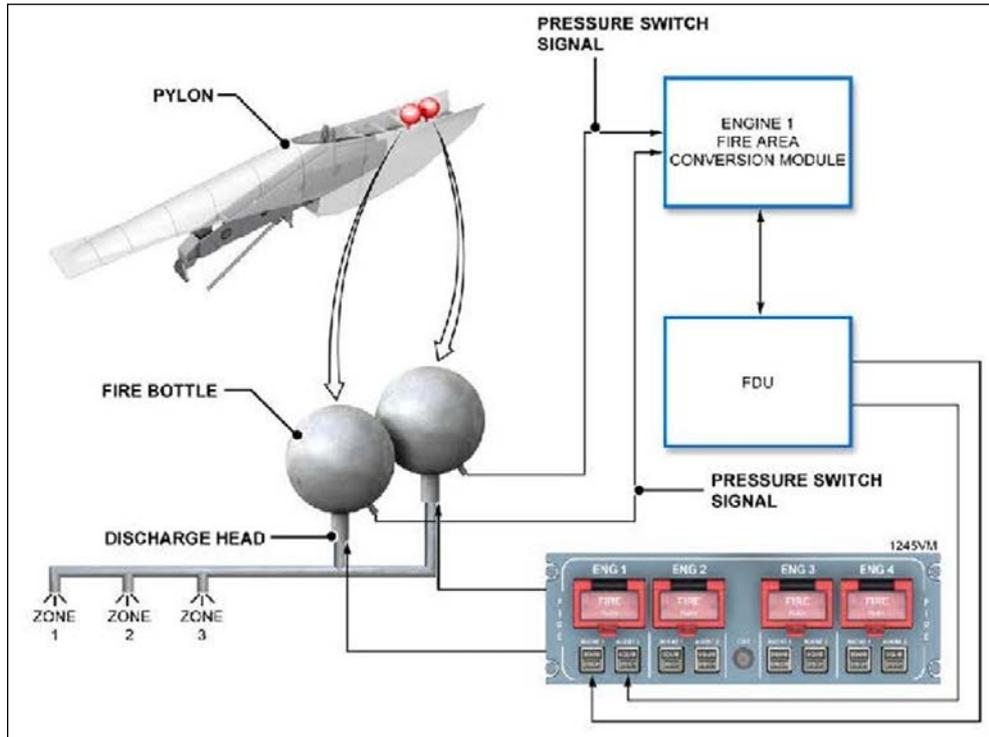
**Figure 22: Fire suppression system for engine No. 1 (similar system for engines No. 2, 3 and 4)**

The engine fire suppression system consisted of two fire extinguishing bottles for each engine, a control subsystem and a distribution subsystem (Figure 22). A post-flight inspection of the aircraft revealed that one of the No. 2 engine's fire bottles had discharged.

The aircraft manufacturer determined that the damage to the wiring from the uncontained engine failure had prevented the discharge of the second bottle and the provision to the flight crew of an indication of the status of the bottles. This prevented an accurate determination of when the crew attempted to activate the fire suppression system.

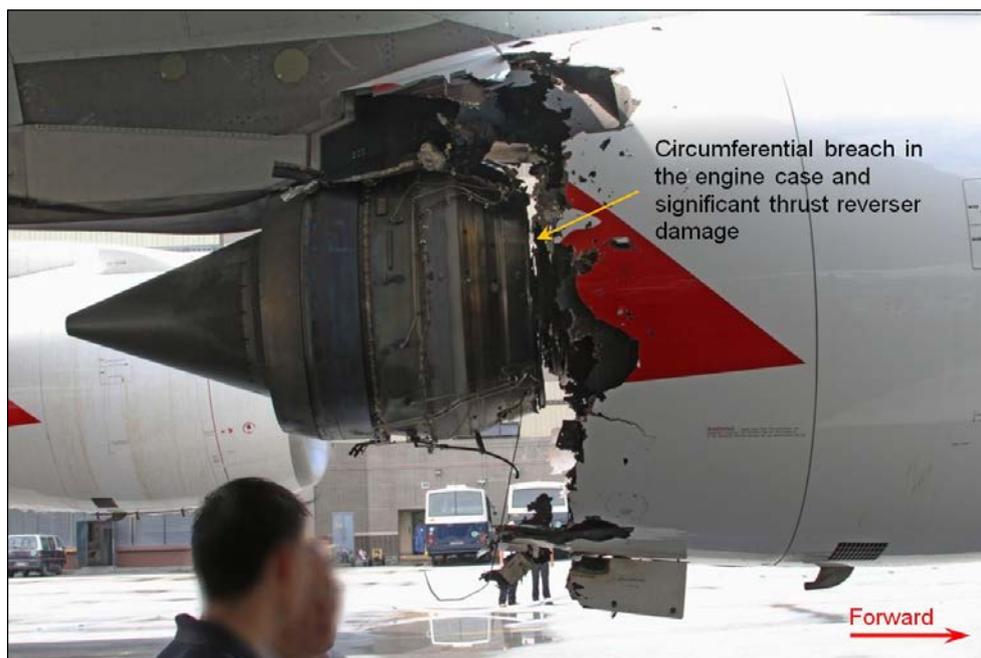
The primary damage to the engine occurred in the region of the IP turbine. An initial ‘on-wing’ visual examination of the engine identified that the entire circumference of the case around the IP turbine was breached and that the IP turbine disc was missing (Figure 32). The thrust reverser cowl and cold airstream<sup>61</sup> duct fairings sustained significant damage and the section of the thrust reverser cowl and cold airstream fairings to the rear of the primary damage had separated from the engine.

**Figure 32: General damage to the engine (looking outboard)**

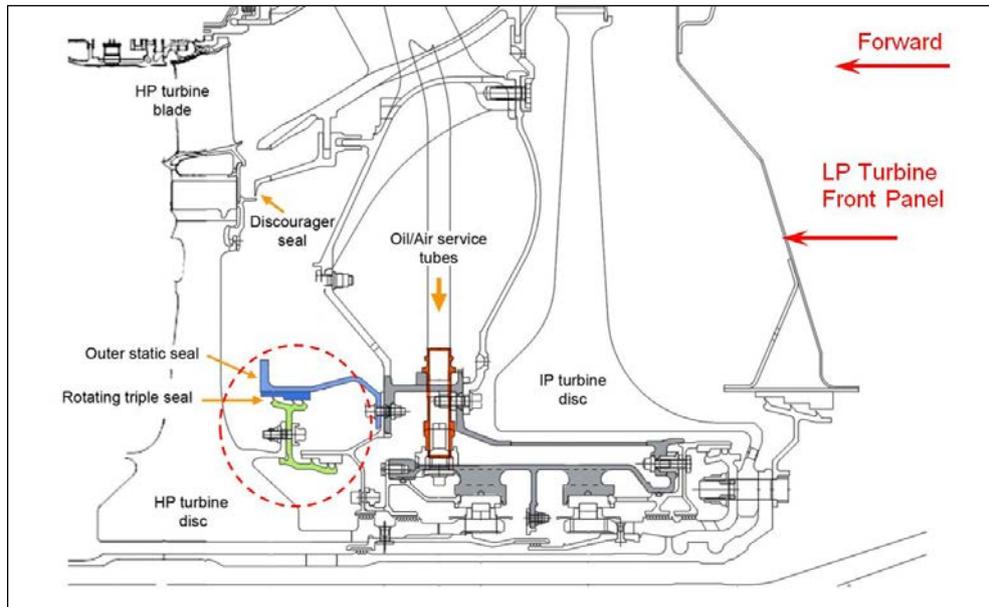
**Figure 34: Location of the HP turbine triple seal**

Damage was also identified between the HP/IP bearing support structure and the HP turbine. This included scoring of the HP turbine disc and significant damage to the triple seal. The rotating and static portions of the HP turbine triple seal had separated from their support structures (Figure 34), fractured and then entwined within each other (Figure 35). There was a rough, grey deposit on the surfaces within module 05 near the HP turbine shaft that was identified as melted and resolidified metal.

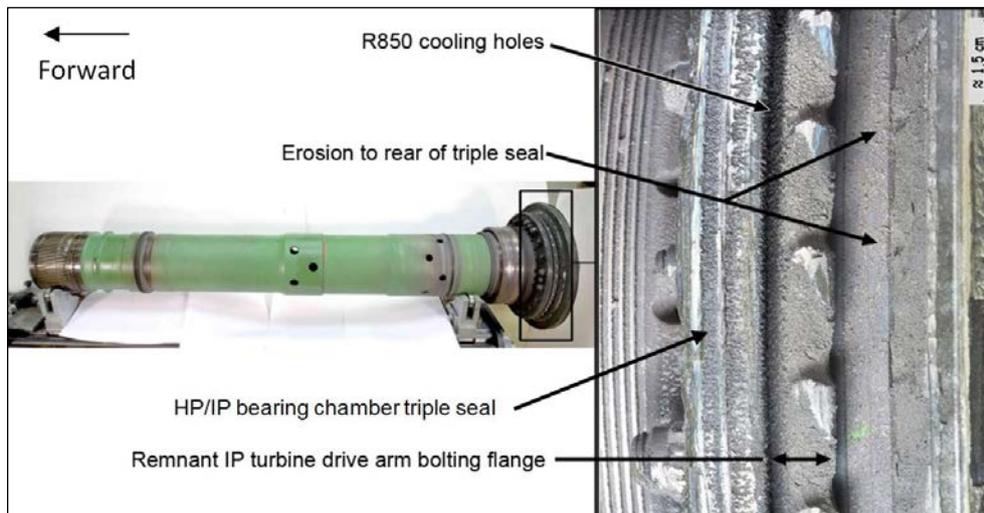
**Figure 36: Damage to IP drive shaft**

Examination of the IP shaft found that a remnant of the IP turbine drive arm bolting flange was still attached to the drive shaft (Figure 36). The IP turbine drive arm had separated from the bolting flange at the R850 cooling holes. There was a significant amount of heat damage and erosion in and around these cooling holes and the surfaces were coated in rough melted/resolidified material. Although much of the surface was damaged by metal-to-metal contact, sections of the original fracture surface were examined and found to be consistent with tensile and shear overstress.

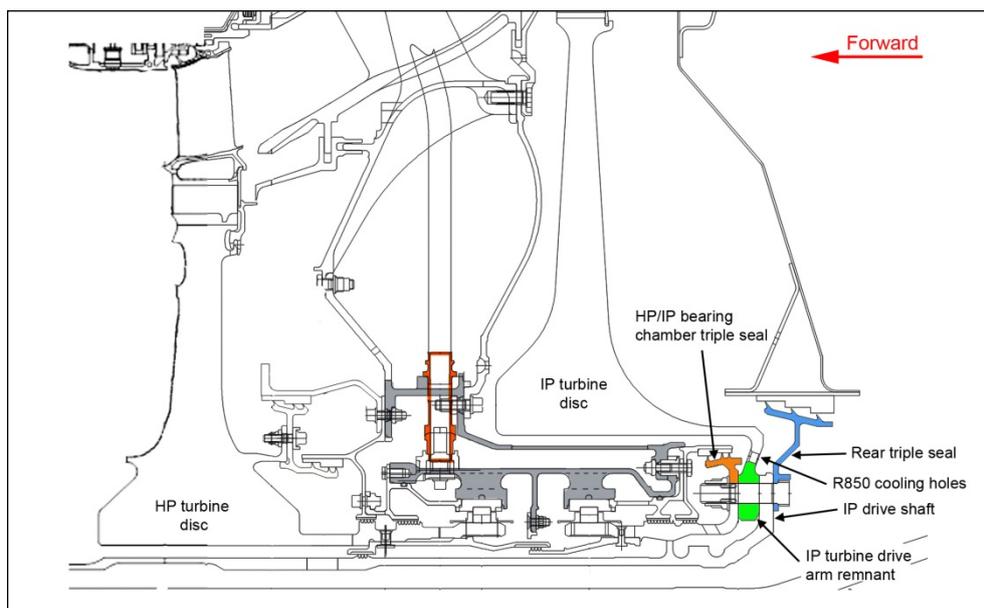
**Figure 37: Location of the triple seals**

The HP/IP bearing chamber triple seal and the rear rotating triple seal between the IP and LP turbines showed a significant amount of erosion and heat damage (Figure 37). The flange of the rear rotating triple seal also contained erosion pits immediately behind each of the R850 cooling holes.

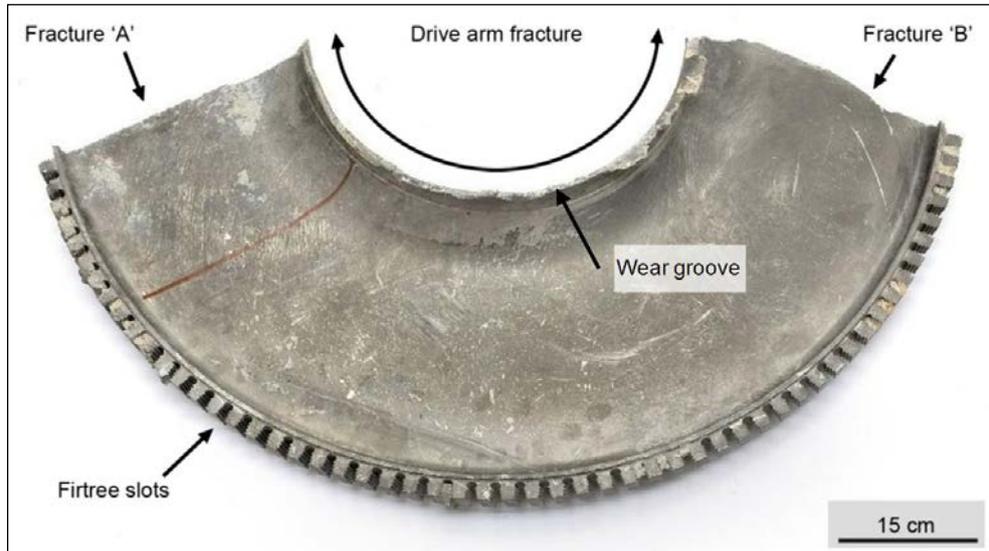
**Figure 38: Recovered section of IP turbine disc – looking forward (radial fractures labelled ‘A’ and ‘B’)**

The rear face of the disc contained a circumferential wear groove in the radius where the disc transitions to the drive arm. This wear groove was consistent in size and location with the forward flange on the LP turbine front panel.

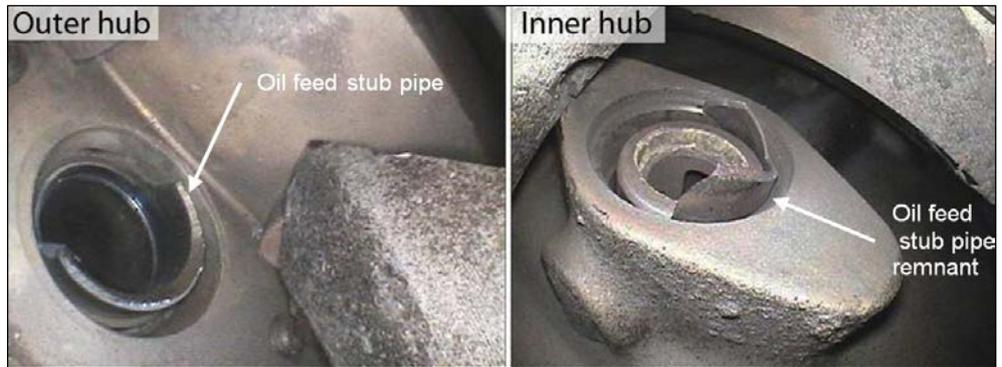
**Figure 41: Inner and outer HP/IP bearing hubs at the oil feed pipe location**

The oil feed stub pipe had detached and displaced outwards about 30 mm from the inner hub. A remnant of the oil feed stub pipe remained in the inner hub (Figure 41).

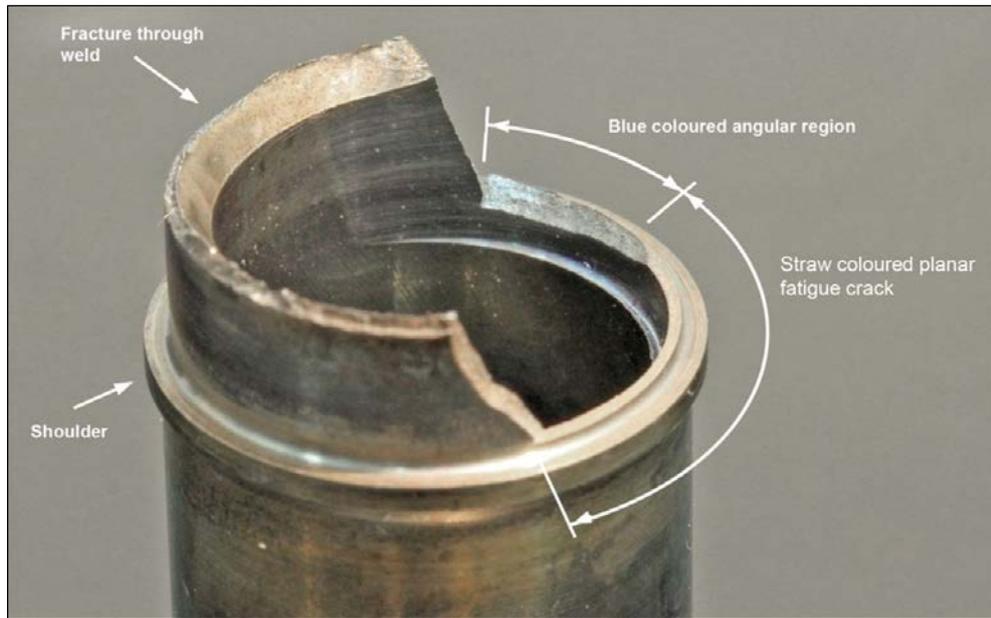
**Figure 43: Oil feed stub pipe fracture**

The oil feed stub pipe was fractured in two planes, one around the weld that attaches the pipe to the inner hub, and the other further outboard, close to the shoulder where the pipe presses into the inner hub. Three distinct fracture regions were identified on the oil feed stub pipe:

- one through the stub pipe-to-hub weld
- a straw coloured planar region
- a blue coloured angular region (Figure 43).

Detailed laboratory examination of the fracture regions found that the majority of the cracking, including the blue coloured region, was typical of an overstress fracture. The planar region covered an arc of about 90° of the oil feed stub pipe and was identified to be a pre-existing fatigue crack. The origin of this crack could not be precisely determined, however, the general shape of the crack indicated its origin on the outer surface of the pipe before growing inwards.

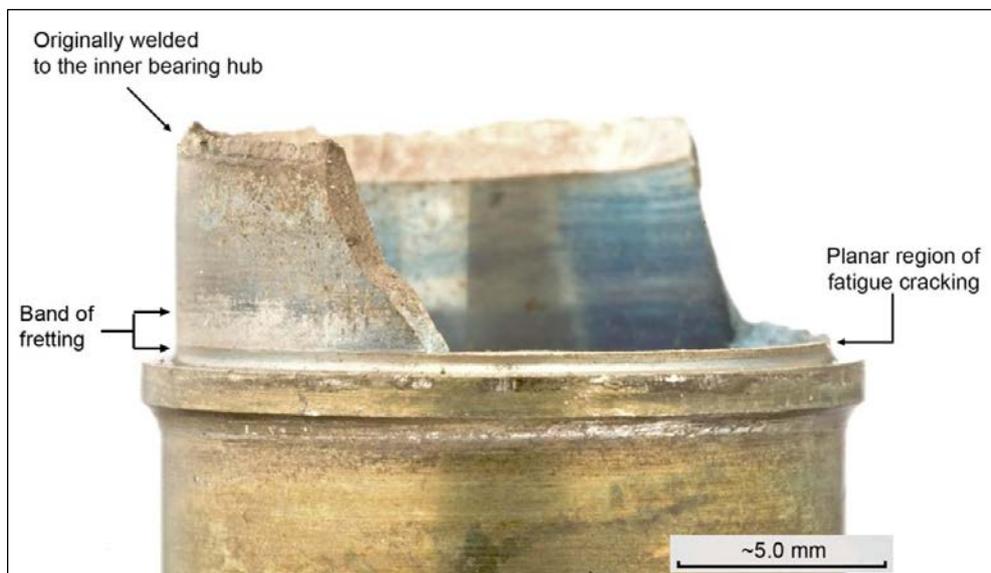
**Figure 44: Oil feed stub pipe fretting**

A band of fretting was identified on the outer diameter of the stub pipe at a position coincident with the fatigue cracking (Figure 44). The fretting was along the area that formed an interference fit with the inner bearing hub, indicating relative movement between the stub pipe and the inner hub interference bore. The engine manufacturer reported observing similar fretting bands on some of the engine's other HP/IP stub pipes.

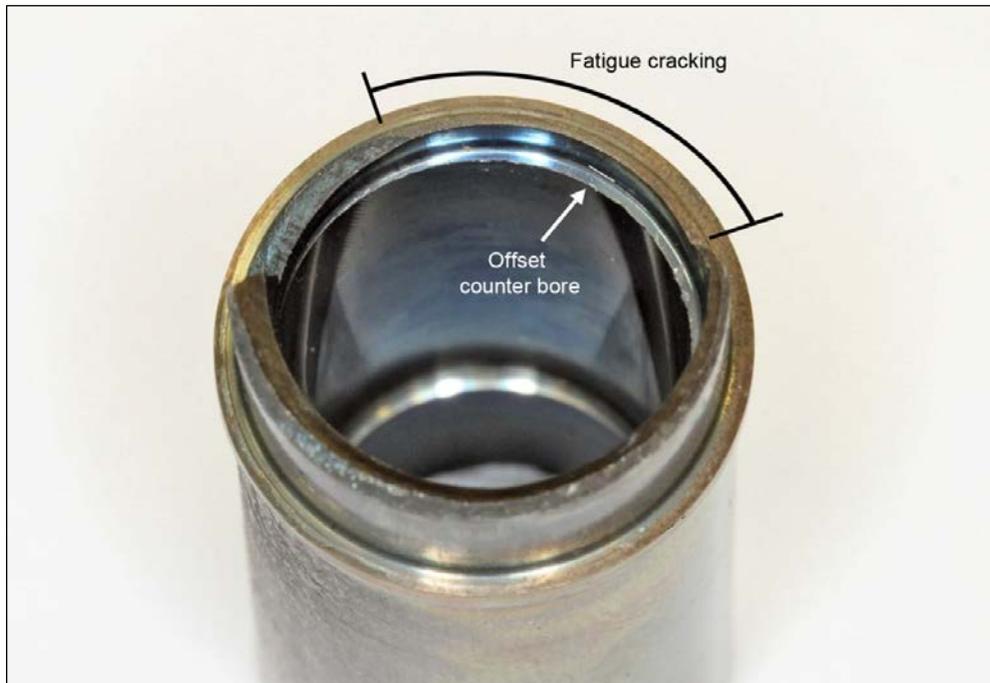
**Figure 46: Offset oil feed stub pipe counter bore**

The fatigue crack coincided with the thinnest wall section and it was apparent that the counter bore<sup>62</sup> used during manufacture to enlarge the inner diameter of the oil feed stub pipe to accept the oil filter was offset from the centre of the pipe (Figure 46). The manufacturer's counter boring operation was a two-stage process that initially involved drilling into the pipe end. The pipe end was then reamed<sup>63</sup> to a shallower depth than the drilled hole to form a close-tolerance fit for the filter body.<sup>64</sup> The drilled and reamed sections of the counter bore were misaligned with respect to the centreline of the pipe and each other (Figure 47).

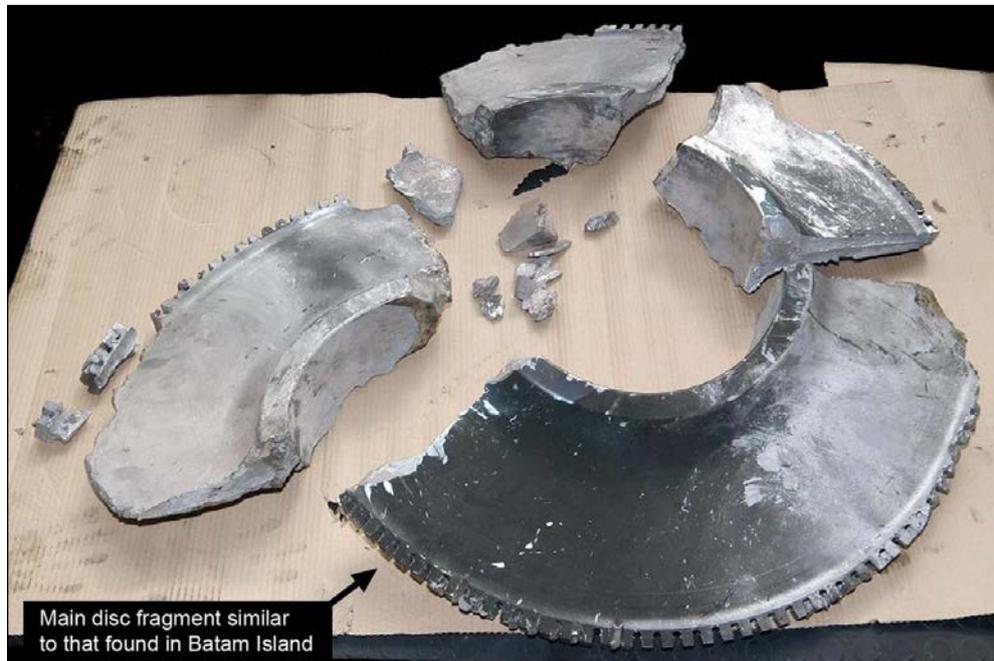
**Figure 48: Trent 900 IP turbine disc after overspeed burst test**

test IP disc burst into four main fragments, the largest of which was similar in size to the one found on Batam Island from the No.2 engine in VH-OQA (Figure 48).

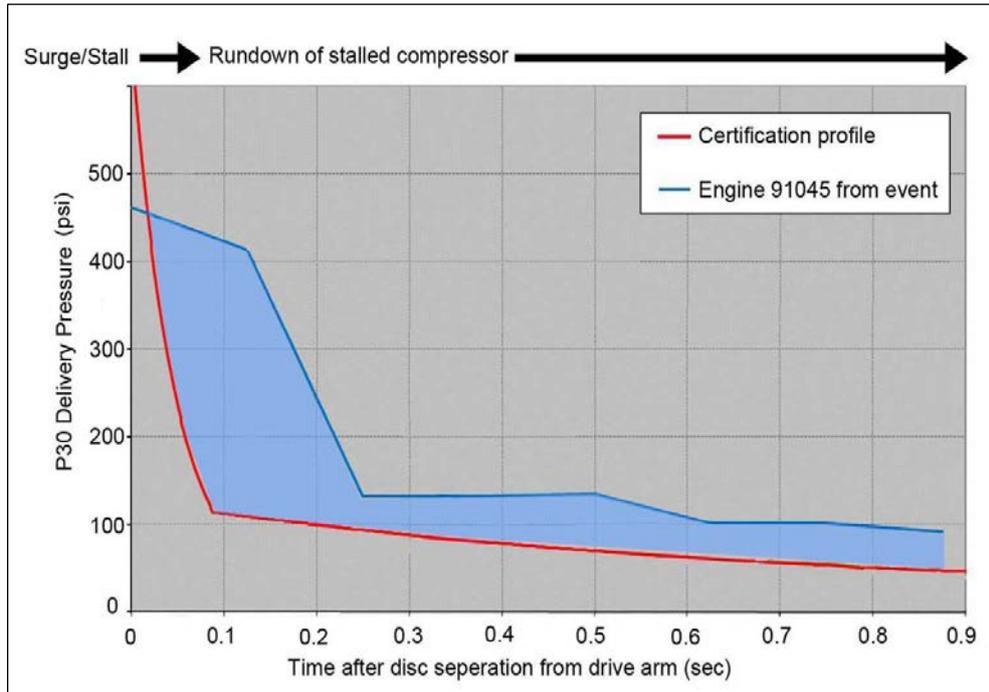
**Figure 49: Post-surge engine behaviour – a comparison of the HP compressor pressure at certification and in ESN 91045**

The recorded data from the uncontained failure of ESN 91045 identified an engine behaviour that differed from that predicted following a drive shaft failure. The data showed that when the drive arm failed at the R850 holes, the engine surged as expected. However, the air pressure in the engine did not decay to the level predicted from the manufacturer's modelling. A comparison between the expected 'certification' P30 delivery pressure profile and that recorded during the uncontained failure in ESN 91045 is presented in Figure 49.

The engine manufacturer determined that the higher than expected pressure recorded during the failure was due to a partial recovery of the HP compressor. That recovery was unexpected, and according to the engine manufacturer had not been previously observed. The additional pressure provided by the HP system following the surge (indicated by the blue shaded area in Figure 49), accelerated the now unloaded IP turbine beyond the predicted terminal and burst speeds.

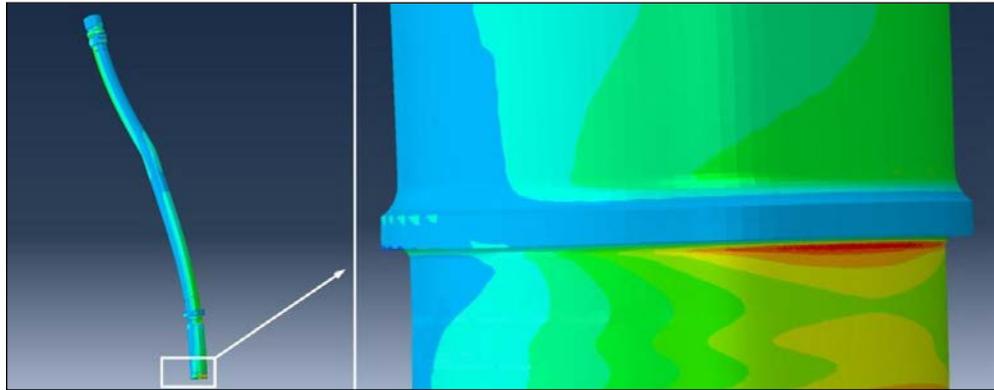
**Figure 50: Oil feed stub pipe stress distribution**

The stress analysis identified that the peak stress in the oil feed stub pipe occurred on the outer surface of the pipe, between the shoulder and the interference fit in the inner hub. That peak stress was highly localised, and was significantly greater than the other stresses in the pipe (Figure 50). The location of the peak stress corresponded with the location of the fatigue crack in the oil feed stub pipe in the occurrence engine.

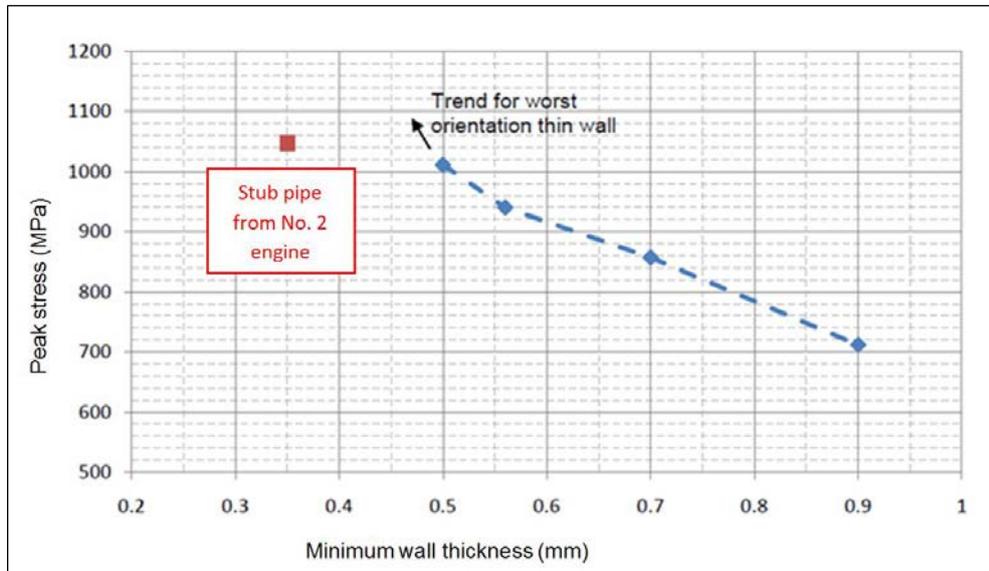
**Figure 51: Effect of wall thickness on peak stress**

To assess the potential for similar fatigue cracking on the remainder of the Trent 900 engine fleet, the manufacturer analysed a number of other misaligned counter bore scenarios. The movement of the hub was directed along the length of the engine and moved rearward as thrust increased. This would generate bending stresses that would be greatest if the minimum wall thickness was towards the rear of the engine. Thus, in order to be conservative, the manufacturer's modelling was based on the minimum wall thickness being located in that position. The minimum wall thicknesses assessed were 0.50, 0.56, 0.70 and 0.91 mm. The resulting stress distributions reflected that shown in Figure 50. The peak stresses recorded below the shoulder in the manufacturer's testing are presented in Table 8 and Figure 51.

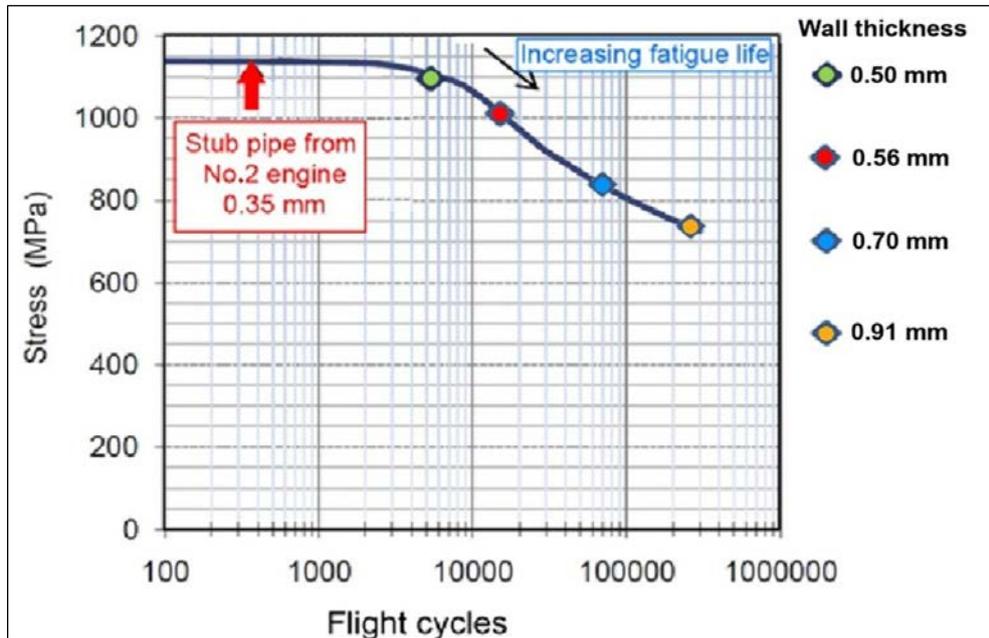
Figure 52: Calculated fatigue lives

A detailed vibration survey was also carried out by the manufacturer and it was determined that the number of engine cycles (low-cycle fatigue) was the primary contributor to the fatigue in the oil feed stub pipe, rather than the effects of a high frequency vibration (high-cycle fatigue). Based on these findings, the manufacturer carried out a fatigue life analysis of the oil feed stub pipe. This analysis conservatively assumed that the engine developed full thrust for each of its operating cycles, effectively representing a worst case scenario in an engine's life.<sup>73</sup> The resulting worst case fatigue lives are presented in Table 9 and Figure 52, along with ESN 91045's actual life of 677 cycles at the time of the uncontained failure.

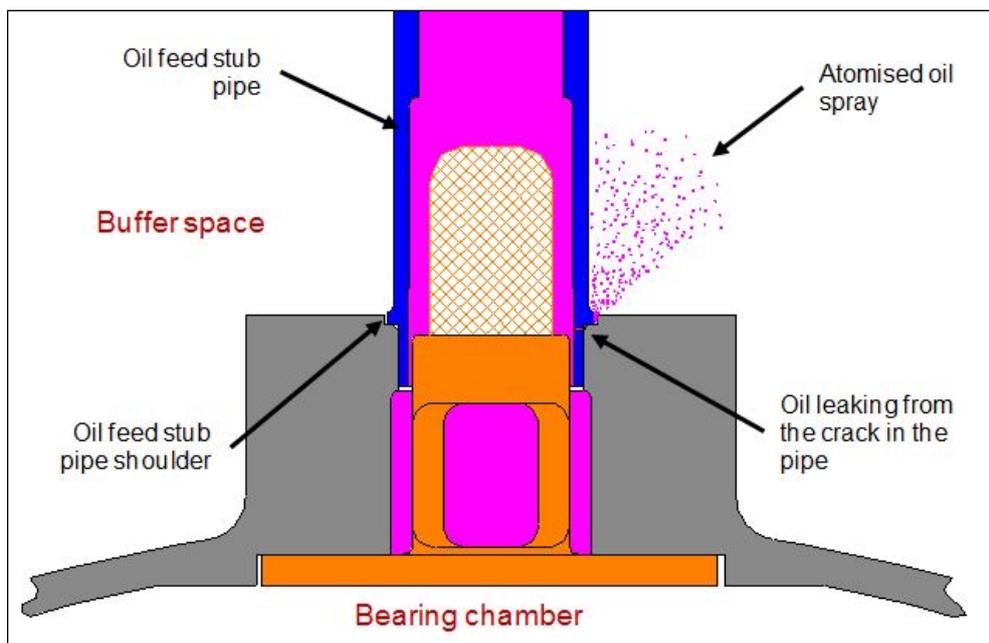
Figure 57: Oil leak into the buffer space

As described in Part 2 of this report, a fatigue crack initiated and grew in the HP/IP oil feed stub pipe below the shoulder where it fits into the HP/IP bearing chamber inner hub. It was not determined when the crack started; however, during the occurrence flight the crack grew to a size that allowed oil to leak out of the pipe and into the buffer space. The leak was at a low rate but at a pressure that likely resulted in an atomised oil spray (Figure 57).<sup>77</sup>

The temperature in the buffer space was reported by the manufacturer to be in the range of 365 to 375 °C. The synthetic oils used in the engine had auto-ignition temperatures as low as 280 °C. A comparison of these temperatures indicates the potential for auto-ignition and, given that there were no other ignition sources identified, it was likely the leaking oil auto-ignited when it atomised on entry into the buffer space.

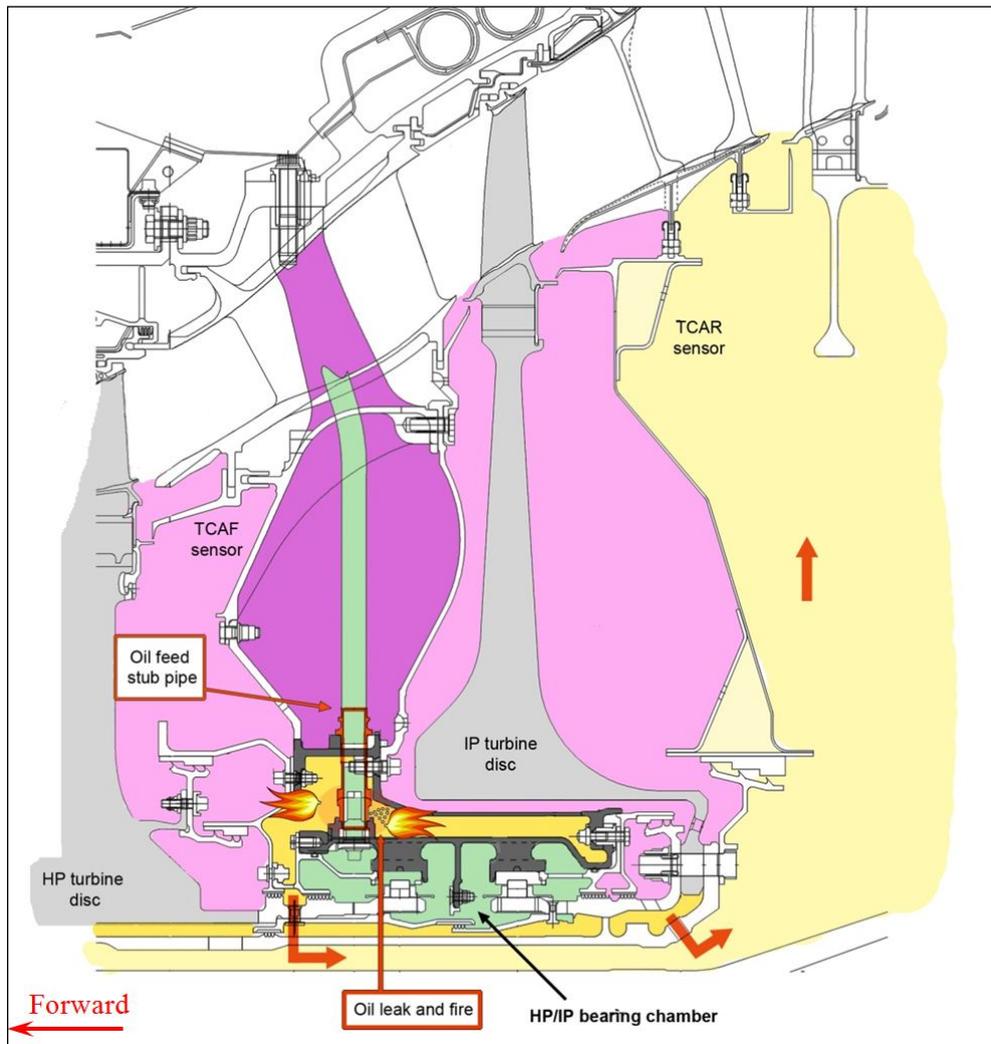
**Figure 58: Oil leakage and fire**

The direction of the airflow was from the buffer space, along the IP drive shaft and into the low pressure (LP) turbine cavity (represented as red arrows in Figure 58), where the TCAR sensor was located. That airflow directed a portion of the fire forward from the leaking oil pipe and onto the front of the HP/IP buffer space.

Given that the air temperature, as measured by the TCAR sensor, started to increase at about 02:00:07, 60 seconds before the engine failure, it is likely that the fire started shortly before that time.

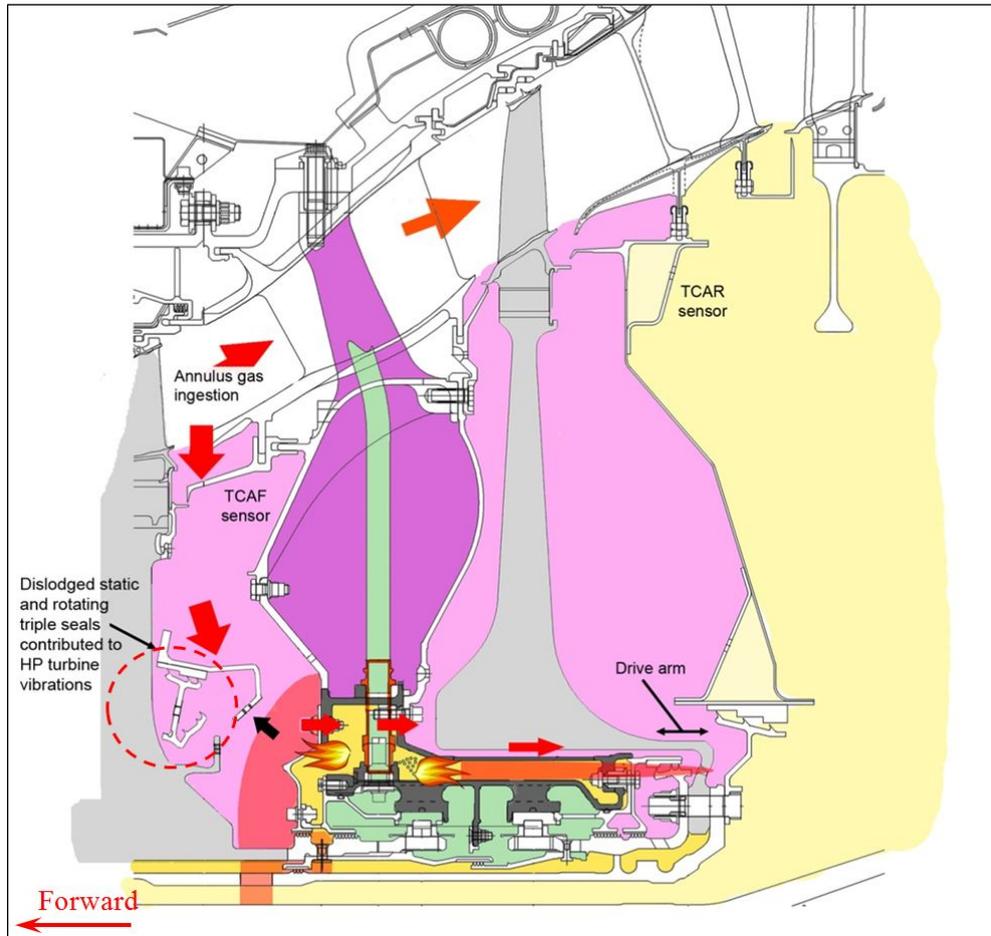
**Figure 59: HP turbine triple seal failure**

when the triple seal separated from the structure and the static and rotating portions became entwined, scoring the rear face of the HP turbine disc (Figure 59).

The design of the engine was such that the pressure within the buffer space and behind the IP turbine was lower than the hot (annulus gas) airstream exiting the HP turbine. This meant that when the triple seals were breached, those hot gases were drawn into the space behind the HP turbine disc, where the TCAF sensor was located (Figure 59).

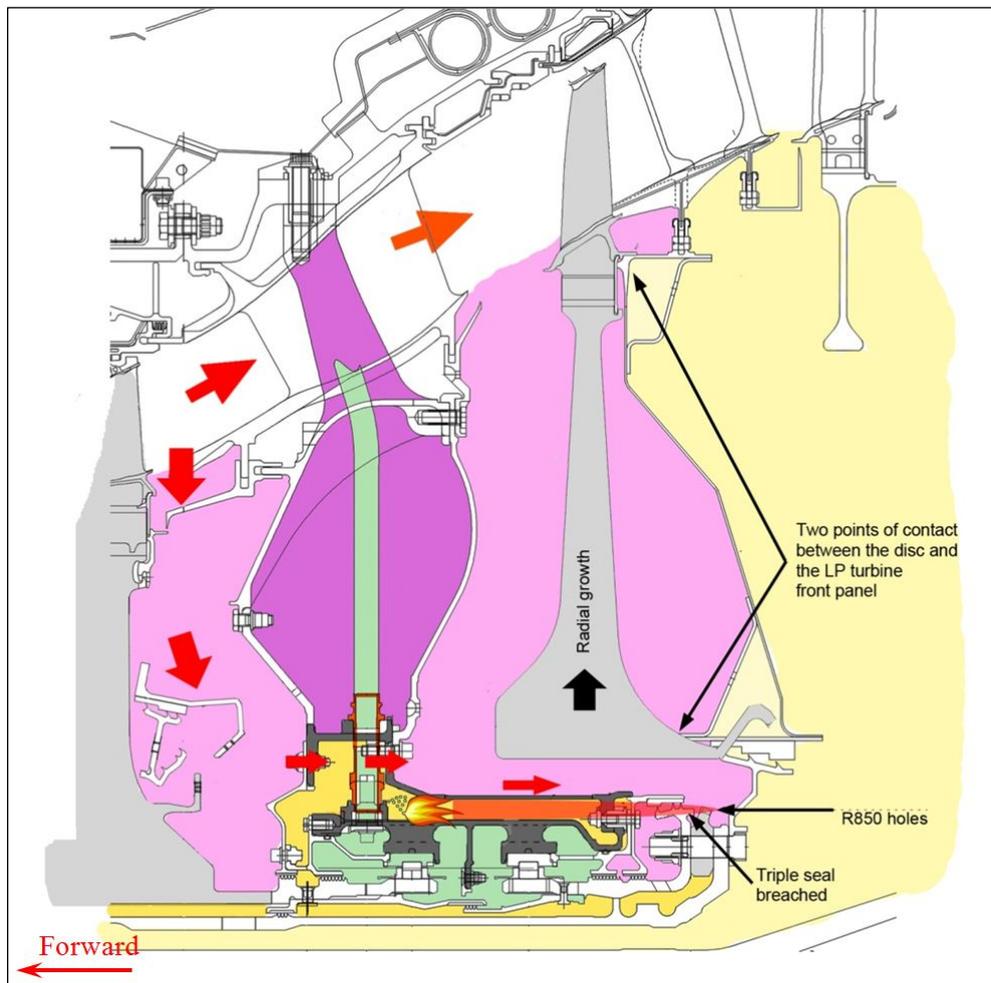
**Figure 60: Drive arm heating and disc separation from the drive shaft**

The IP turbine drive arm rapidly heated in the area of the R850 holes, reducing the strength of the material. The flame also eroded areas of the drive arm around the holes, further reducing its strength and, at 02:01:07 the drive arm failed in overstress, separating the IP turbine from the IP drive shaft. As a result of the air pressure loads across the turbine, the unrestrained turbine moved rearwards and contacted the LP turbine front panel (Figure 60).
