# In-flight uncontained engine failure Airbus A380-842, VH-OQA

overhead Batam Island, Indonesia | 4 November 2010

**ATSB Transport Safety Report**  
Aviation Occurrence Investigation  
AO-2010-089  
Final – 27 June 2013

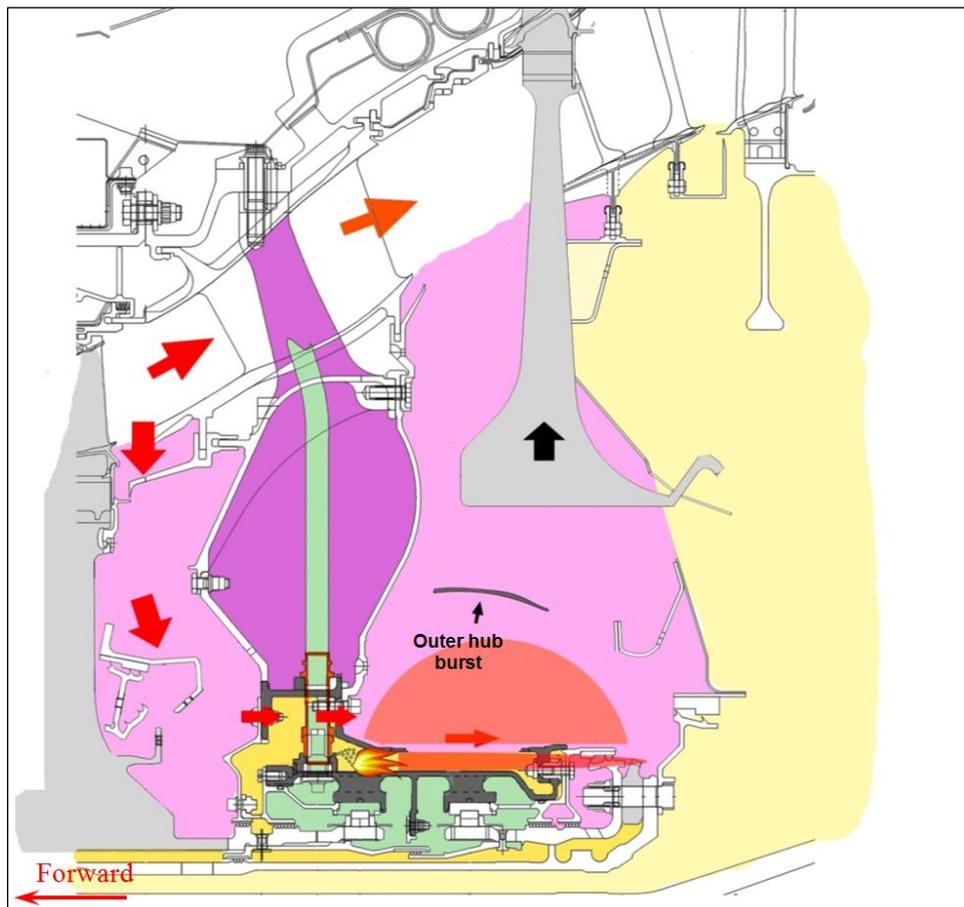
**Figure 61: Unrestrained IP turbine disc acceleration and burst**

Although the pressure in the engine rapidly decreased, there was still sufficient air flow to accelerate the unrestrained IP turbine disc. With the partial recovery of the HP system, the pressure of the air passing through the IP turbine was greater than expected. The friction between the disc and the LP front panel, and the loss in efficiency from the IP turbine blades as the disc moved rearwards out of the normal airflow, was insufficient to prevent the disc from accelerating past its maximum design rotational speed. As the rotational speed increased, the stresses within the IP disc increased, it expanded radially and at 02:01:11, 4 seconds after its separation from the drive arm, the disc material failed in overstress and the disc burst (Figure 61).

When the turbine case was breached the pressure within the IP disc space dropped to atmospheric pressure. That drop in pressure likely resulted in the heat-weakened HP/IP bearing chamber outer hub bursting (Figure 40 and Figure 61).

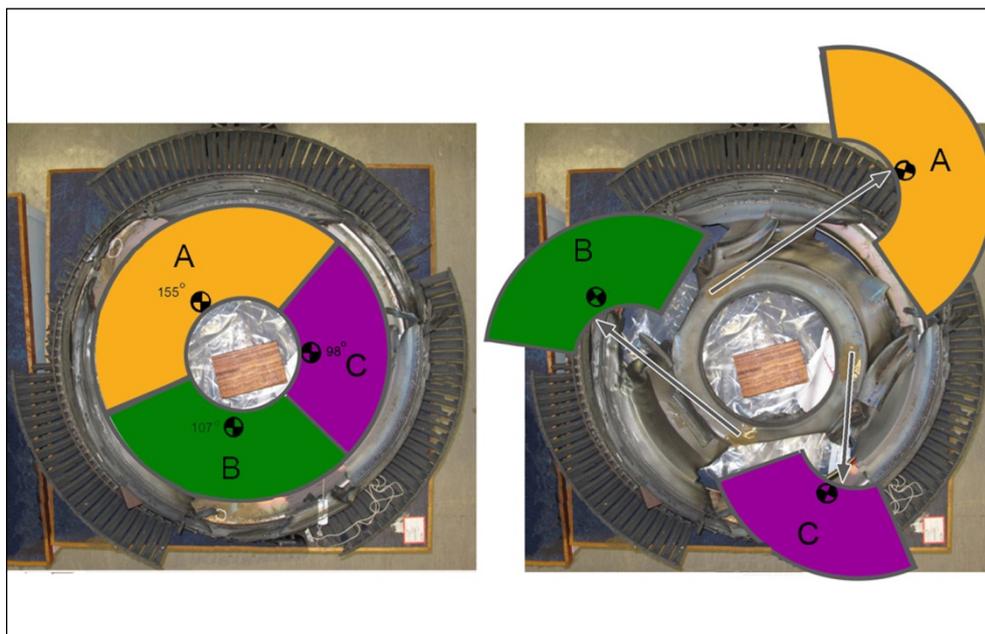
**Figure 62: Initial disc segment trajectories, looking rearward**

The disc fractured into three primary segments that were projected outwards with a force sufficient to breach the engine casing and damage the aircraft. The damage to the LP turbine front panel and LP turbine blades indicated that these segments were initially projected outwards in different directions (Figure 62).

Note: Segment A was recovered from Batam Island. Segments B and C were not recovered. The size of segments B and C were estimated from turbine blade fragments that were recovered from the aircraft, Batam Island and from the damage to the LP front panel.

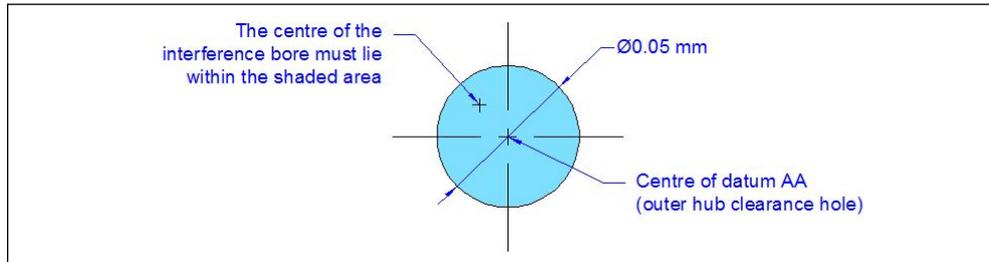
**Figure 65: Physical interpretation of 'geometric positional tolerance' using the interference bore as an example**

The dimensional information for the oil feed stub pipe interference bore included a geometric positional tolerance that required it to be positioned with respect to datum AA to within a diameter ( $\varnothing$ ) 0.05 mm circle. This meant that the centre of the interference bore was required to lie within a 0.05 mm diameter circle centred on the centre of datum AA (Figure 65).

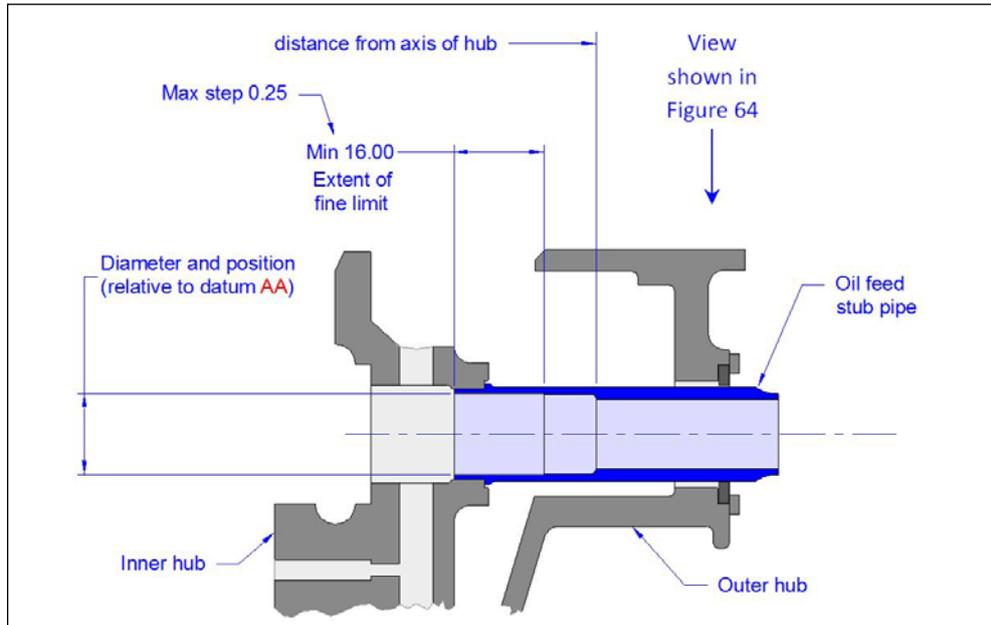
**Figure 66: Representation of the design definition drawing that defined the oil feed stub pipe counter bore**

The ATSB determined that the nominal wall thickness of the oil feed stub pipe within the counter bore was 0.91 mm. Using the 'worst case' tolerance combination of the interference bore at its smallest size, the oil feed pipe counter bore at its maximum size and the positional tolerances at their extreme values in opposite directions, the minimum permissible wall thickness was calculated to be 0.82 mm.

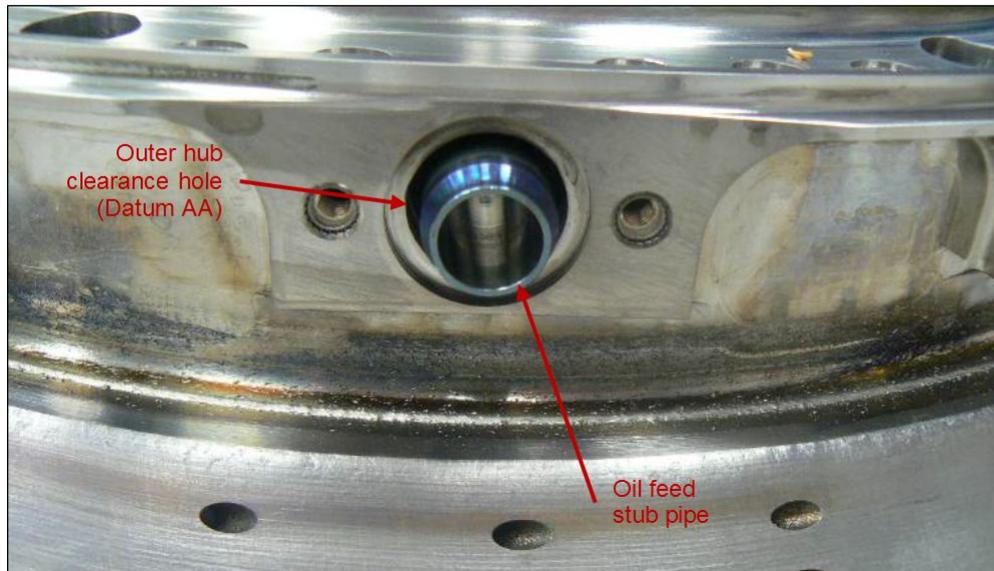
**Figure 67: Inaccessibility of Datum AA with the oil feed stub pipe installed**

Following the manufacturing acceptance of the design definition and during the preparation of the manufacturing specification and instructions, the MEs identified that the oil feed stub pipe needed to be fitted and welded in place before the oil feed stub pipe counter bore could be machined. Because the pipe was in place, the inner surface of the clearance hole in the outer hub was not accessible to the machining or inspection probes. As a result, datum AA could not be used as a reference for further machining operations (Figure 67).

There was no indication that the design or manufacturing personnel identified, either before or during the manufacturing acceptance of the design definition drawings, that datum AA would be inaccessible following fitment of the oil feed stub pipe into the hub assembly.

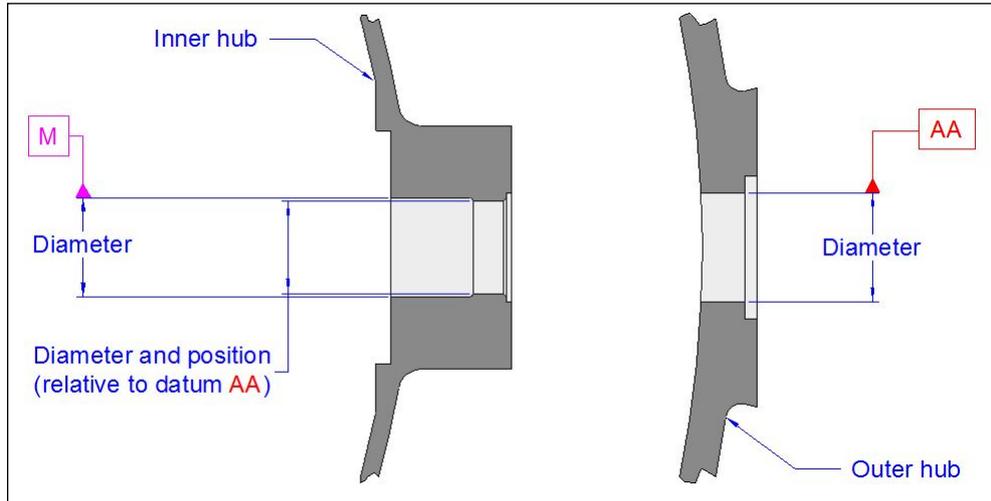
**Figure 68: Representation of the manufacturing stage drawing that identified datum M**

Because no positional tolerance was specified for the inner hub counter bore, datum M was not geometrically constrained. The result was that, according to the manufacturing stage drawings, there was no positive geometric connection between datum M and the interference bore.

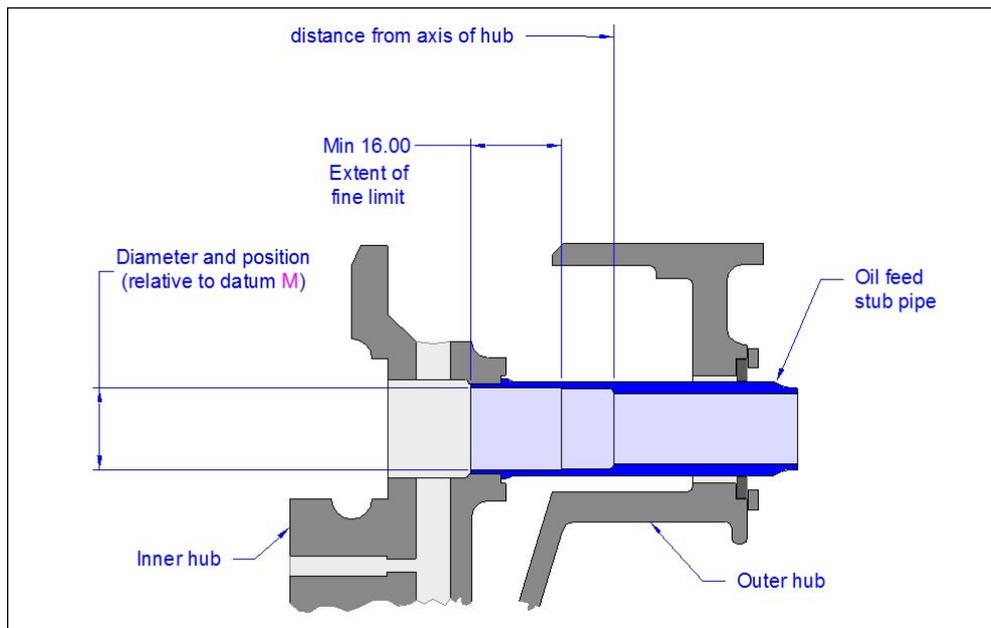
**Figure 69: Representation of the manufacturing stage drawing that defined the oil feed stub pipe counter bore**

The oil feed stub pipe counter bore detail on the manufacturing stage drawing differed from the design definition in that the positional tolerance for the feature was referenced to datum M, rather than datum AA. The positional tolerance on the drawing was specified as  $\varnothing 0.2$  mm, rather than the 0.1 mm specified on the design definition.

There were significant differences between the sizes of the positional tolerances specified on the design definition and manufacturing stage drawings. The ATSB did not identify an explanation to account for those differences.

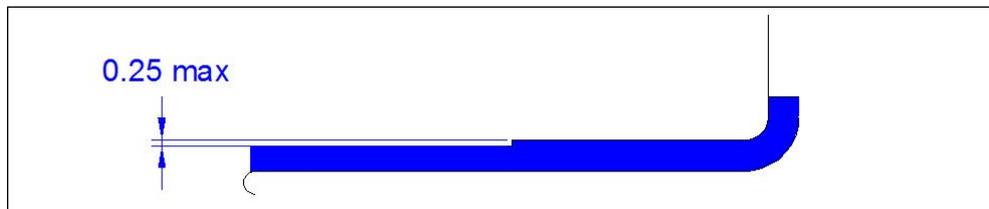
**Figure 70: Depiction of the max step feature on the manufacturing stage drawing**

Similar to the design definition drawing, the oil feed stub pipe counter bore feature on the manufacturing stage drawings only had the diameter of the fine limit counter bore specified. The counter bore max step feature was also specified in a different manner to that in the design definition drawing. Rather than an annotation to the 'min 16.00 extent' dimension on the feature on the design definition drawing (Figure 66), the step was depicted in a separate enlarged view on the same drawing sheet (Figure 70).

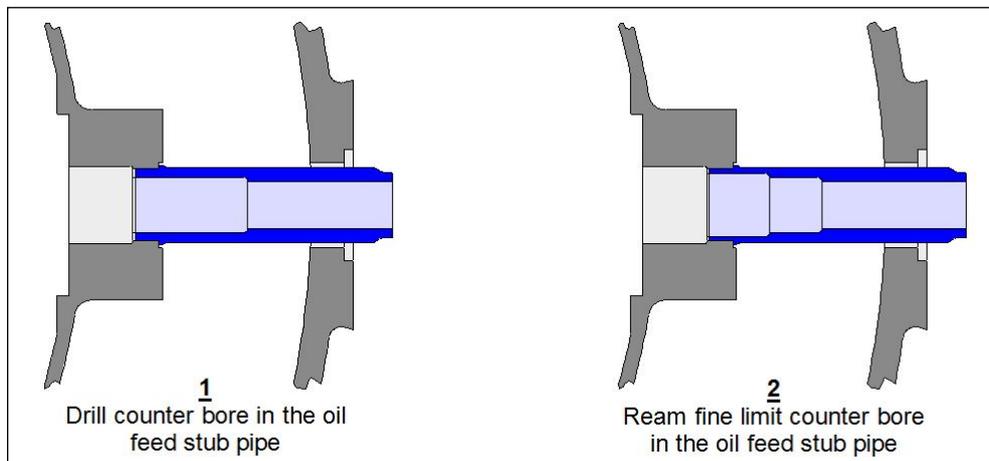
**Figure 75: OP 190 oil feed stub pipe counter bore**

During the milling operation, the oil feed stub pipe counter bore was drilled and reamed (see 1 and 2 respectively in Figure 75).

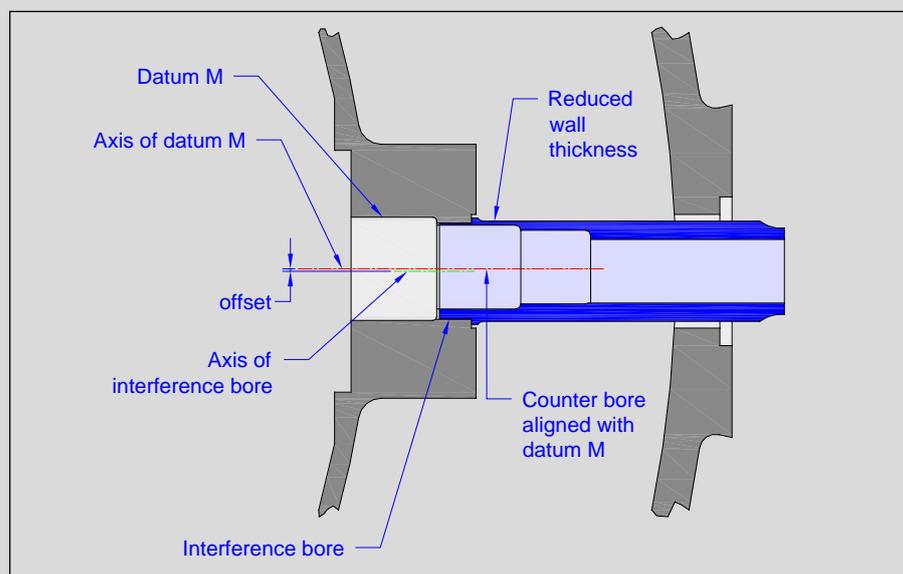
**Figure 76: Reduced oil feed stub pipe wall thickness due to misalignment**

misalignment of the oil feed stub pipe counter bore with respect to the outside diameter of the stub pipe. This would in turn result in a reduced wall thickness within the stub pipe (Figure 76).

The engine manufacturer was unaware of the potential for a reduced oil feed stub pipe wall thickness until identified in March 2009. Detail regarding the identification of this and how it was managed is provided in sections 4.12 and 4.13 of this report.

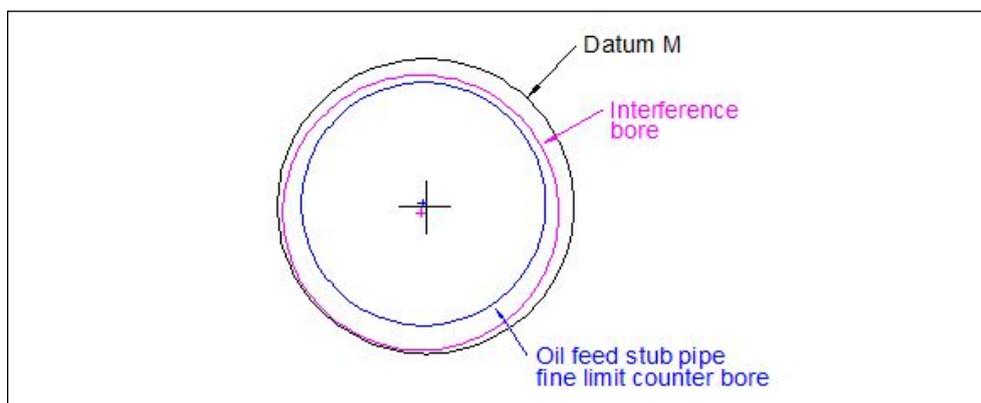
**Figure 85: Graphical representation of the true positions of the bores and datum M on the oil feed stub pipe from hub 0225**

A dimensional examination of the oil feed stub pipe from hub 0225 was carried out by the ATSB. That examination found that the (Figure 85):<sup>92</sup>

When hub 0225 was manufactured, the true position of the interference bore was probably in excess of the limits contained within the CMM program for the OP 70 inspection. Given the extent of the deviation of the as-measured true position from the acceptable tolerance, it would have been expected that the CMM detected the difference and produced an error on its report. The expected error was estimated to have been in the range from  $\varnothing 0.40$  to  $\varnothing 0.48$ mm.

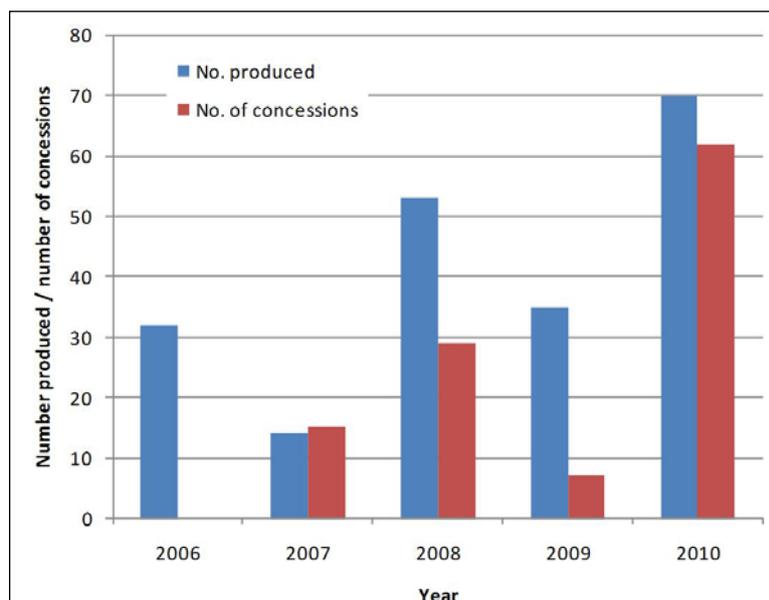
**Figure 86: Hucknall facility HP/IP support assembly concessions**

A review of the manufacturer's concessions register found that, between February 2006 and July 2007, there was only one concession raised for the Trent 900 HP/IP assembly. Thirty-two assemblies were produced in that period. In contrast, there was a significant increase in the number of concessions raised on the HP/IP assembly following the Hucknall major quality investigation in 2007 (Table 11 and Figure 86).

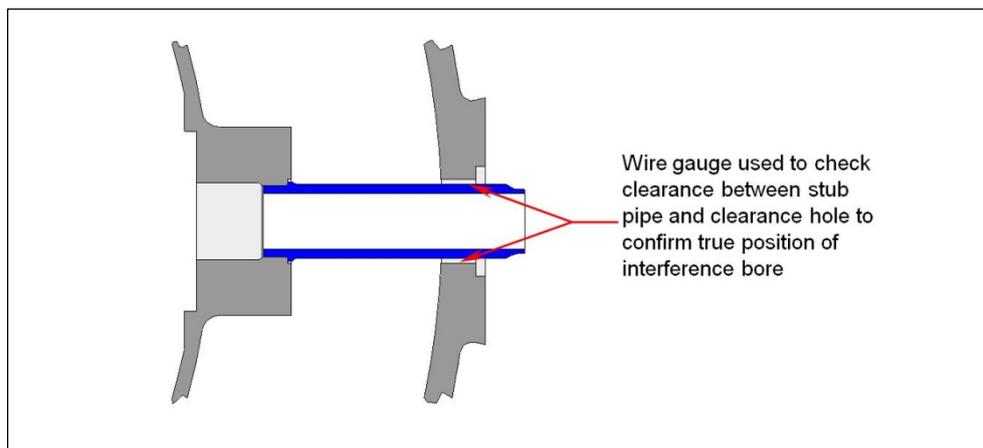
**Figure 87: Wire gauge check**

The results from a wire gauge check of the clearance between the respective stub pipes and the outer hub clearance hole were attached to the concession (Figure 87).<sup>96</sup> Those results showed a consistent clearance around the pipe, indicating that the pipe was centrally located within the outer hub clearance hole.

The concession was reviewed and accepted by design, stress and air/fluid systems engineers and categorised as a Cat 3 non-conformance. The categorisation of non-conformances was discussed in section 4.8.4 of this investigation report.

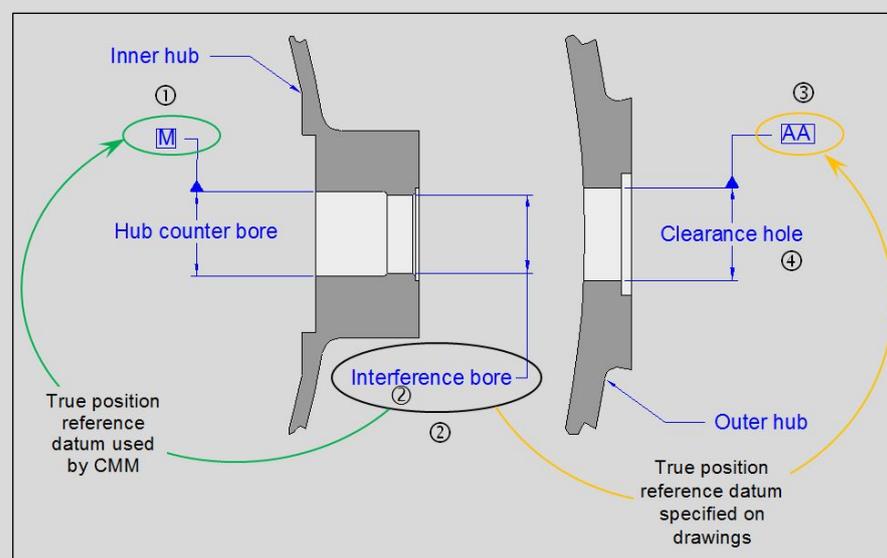
**Figure 88: Differences in the interference bore reference datums**

Both the manufacturing engineer who prepared the concession form and the non-conformance authority would have been unaware that the CMM had actually measured the true position of the interference bore relative to datum M, not datum AA as listed on the design definition (Figure 88). Given that the results of the wire gauge checks indicated that there was not a clearance issue, it was reasonable for the non-conformance authority to have determined that the non-conforming part was acceptable for use and to have approved the concession without understanding that there was a potentially thin wall on the stub pipe.

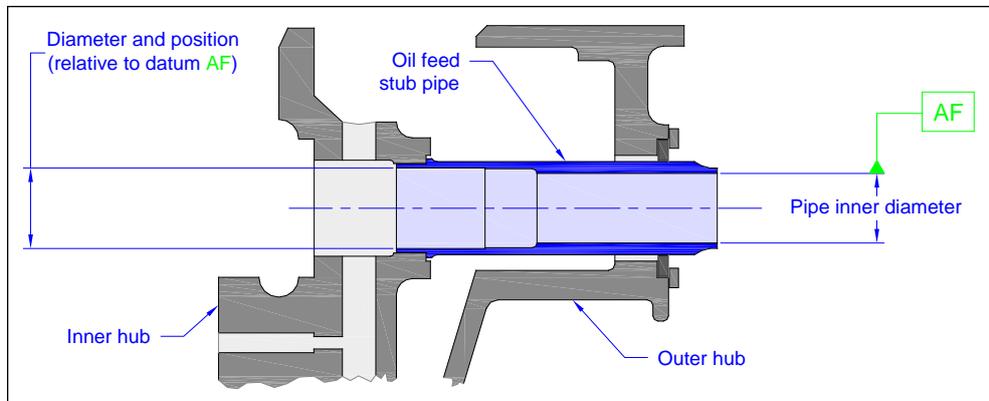
**Figure 89: Revised oil feed stub pipe counter bore definition**

The definition alteration request listed the requested definition changes and included a proposed change in the reference datum for the counter bore in the oil feed stub pipe. This included the introduction of a new datum (AF) and a request to change the positional tolerance reference from AA to AF. Datum AF was defined as the inner surface of the oil feed stub pipe (Figure 89).

The definition alteration request was approved in April 2008 with the justification that the requested changes did not affect the design intent of the assembly (form, fit and function) and was to be incorporated into the next HP/IP bearing support assembly standard (the C-standard). The alteration request also contained a handwritten note indicating that it had been incorporated at the request of Manufacturing. The design definition drawing for the B-standard HP/IP bearing support assembly was amended in July 2008 to incorporate the requested changes.

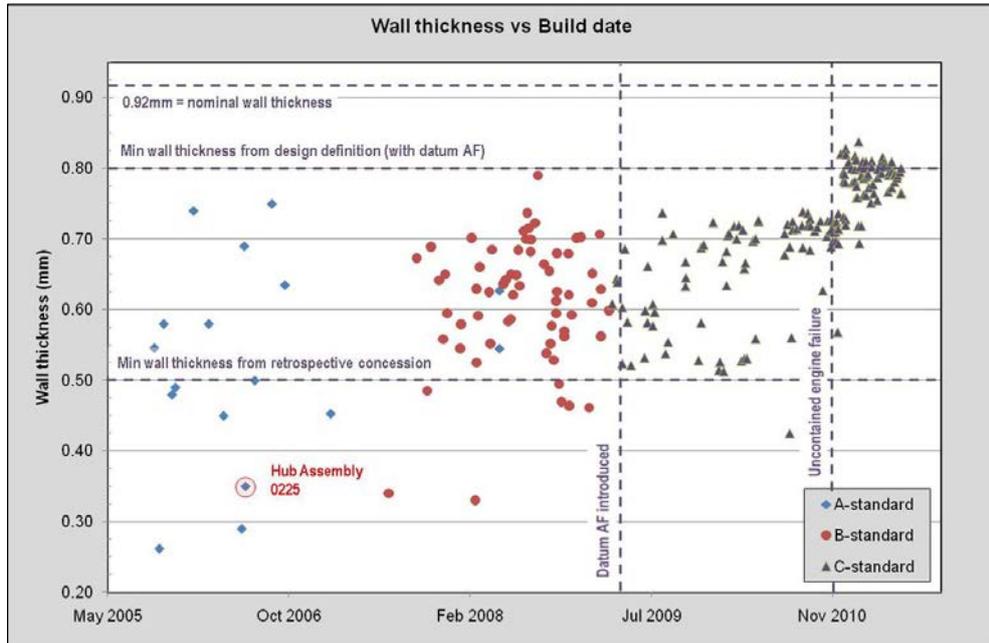
**Figure 91: Oil feed stub pipe wall thickness survey, determination and estimates (No. 2 engine hub assembly from VH-OQA highlighted)**

Measurements were taken between the internal pipe diameter and the drilled counter bore, and the wall thickness estimated from those measurements. There were a number of limitations on that method, including assumptions that the reamed counter bore was offset in the same direction as the drilled counter bore (which, in the case of ESN 91045 was not), of nominal dimensions for all other features, and that the inside diameter of the pipe was coaxial with the interference bore.

Note: The wall thicknesses from 17 of the 38 A-standard HP/IP bearing support assemblies produced were available to the ATSB.

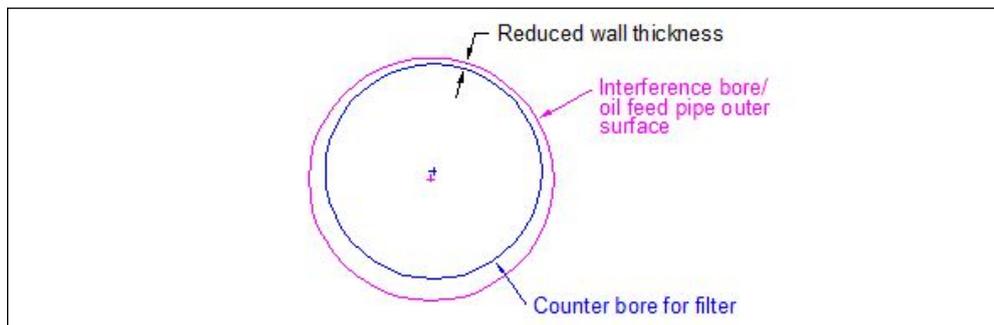
**Figure 92: Effect of misaligned counter bore on pipe wall thickness**

After the oil feed stub pipe was fitted to the hub, the oil feed stub pipe counter bore was machined using the inner hub counter bore as the reference datum to position the counter bore. Because the inner hub counter bore was misaligned with the axis of the stub pipe, so too the oil feed stub pipe counter bore was misaligned with the axis of the stub pipe. This resulted in a locally thin wall in the oil feed stub pipe (Figure 92).

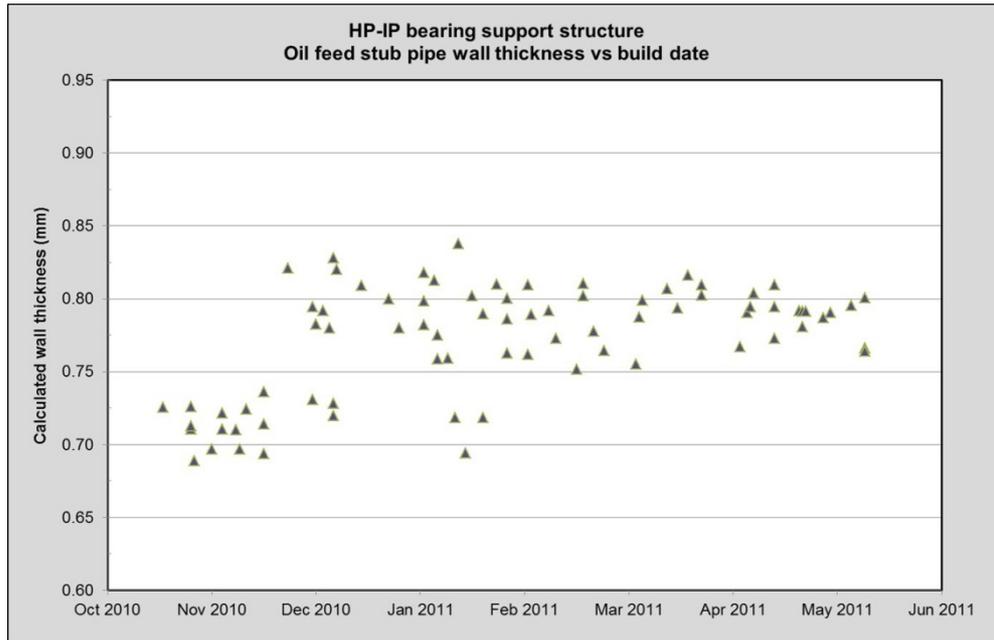
**Figure 93: Production data for the HP/IP bearing support structures that were manufactured at the Hucknall facility**

Rolls-Royce production data showed that, after the introduction of this revised limit in December 2010, the quality control of the manufacture of the HP/IP bearing support structure at the Hucknall facility had improved (Figure 93).

Following the occurrence, the stub pipe wall thickness production limit was restricted to 0.70 mm for all newly manufactured engines (Figure 93). The revised limit was introduced in December 2010, along with enhanced techniques for the measurement of critical dimensions within the counter bore region.

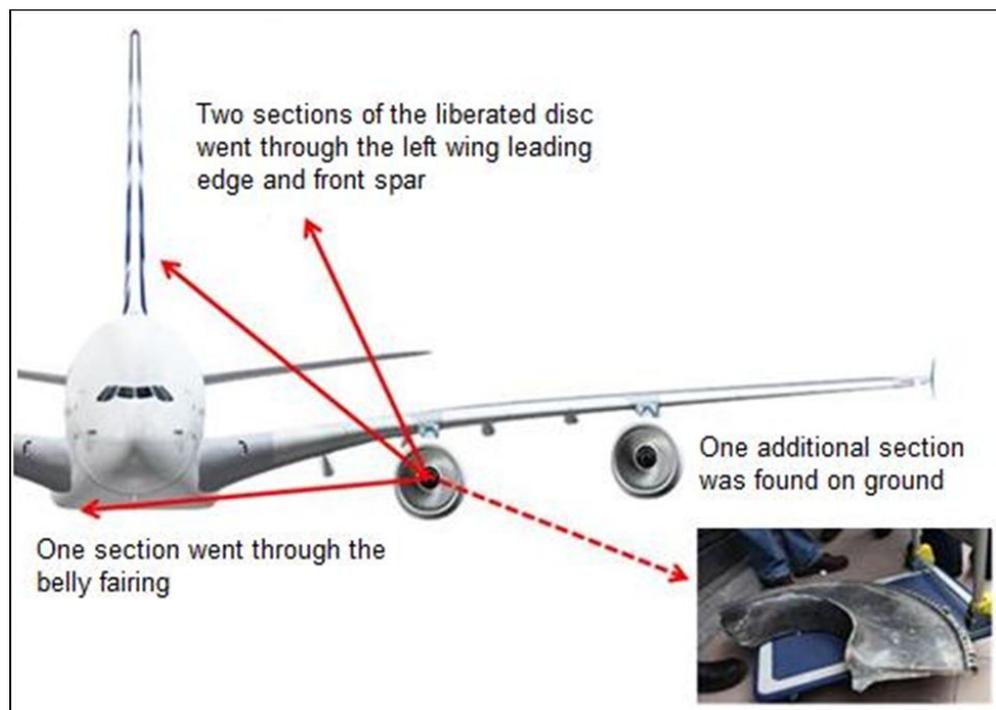
**Figure B1: Trajectory of the major disc segments. Two main fragments impacted the wing. A smaller, high energy fragment followed a different ballistic trajectory and penetrated the fuselage belly fairing structure.**

It is likely that at least one of the three main disc fragments broke up into smaller pieces during its initial ballistic trajectory through the engine case, before impacting the left wing structure. A smaller disc fragment and associated engine debris penetrated through the wing-to-body fairing and impacted airframe structure. Smaller, high-energy disc fragments and engine debris also impacted the airframe, resulting in significant damage (Figure B1).

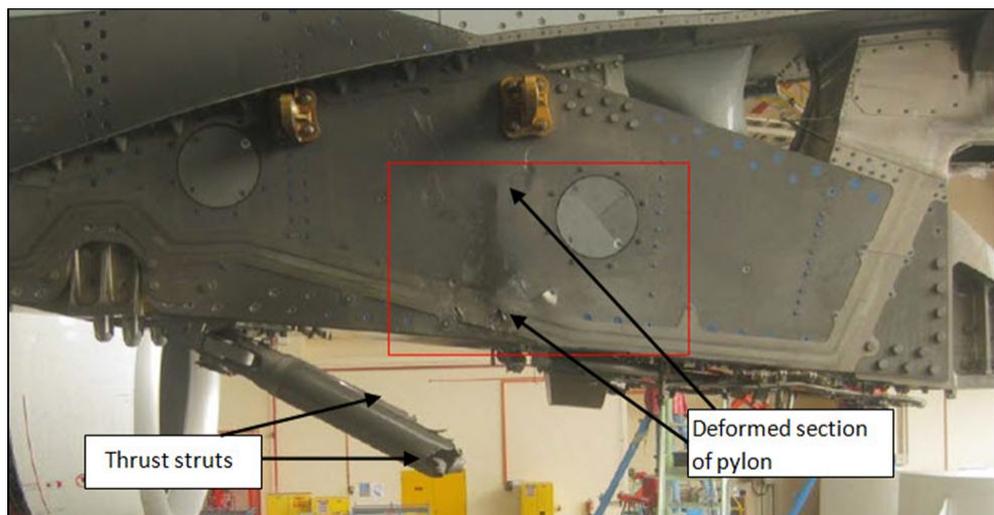
**Figure B2: Inboard side of the No. 2 pylon highlighting the deformation and the severed thrust struts (links)**

The engine pylon attached the engine to the wing. The No. 2 engine pylon sustained impact damage to its sidewalls including bending, scratches and small gouges. A section of the pylon was deformed along its length and width (Figure B2).

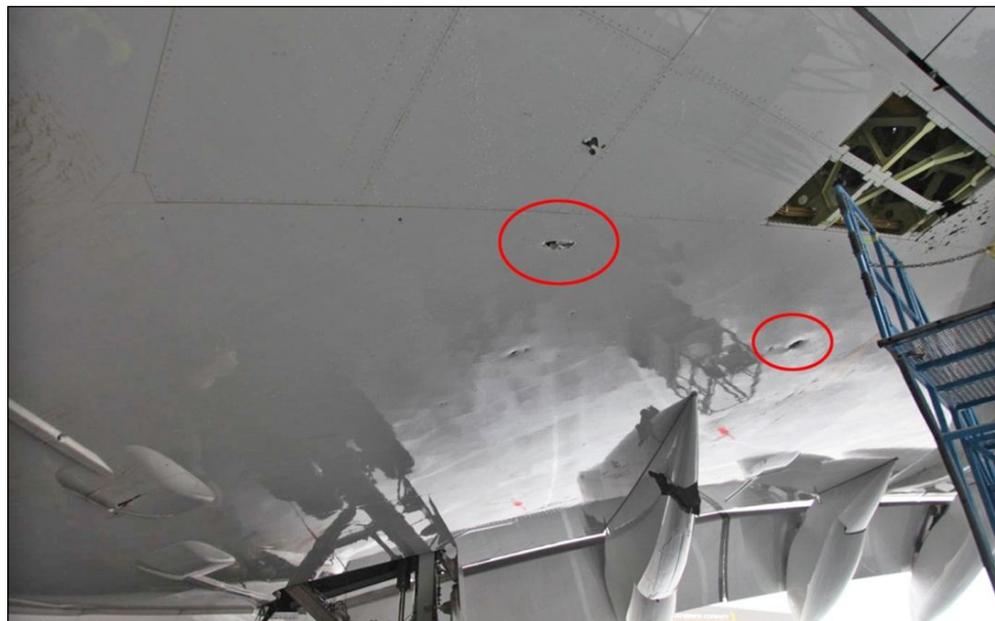
**Figure B11: Lower wing skin perforations (circled) leading to fuel leakage from the No. 2 feeder tank**

Lower wing skin (Figure B8) comprised of panels 1, 2, 3 and 4 (Figure B9). Impact damage was evident in 35 locations, including 2 perforations through to feed tank 2 (Figure B10 to Figure B13).

Damage to the left wing lower skins included two puncture holes and impact damage including scores, dents and gouges measuring from a few millimetres to about 200 mm in length (Table B1). Most of the damage was concentrated between ribs No. 8 to Rib No. 14, with additional damage evident further outboard. A significant amount of fuel leaked from feed tank No. 2 as a result of the puncture holes.

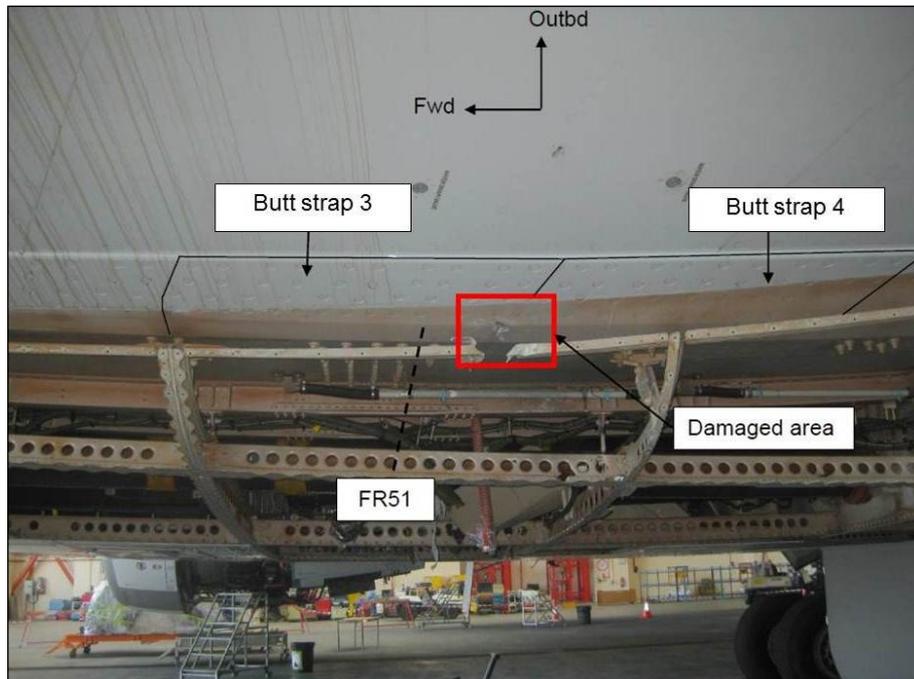
**Figure B21: Butt-straps No. 3 and No. 4 with damage highlighted**

A butt-strap is a drop-forged fitting that overlaps and fastens the wing to the fuselage in conjunction with other structural components. Butt-straps No. 3 and 4 are located at the lower fuselage joint between Frames 46 and 56. These straps sustained impact damage, included gouging over an area of about 76 cm<sup>2</sup> from liberated engine debris between frames 51 and 52 (Figure B21, Figure B22, Figure B23).

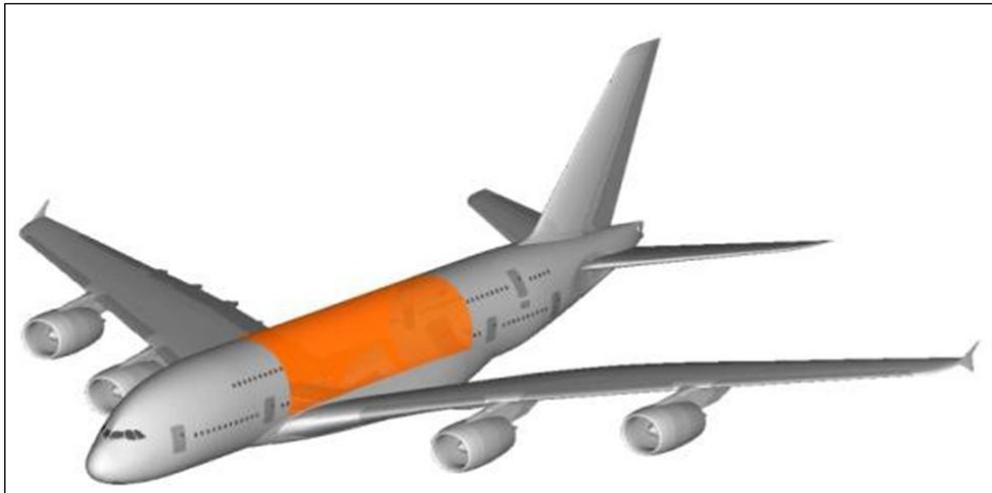
**Figure B24: Centre fuselage – section 15 highlighted in orange**

- Three fuselage skin panels were damaged in section 15 (Figure B24 and Table B3) that damage included:
- FR46-FR62, STGR6LH-STGR22LH, 39 items of impact damage (scratches, gouges and dents) and 6 windows damaged in that location.
- FR46-FR62, STGR22LH-STGR39LH, 19 items of impact damage (scratches, gouges and dents) and 1 window damaged in that location.
- FR62-FR74, STGR22LH-STGR39LH, 4 items of impact damage (scratches, gouges and dents) and 1 window damaged in that location.

Type of Damage	Between Frames	Between Stringers
Gouges	54-55	18-21
Gouges	55-56	17-18
Gouges	55-56	22
Gouges	55-56	18-21
Gouges	55-56	18-21
Scratches	55-56	21
Scratches	56-57	18-21
Gouges on Window	56-57	18-21
Gouges	56-57	15-16
Gouges	56-57	21
Gouges	57-58	18-21
Gouges	58-59	18-21
Scratches Window/Frame	67-68	18-21
Gouge	50-51	25
Gouge	50-51	25-26
Gouge	50-51	24-25
Gouge	54-55	24-25
Scratch	54-55	23-24
Gouge	54-55	26-27
Gouge	55-56	25-26
Gouge	55-56	25-26
Gouge	56-57	24-25
Gouge	59-60	22-23
Gouge/Dent	47-48	28-29

Type of Damage	Between Frames	Between Stringers
Gouge	52-53	30-31
Gouge	54-55	33
Gouge	52-53	32-33
Gouge	53-54	27-28
Gouge	55-56	27-28
Gouge	59-60	27-28
Gouge	61-62	35-38
Gouge	63-64	29
Gouge on Window	65-66	35-38
Gouge	68	32-33
Gouge	69	33-34

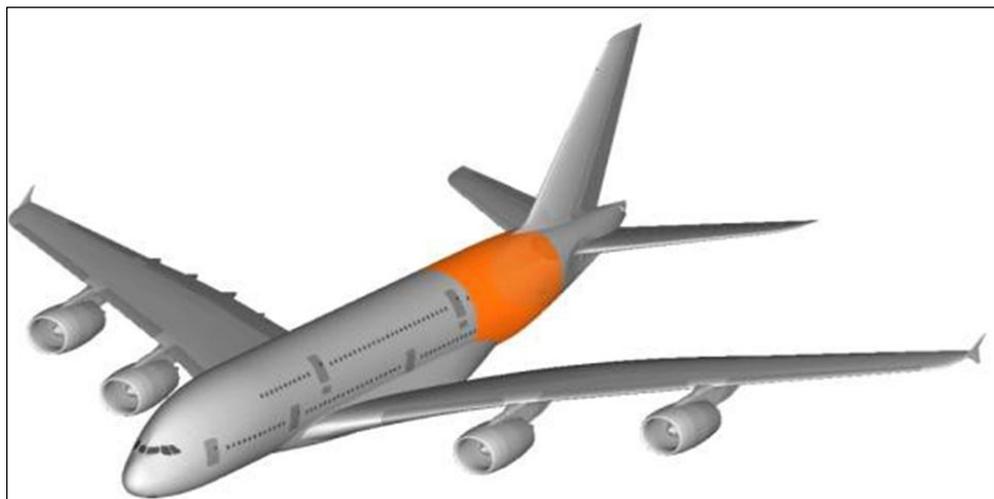
**Figure B25: rear fuselage – section 19 highlighted in orange**

Three fuselage skin panels were damaged in section 19 (Figure B25), Damage at that location required repair prior to further flight, that damage included (Table B4):

- FR74-FR89, STGR6LH-STGR22LH, 5 items of impact damage (scratches, gouges and dents) in that location.
- FR74-FR81, STGR22LH-STGR39LH, 5 items of impact damage (scratches, gouges and dents) in that location.
- FR81-FR89, STGR22LH-STGR39LH, 3 items of impact damage (scratches, gouges and dents) in that location.

Type of Damage	Between Frames	Between stringers
Gouge	77-78	22-23
Gouge	79-80	18-21
Gouge	79-80	18-21
Gouge/Scratch	81-82	18-21
Gouge	81-82	18-21
Gouge	74-75	23-24
Gouge	75-76	23-24
Gouge	75-76	23
Gouge	81	23-24
Scratch	83	23-24
Gouge	88-89	16-17
Gouge	75-76	30-31
Gouge	81-82	38-39

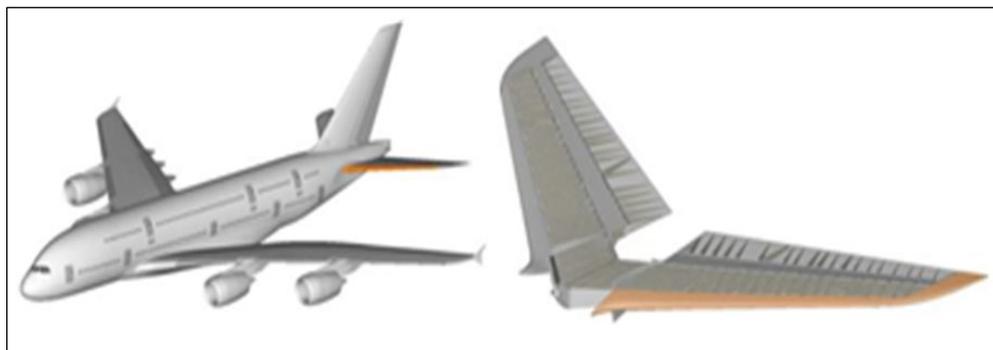
**Figure B26: Trimmable Horizontal Stabiliser leading edge skin panels highlighted in orange**

The left side of the trimmable horizontal stabiliser leading edge (Figure B26) was damaged from engine and airframe debris at five locations along the leading edge (scratches, gouges and dents). Damage at that location required repair prior to flight.

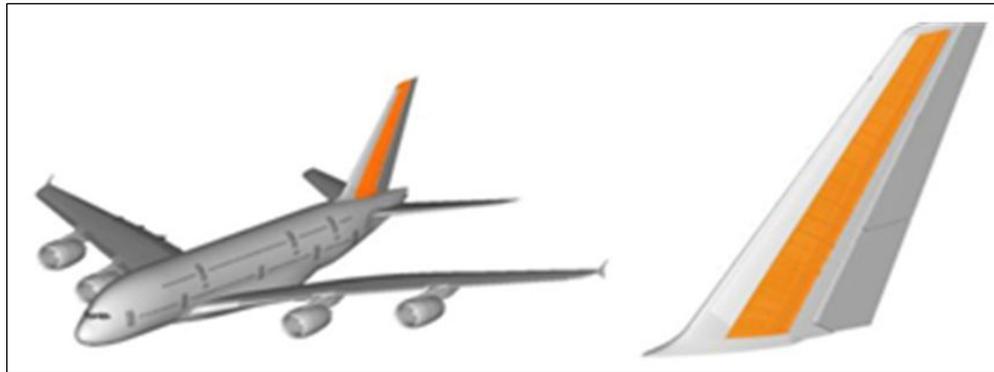
**Figure B27: Vertical stabiliser spar box skin highlighted in orange**

The left side of the vertical stabiliser (Figure B27) was damaged from engine and airframe debris at five locations along the leading edge (scratches). Damage at that location required repair prior to flight.

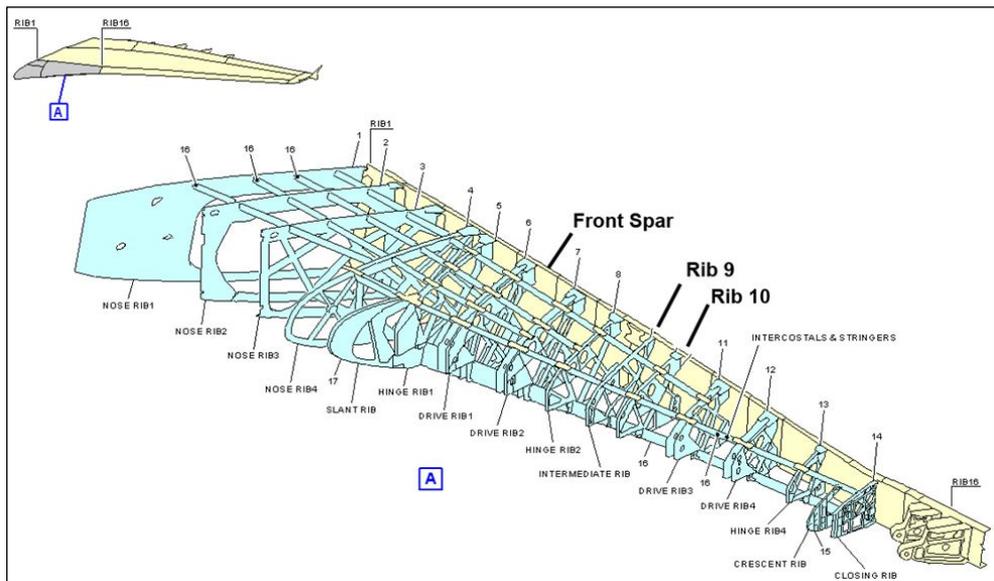
**Figure B28: Wing leading edge sub structure diagram**

The left wing leading edge substructure, droop nose flaps, composite skins and components in that area, between the number two engine and the fuselage (Figures B28-B30) were subject to significant impact forces. Although the damage incurred was significant, it was not considered to be major structural damage.

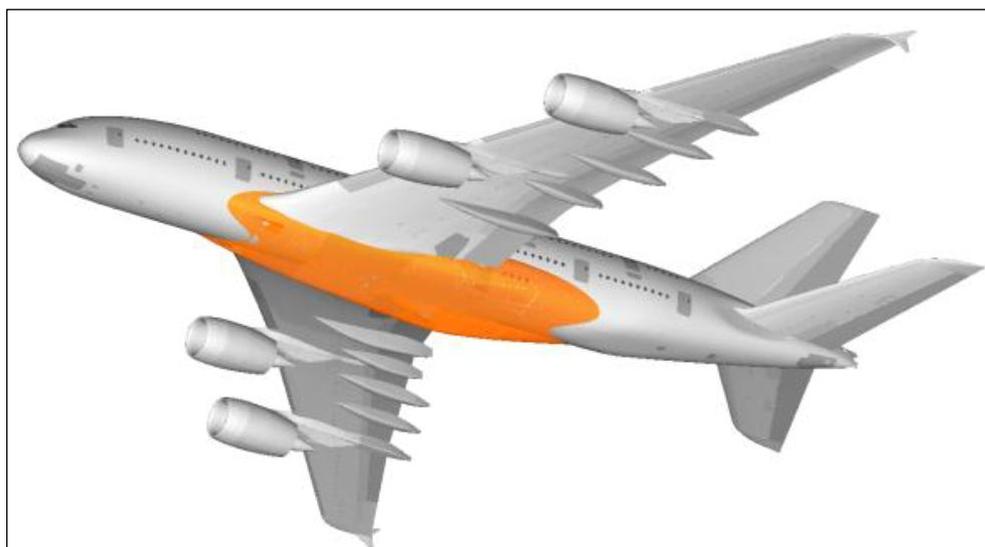
**Figure B31: General location of the belly fairing panels on the A380 aircraft highlighted in orange**

The belly fairing and centre wing box structure (Figure B31) of the aircraft sustained significant damage from engine fragments. A smaller-sized, high-energy disc fragment penetrated the belly region of frame 51 (Figure B32 to Figure B36).

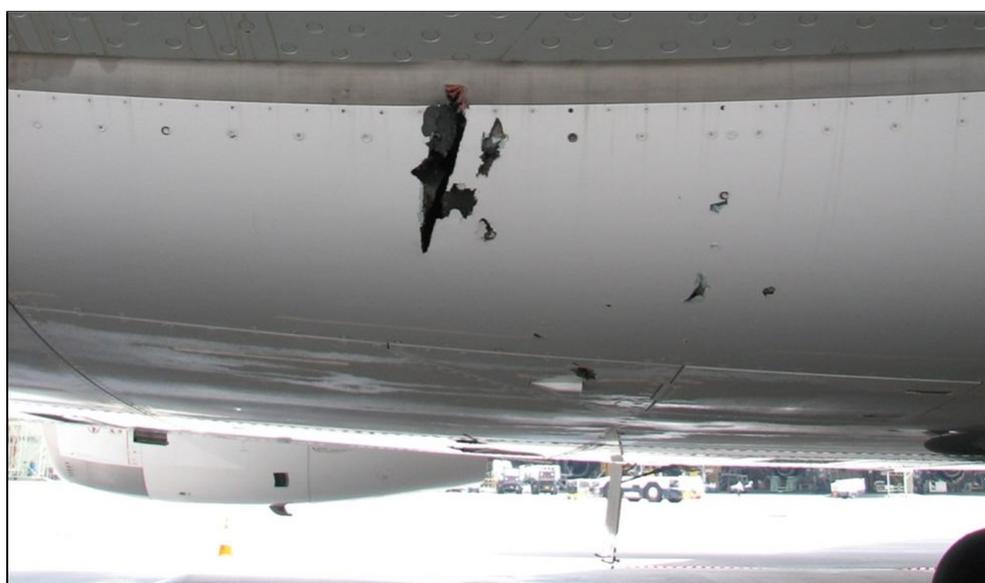
**Figure B32: A smaller, high energy fragment of the IP turbine cut a swath directly through the belly fairing of the aircraft—view looking to the right of the aircraft with the No. 3 engine in the background.**

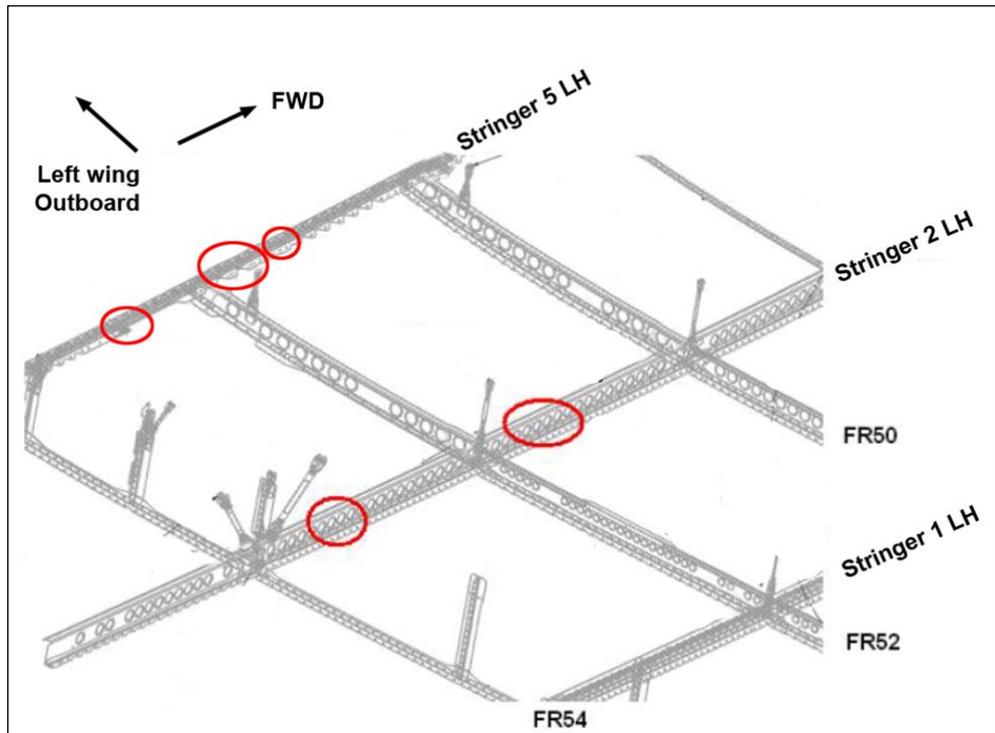
**Figure B33: Structural arrangement of the fuselage between frames 50 and 54 showing the damage points from engine debris that penetrated the belly fairing**

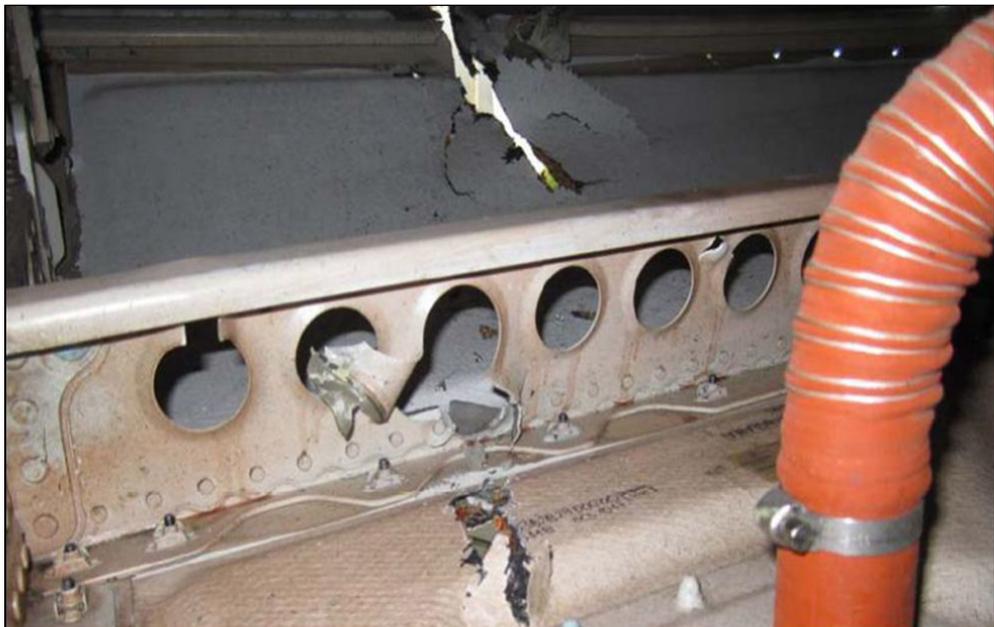
**Figure B36: Stringer 5 LH impact damage**

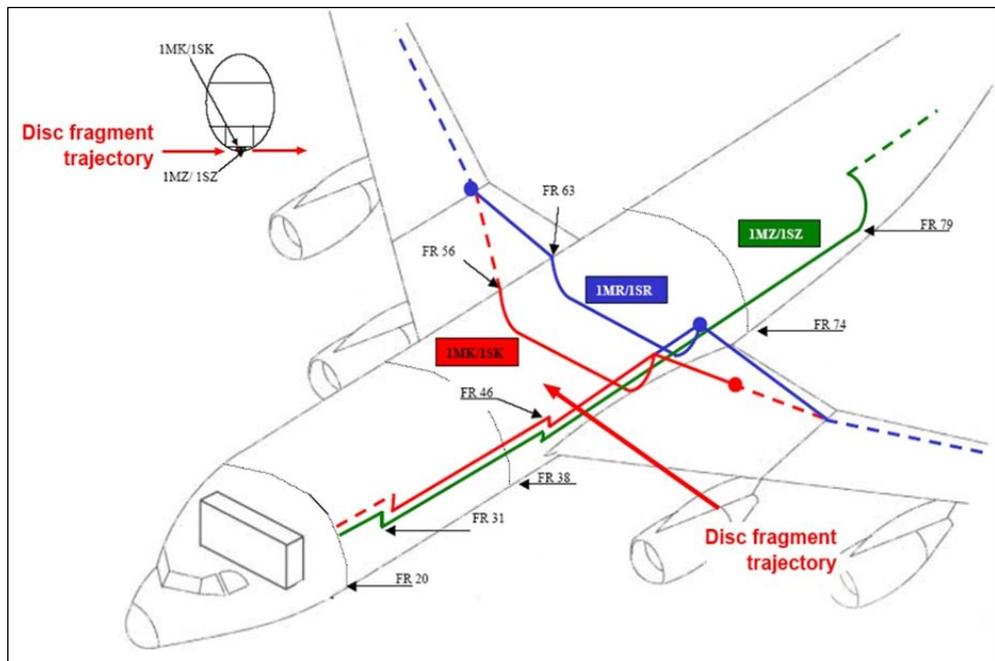
The debris from the engine failure directly damaged a number of systems, which in turn affected a number of other systems. Although some systems sustained direct mechanical damage, most of the affected systems were damaged through debris impact to the respective wiring looms. Two main wiring looms were impacted by debris; one running through the leading edge of the left wing, and the other in the belly fairing. This resulted in damage to about 650 wires in total (Figure B37 to Figure B51).

**Figure B37: Representation of the smaller, high energy disc fragment's trajectory through the aircraft belly fairing (keel beam) which severed wiring harnesses**

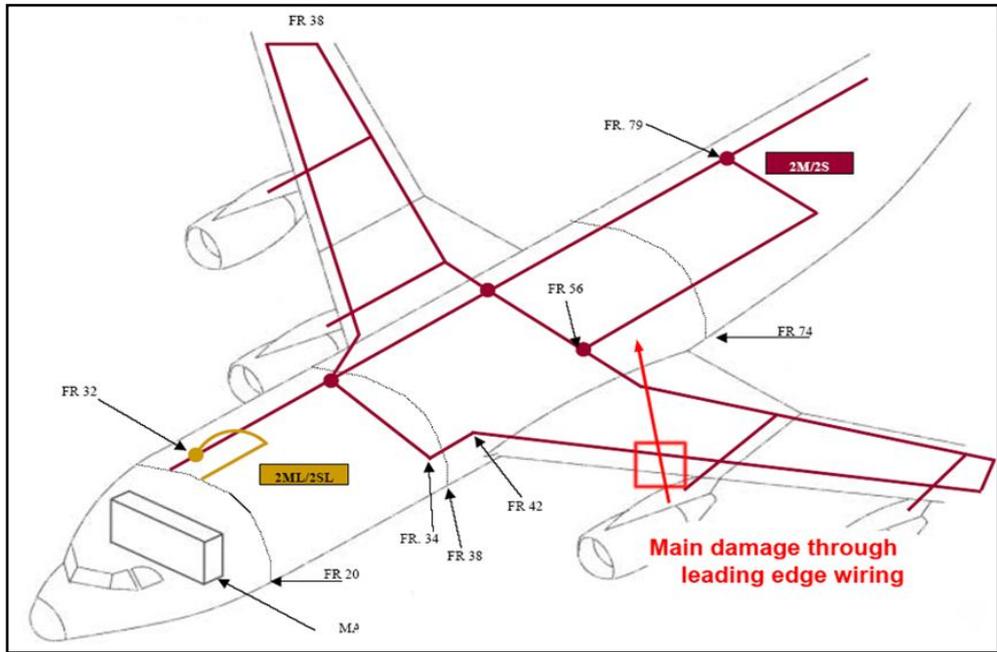
**Figure B38: Representation of the disc fragment trajectory through the aircraft left wing leading edge which severed numerous wiring harnesses**
