# In-flight uncontained engine failure Airbus A380-842, VH-OQA

overhead Batam Island, Indonesia | 4 November 2010

**ATSB Transport Safety Report**  
Aviation Occurrence Investigation  
AO-2010-089  
Final – 27 June 2013

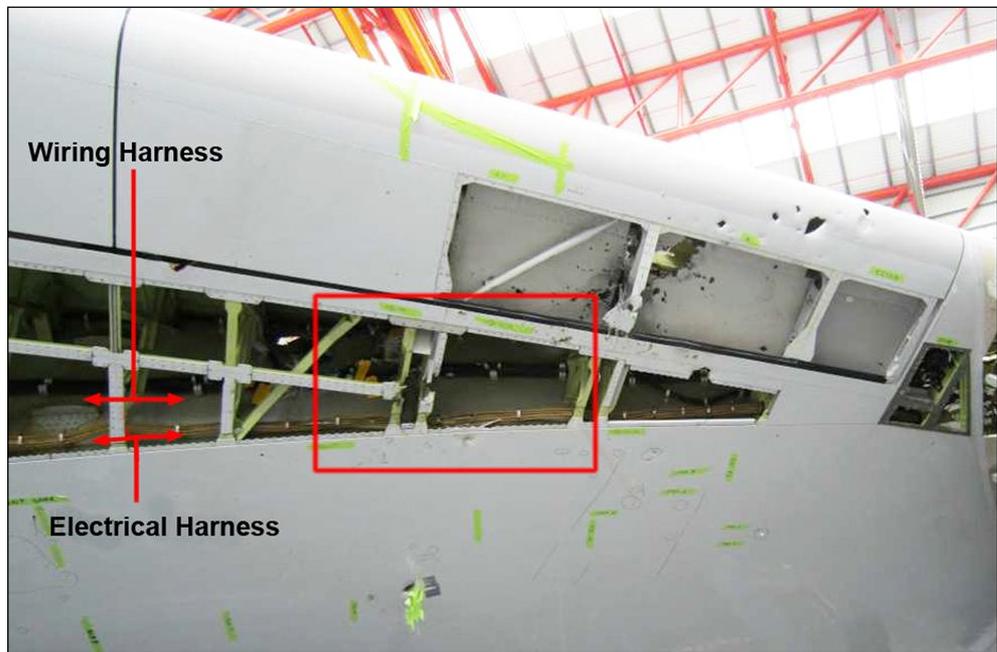
**Figure B39: General location of the wiring harness damage within the leading edge of the left wing—red framed area expanded in Figure B40**

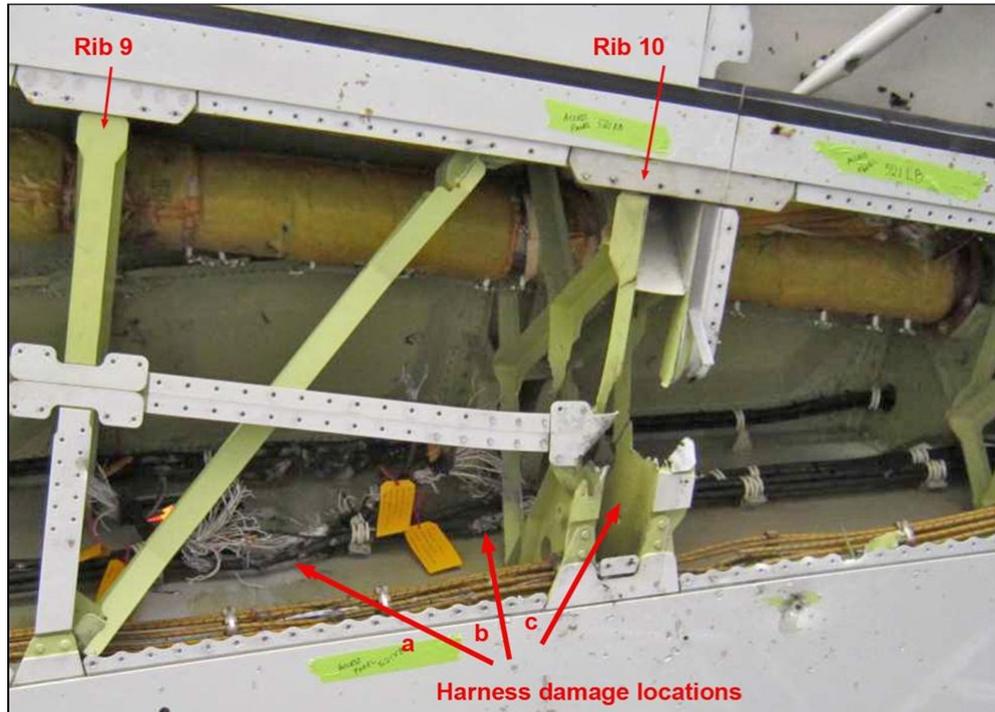
**Figure B40: Wiring harness damage at three main locations within the leading edge of the Rib 9 and Rib 10 area**

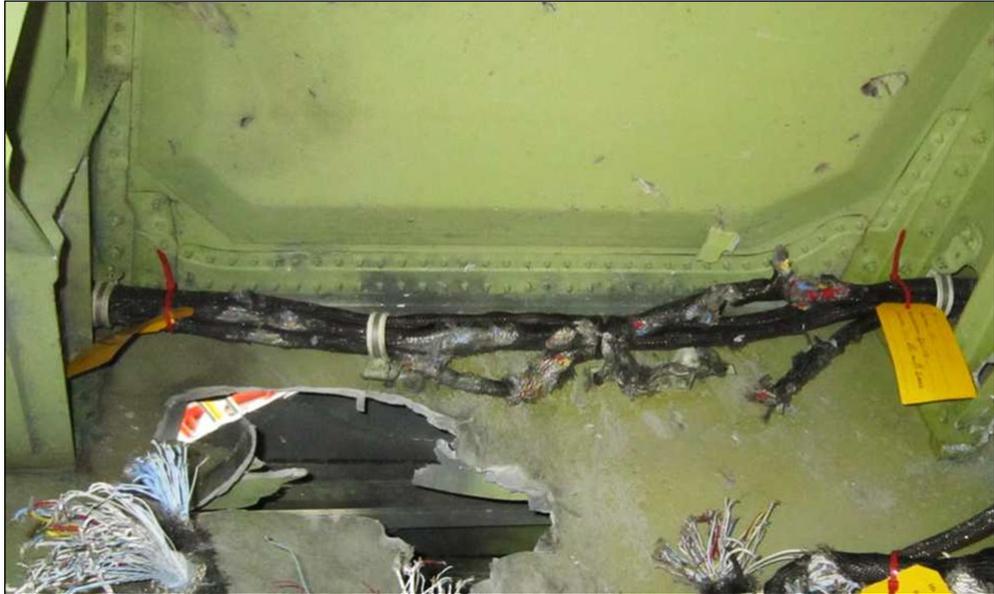
**Figure B44: Main damage to the route 1P route harnesses (looms 3025VB, 3027VB, 3031VB and 3033VB), between Rib 9 and Rib 10 of the left wing lead edge. All wires within the harness were completely severed. The debris entry/exit hole through the front spar is also evident**

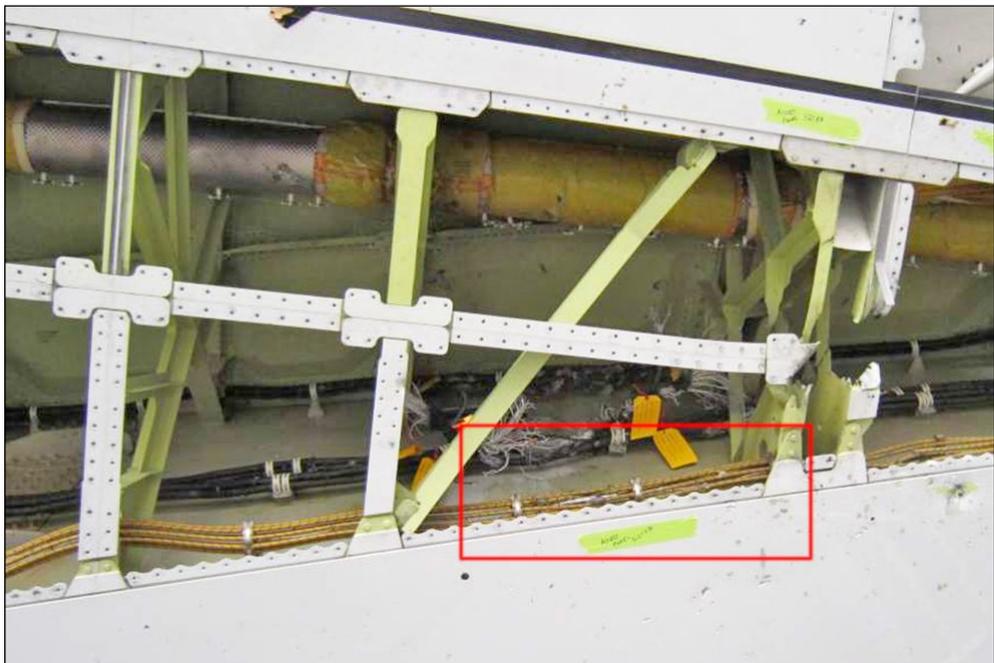
**Figure B45: Detailed locations of damage to the 1G route (electrical harness 3029VB), primarily between Rib 9, 10 and 11 of the left wing; four of the 9 feeder and exciter cables have been severed—red framed area expanded in Figure B46**

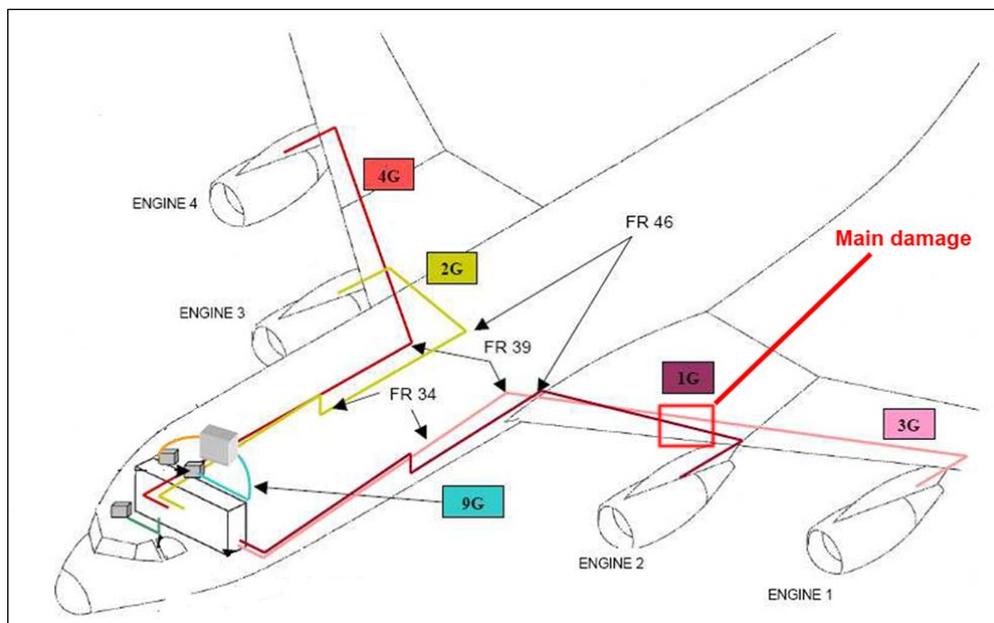
As the electrical system was locked in the air mode, only APU generator A was available to supply power following the shutdown of engines No. 3 and 4. This resulted in only AC BUS 1 and the essential bus bar continuing to be supplied with AC power. This limited power source resulted in some flight deck display screens being lost and only the VHF 1 radio being available for use by the flight crew.

**Figure B55: Engine feeder routing and the main damage location**

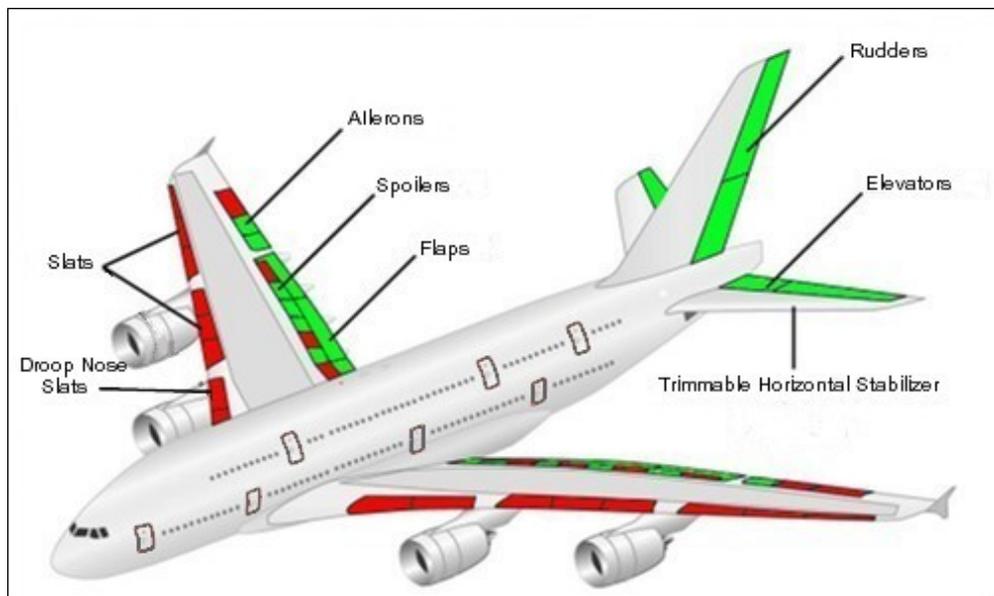
The availability of the primary and secondary flight control surfaces following the uncontained engine failure and subsequent ECAM actions by the crew are depicted in Figure B56.

**Figure B56: Flight control surface status following the engine failure and ECAM actions by the crew (unavailable control surfaces highlighted in red)**

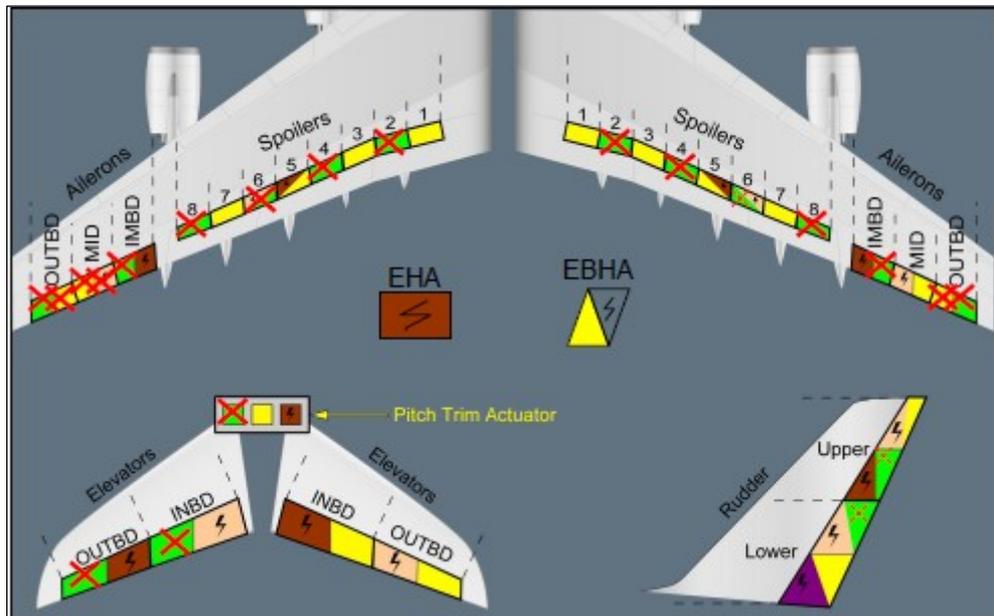
**Figure B58: Primary flight controls actuation system (a red cross indicates the loss of actuator operation after the engine failure)**

The loss of the Green hydraulic system and impact damage to the aircraft's wiring combined to affect the availability of the left aileron system for the remainder of the flight. As a result, the outboard aileron Yellow and Green servocontrols, mid aileron EHA and Yellow servocontrol and the inboard aileron Green servocontrol were unavailable. As a result, the left outer and mid ailerons were disabled. (Figure B58).

Each wing had eight spoilers, numbered 1 to 8 outwards from the aircraft centreline (Figure B58). The loss of the Green hydraulic system and wiring damage resulted in the unavailability of spoilers 2, 4, 6 and 8 on the left wing and of spoilers 2, 4 and 8 on the right wing.

Pitch trim operation was unaffected following the uncontained engine failure. The trimmable horizontal stabiliser had three independent actuators, numbered 1 to 3 from left to right, for redundancy (Figure B58). The loss of the Green hydraulic pressure rendered the No. 1 actuator inoperative, while actuators 2 and 3 continued normal operation.

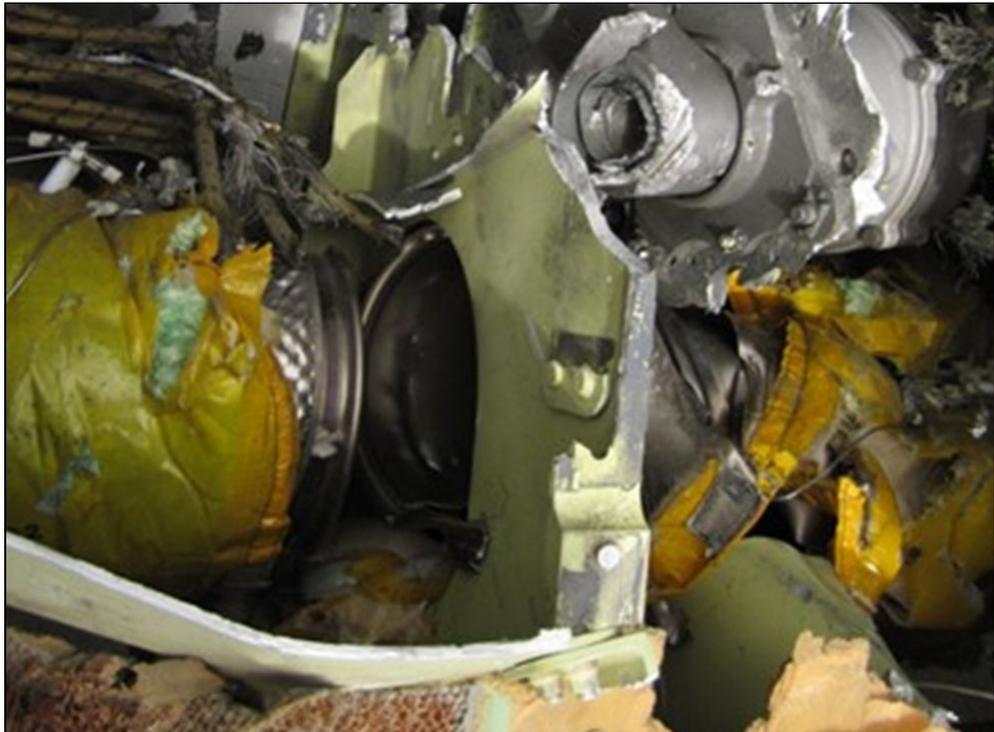
**Figure 60: Bleed air duct damage**

The bleed air ducts in the left wing leading edge and centre fuselage were damaged from impact by the engine debris, affecting the distribution of bleed air from engines No. 1 and 2 and the APU (Figure 60). The damage was detected by the ODS and the affected pneumatic systems were isolated in less than 10 seconds. There was no operational impact.

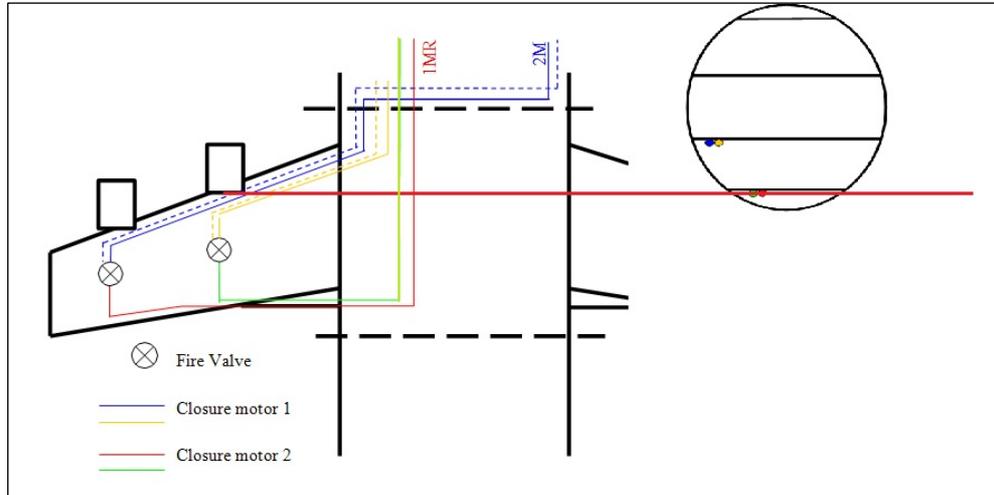
Severing of signal wires in the left wing leading edge and belly fairing of the aircraft contributed to the loss of control of the No. 1 engine LPSOV. This resulted in the inability to shut down that engine after the aircraft had landed at Changi Airport, Singapore. Although the leading edge wing damage was from major disc fragments, the damage to the belly fairing and its internal wiring was established to be from a smaller fragment.

**Figure B62: Schematic showing the trajectory of the disc fragments as they exited the No. 2 engine case and impacted the left wing and airframe. A smaller, high energy disc fragment penetrated the belly fairing and severed the LPSOV control wires for the No. 1 and No. 2 engines**

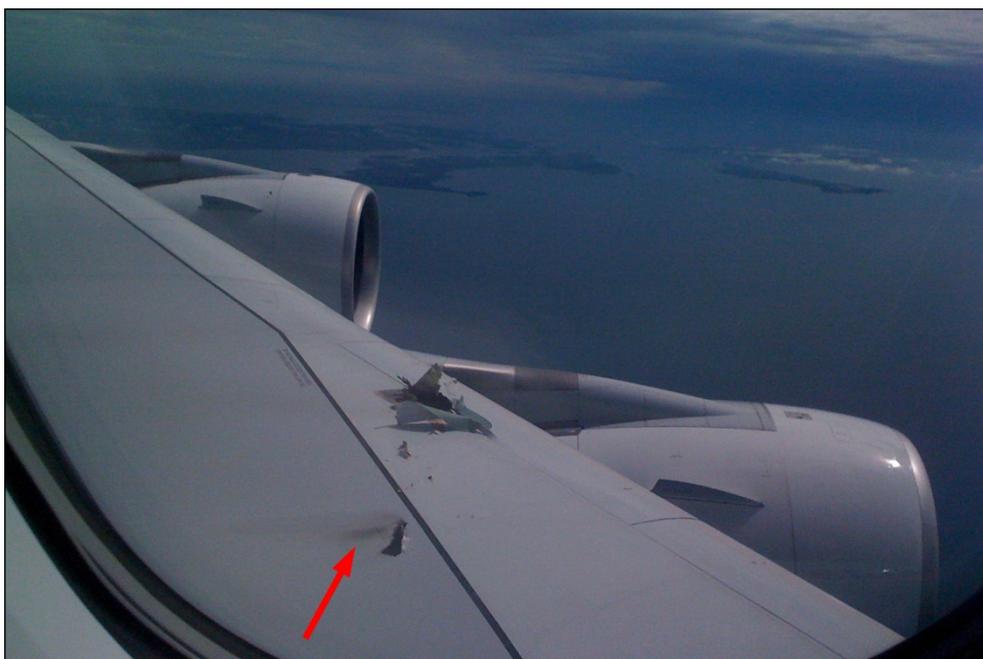
**Figure D1: View from the window on the upper deck, left side showing the presence of smoke/dark residue on the aft side of the hole (arrowed)**

Photographs supplied by the witness, those taken after the aircraft had landed and visual confirmation by the ATSB all showed the presence of smoke/dark residue on the aft side of the hole in the upper wing skin (Figure D1 and Figure D4).

A review of the damage observable from the passenger's seat on the upper deck indicated that the engine mechanicals and structure could be seen through the arrowed hole in Figure D1.

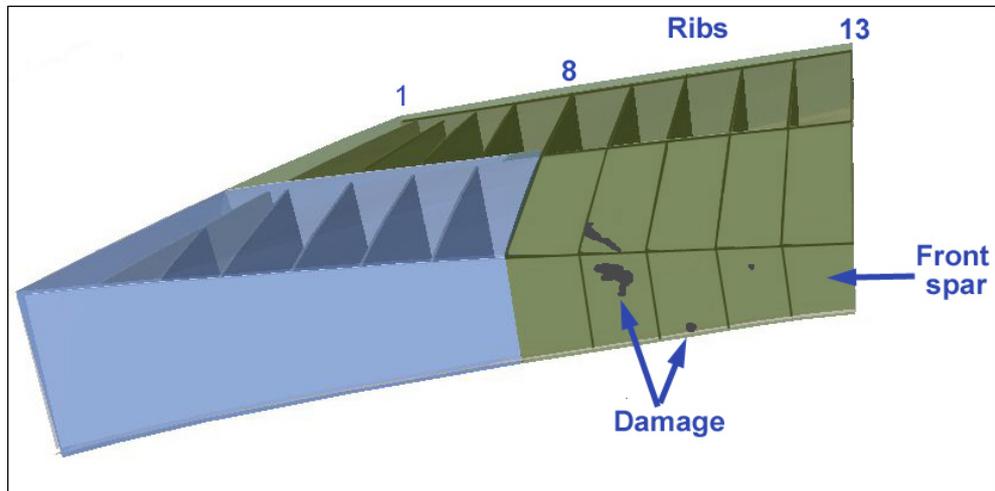
The LIT structure was considerably damaged by debris from the No 2 engine failure. The damage resulted when a large segment of the liberated IP turbine disc struck the wing bottom skin and passed through the front spar and LIT structure, before exiting through the wing upper skin. As a result of the disc's trajectory, the most significant damage to the LIT occurred to the front spar between ribs 9 and 10, and the upper wing skin in the region of rib 9 (Figure D3 to Figure D5). Table D1 provides the dimensions of the through-penetrations that were identified in the LIT.

**Figure D3: Schematic of the LIT (green) and feed tank 2 (blue), showing the location of the major front spar and top skin damage**

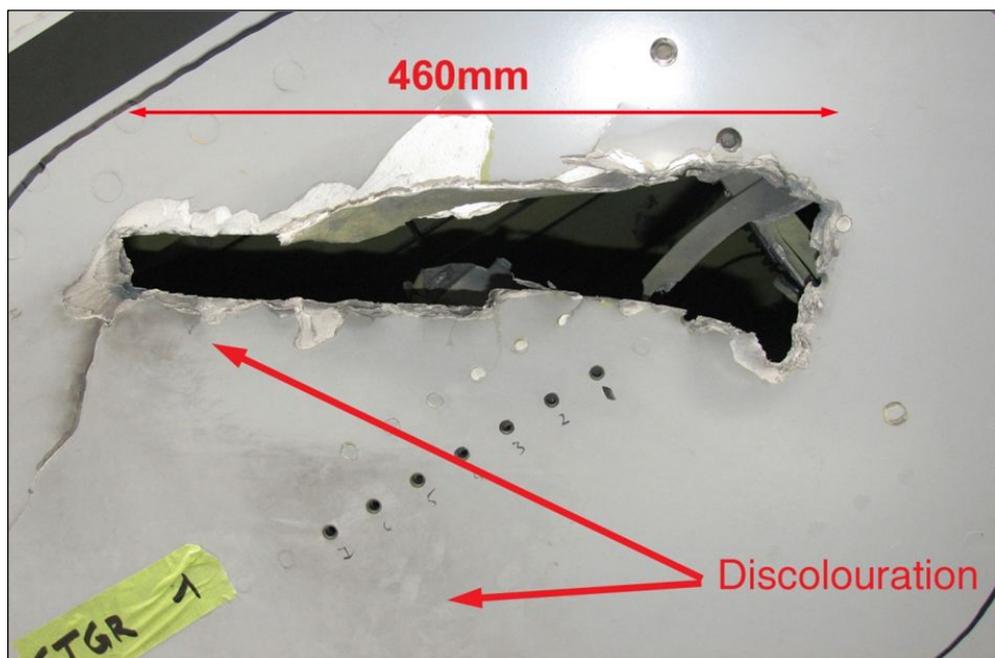
**Figure D4: Major damage on the LIT upper wing skin**

During the aircraft damage assessment, a dark coloured residue was identified on some surfaces within the LIT. Minor discolouration was also observed on the fractured surfaces of the large hole in the upper wing skin and on the painted surface of the skin towards the rearward side of the disc exit hole (Figure D4).

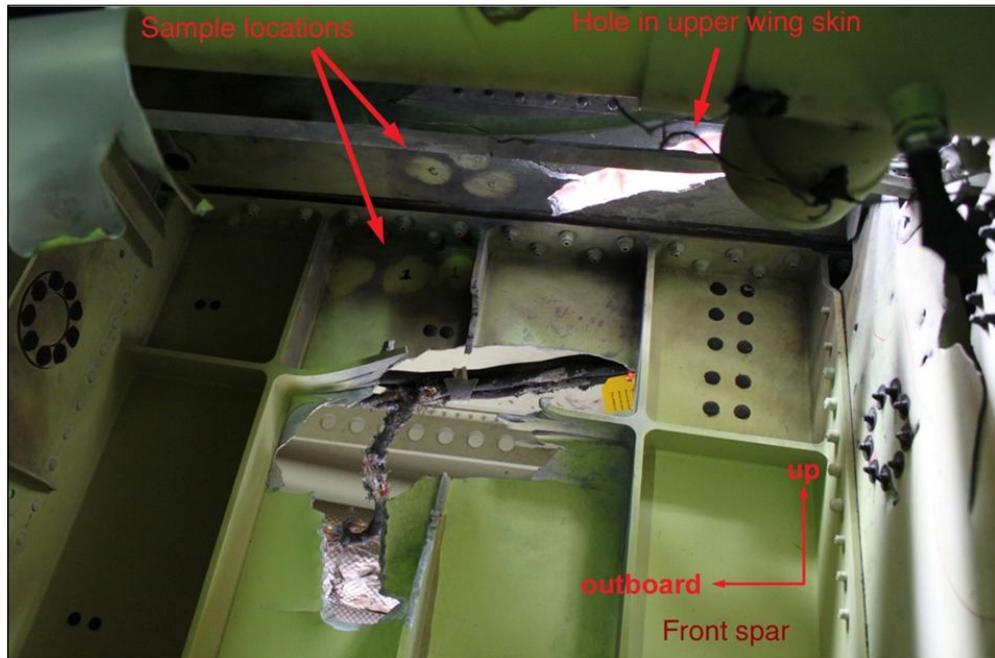
An examination of the internal surfaces of the LIT showed the residue to be principally located on the upper regions of the front spar (above the large hole), and along the underside of the top skin on the surfaces of the stringers (Figure D5 and Figure D6). The residue was also observed within the vent pipe shown in Figure D6. No evidence of dark residue was observed on either the wing underside, or on the front droop-nose structure.

**Figure D5: Damage and residue on the front spar (viewed forward from inside the LIT)**

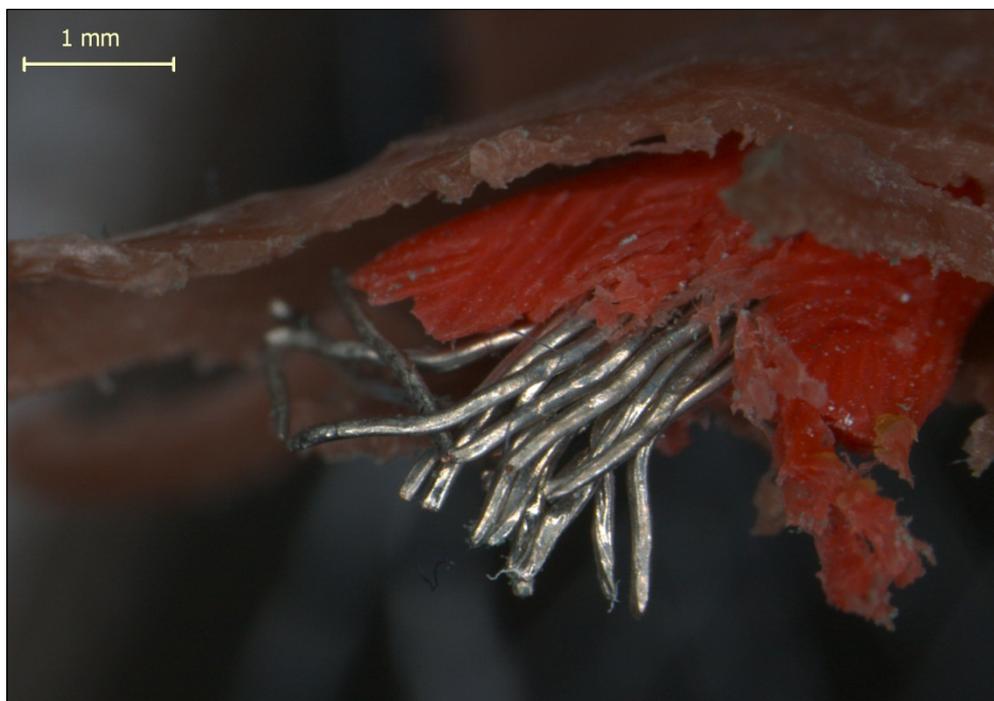
**Figure D8: Magnified view of the severed end of the FQIS wiring**

The section of FQIS wiring supplied was a y-shaped piece, approximately 1.2 m long, which had been severed during the engine failure. A small area of additional damage was observed towards the end of one of the sections. A visual inspection of the exposed wires showed severe mechanical damage; many of the conductors exhibited significant deformation as a result of contact with the liberated engine debris. The inspection identified a number of 'cup and cone' and angular shear fractures, all consistent with tensile overstress failure (Figure D8). No evidence of any discolouration or arcing was observed on the fractured ends of the wires, and the plastic coating did not exhibit any discolouration, burning or charring.

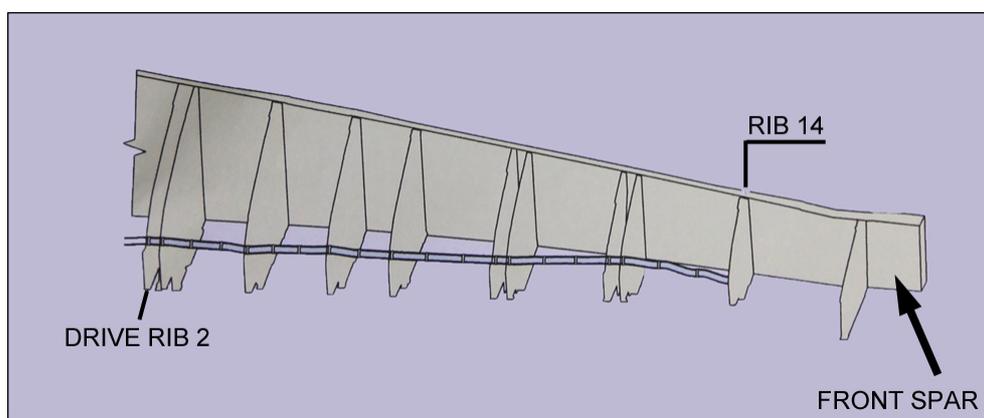
**Figure D9: Location of VFG1 and 2 feeder cables along the wing front spar**

The VFG feeder cables for the No. 1 (VFG1) and No. 2 (VFG2) engines were located in the bay forward of the front spar (Figure D9). The VFG1 and VFG2 feeders had been severed at the left wing leading edge. An examination by Airbus reported that there was no visible trace of arcing, short circuit or overheats on any cable.

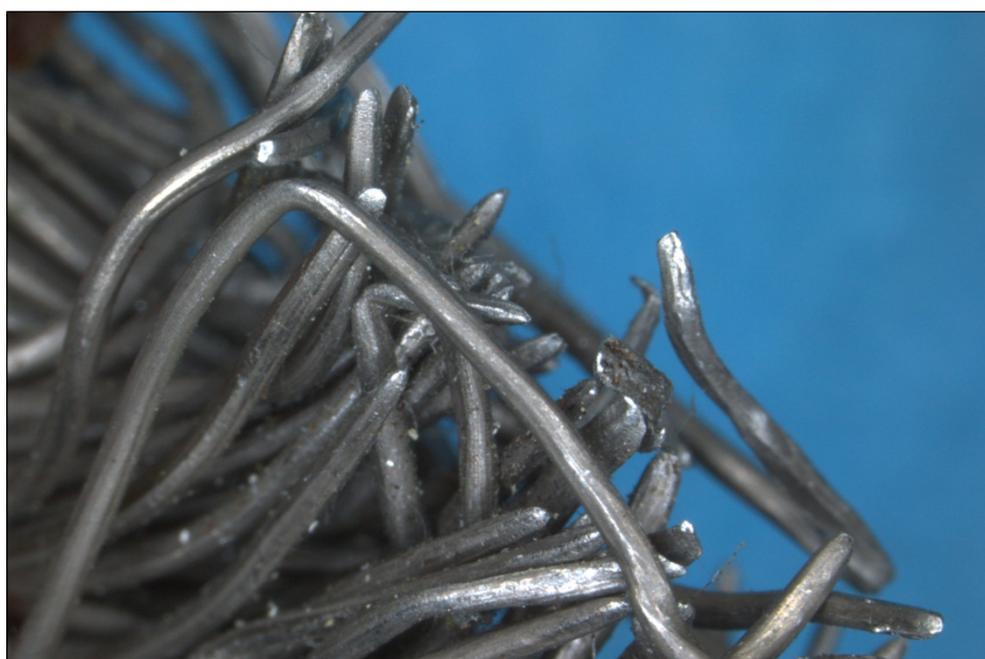
**Figure D10: Magnified view of the severed end of VFG2 wiring**

The severed wires exhibited deformation and markings consistent with the mechanical damage that was observed on the FQIS wiring. The fractured strands exhibited 'cup and cone' features that were indicative of an overstress failure (Figure D10).

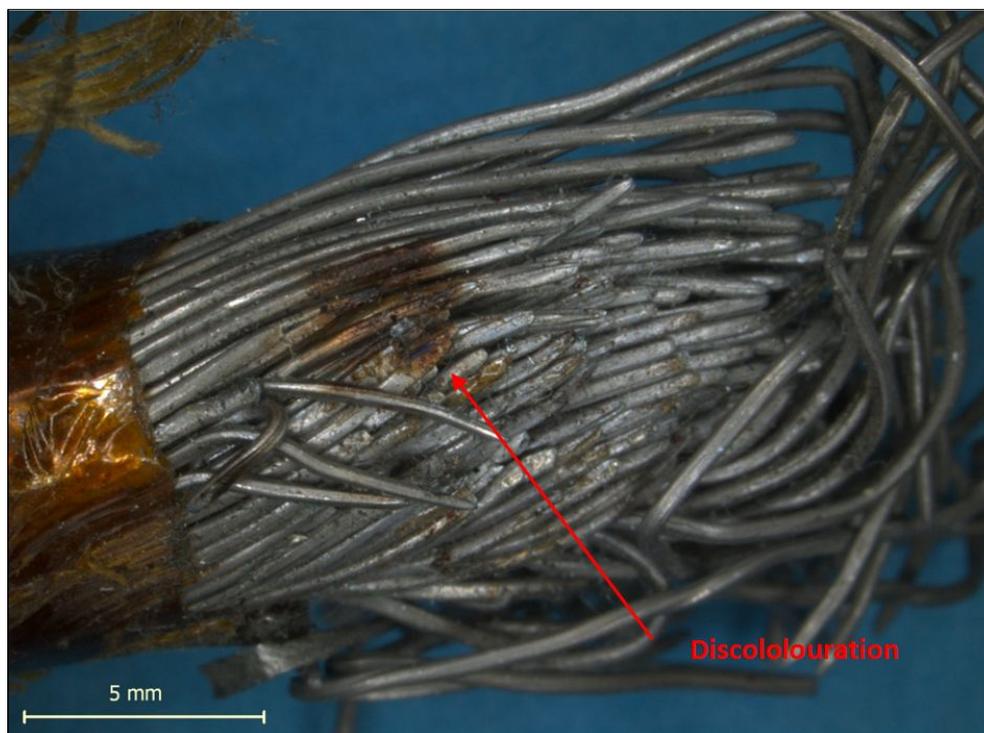
A small discoloured spot was identified on one of the VFG2 cables supplied (Figure D11). While the source of the discolouration was not identified, there did not appear to be any associated melting that would indicate that it was a result of arcing.

**Figure D11: VFG2 cable showing small area of discolouration**

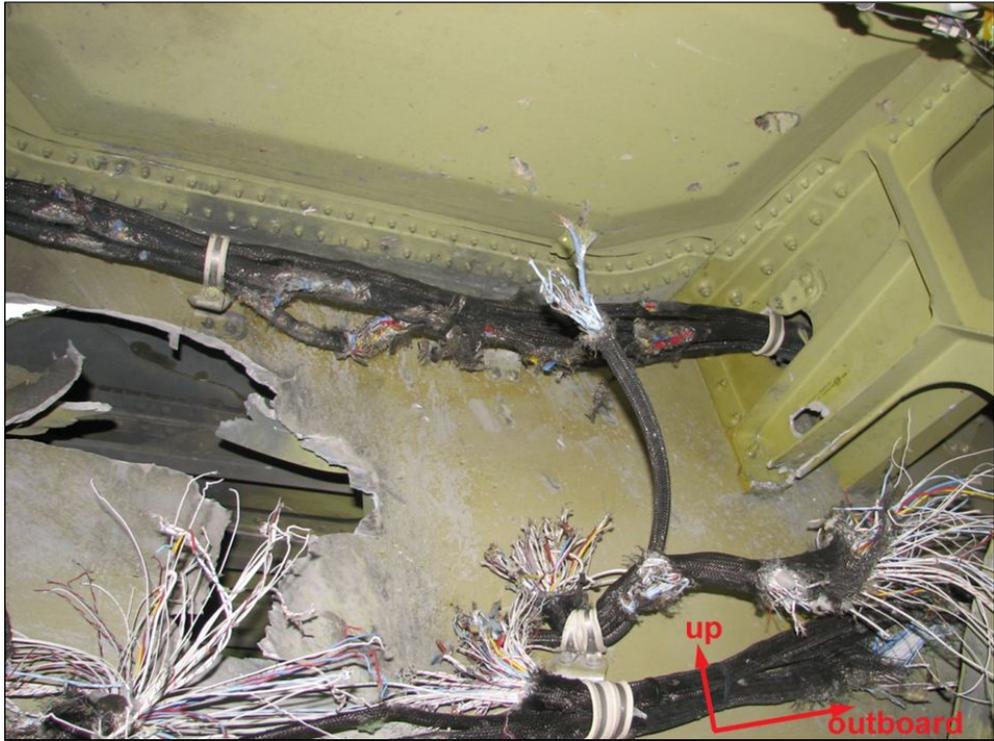
The sections of harness comprised of a number of smaller wires encased in an outer sheath. Damage to the harnesses varied from complete separation to minor damage to the outer sheath and a small number of wires (Figure D12 and Figure D13).

**Figure D12: Overview of severed harnesses in-situ, located in the left wing leading edge (also showing the front spar, looking rearward)**

All of the exposed severed wires were examined, with no evidence of any arcing noted. The fractured ends of the wires were consistent with overstress failures as a result of localised mechanical impact.
